# Comprehensive Waterworks Evaluation and Cost Estimate

## City of Richmond, VA

Virginia Department of Health, Office of Drinking Water

VADOH 183662 | April 8, 2025

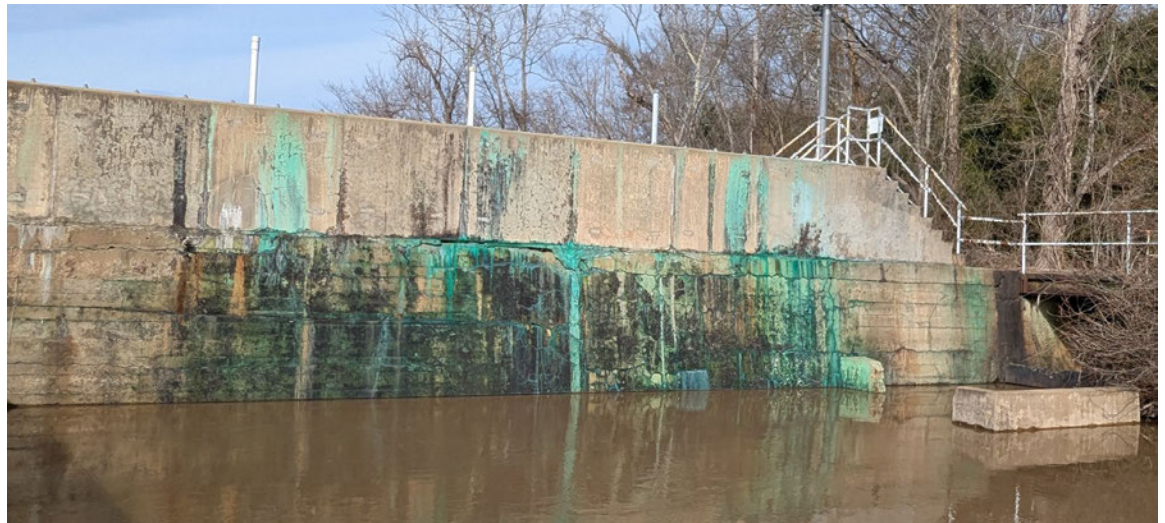
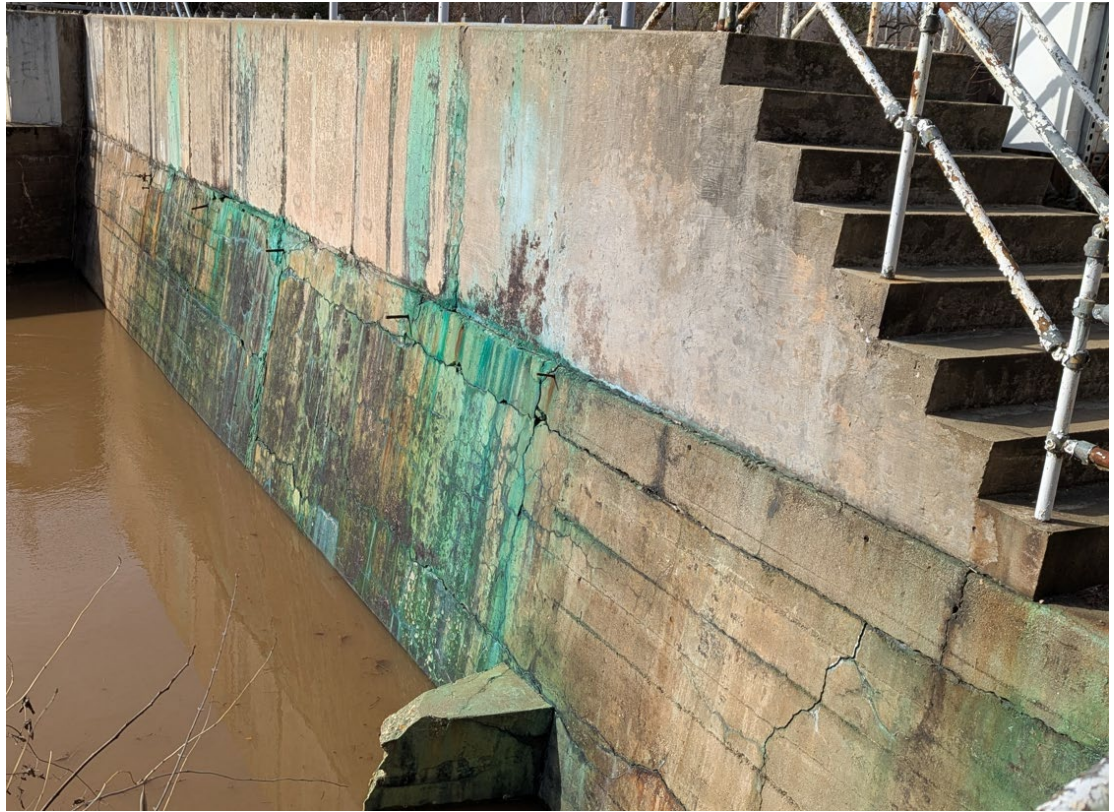
1. The pre-sedimentation intake wall shows signs of damage with significant cracking present. Copper sulfate addition appears to be broadcast over the wall, with significant staining present. Recommend additional structural inspection and repairs.

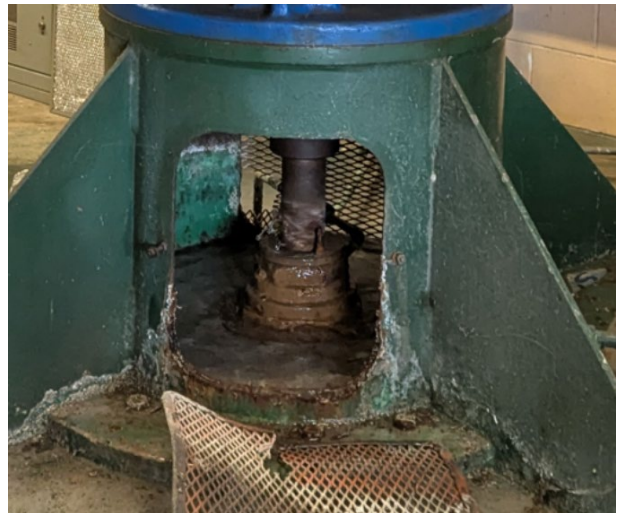
5. Raw Water Pump No. 3 was observed to be leaking water through the shaft packing/seal. It is recommended that the pump is repaired.

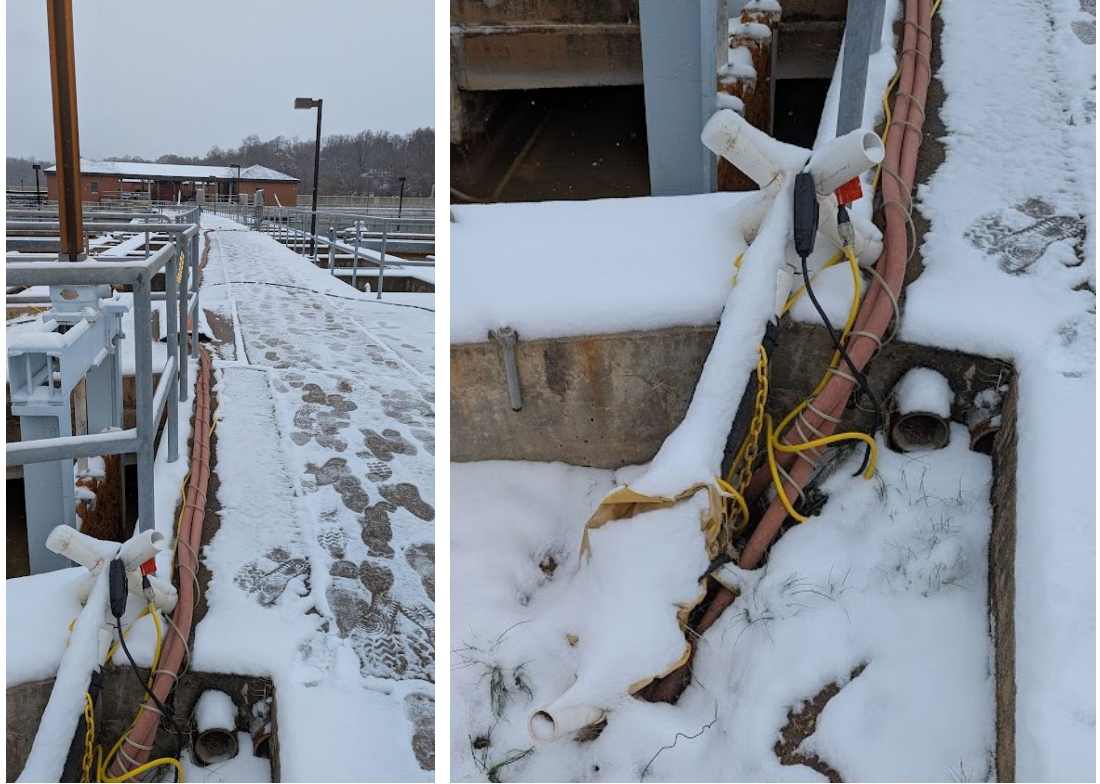
2. SEH staff observed that alum feed hose was installed in a semi-permanent fashion using flexible chemical hoses that were run above the walkway between the raw water channels before discharging into each raw water channel. SEH staff observed the chemical hoses to be routed below the grass before terminating within Plant #2. SEH staff could not locate where the chemical hose transitioned to rigid piping within the building. **12VAC5-590-860** requires that chemical feed lines be protected against freezing and specifically requires that liquid alum does not mix with water before the point of application. Recommend permanently installing feed lines in such a manner to protect them from freezing and damage minimizing trip hazards.

*Alum chemical hoses run above ground and along walkway to channel mixers.  
Extension cords and heat tracing run along hoses.*

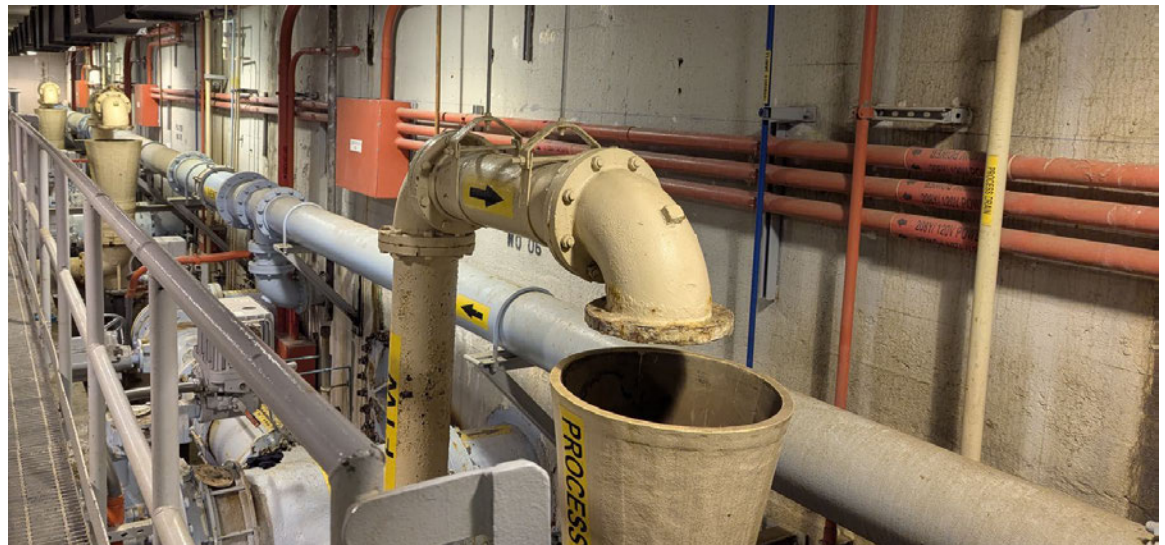
1. The filter piping, bolts, and lower-level structures of Plants 1 and 2 show signs of severe corrosion and damage and are in very poor condition. The stainless-steel air scour piping show signs of severe chlorine induced corrosion and pitting. The facility previously used chlorine gas for disinfection which would have accelerated the damage. The piping gallery in Plant #2 is in noticeably worse condition than Plant #1. Due to the age of piping and severe damage, SEH recommends rehabilitation of filter piping in both Plants 1 and 2. The piping should be blasted, thickness verified, and recoated. All corroded bolts should be replaced. The walkway in Plant #2 should be replaced as the supports are severely corroded with minimal material remaining.

*Plant #1 – Filter Piping Gallery*

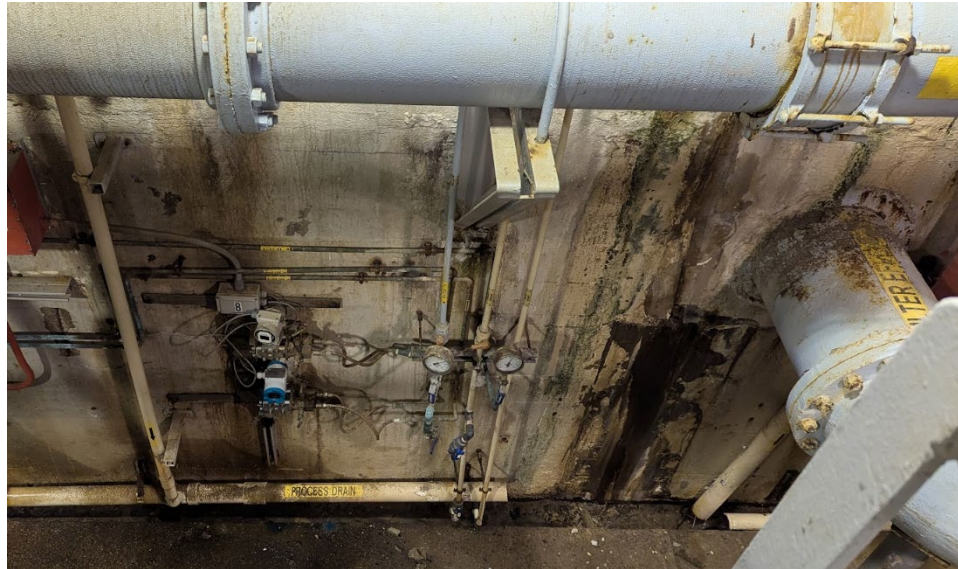
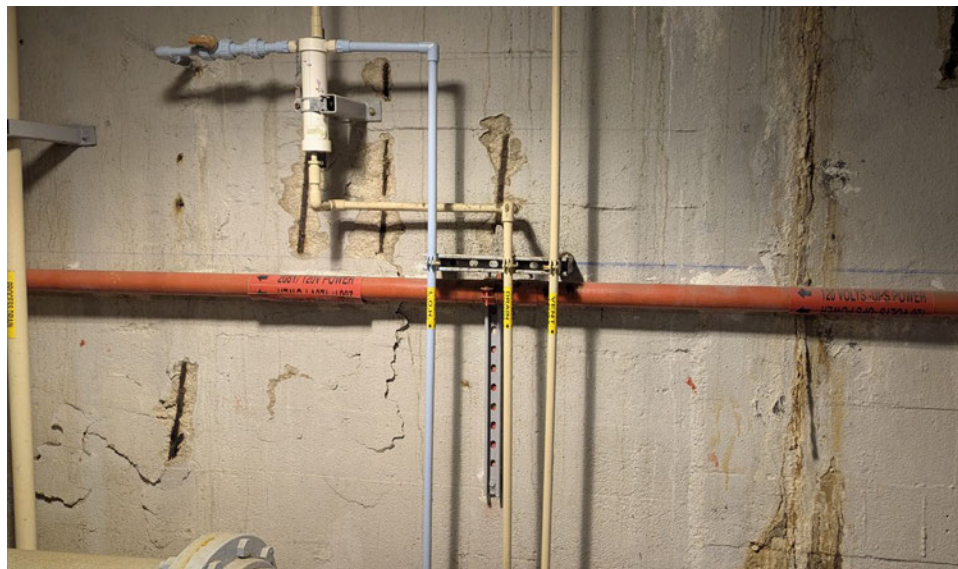
2. There are significant coating failures as well as leaks in the concrete filter walls into the piping gallery. SEH recommends that the filter walls are repaired and re-coated.

*Filter 8 Wall Damage and Leaks – Plant #1*

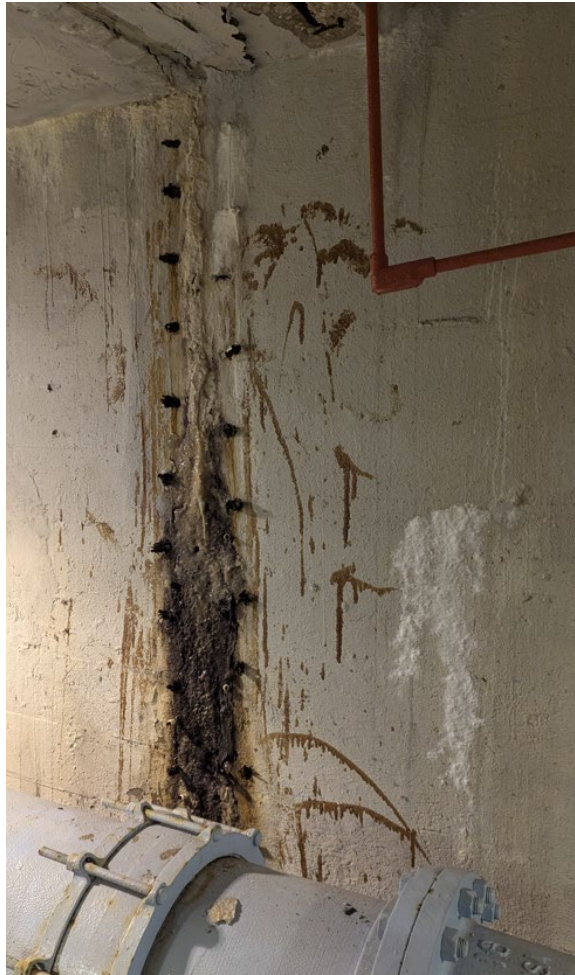
*Filter 10 Wall Damage and Leaks – Plant #1*

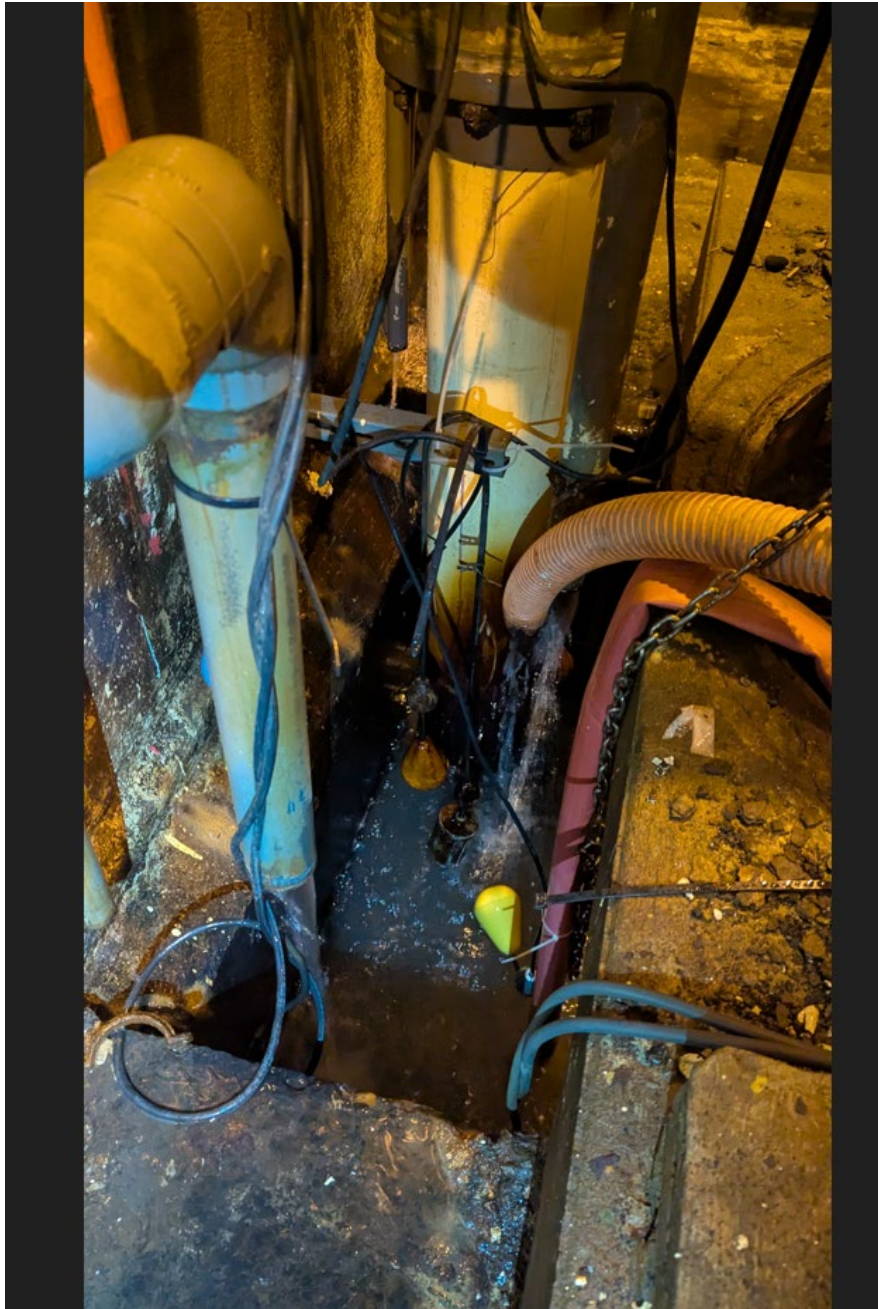
3. There are significant amounts of standing water in the lower level of both filter galleries (Plants 1 and 2) along with significant amounts of leaking water from the filter walls and piping. There were multiple sump pumps throughout the basement that were constantly discharging water to various process drains, with hoses and extension cords running throughout the area. The amount of water present contributes to very high humidity levels which is harsh on electronics and coating systems. Recommend that all source of leaks are identified and repaired, and all wall penetrations sealed. Once repairs have been completed, recommend installation of permanent sump pumps capable of removing water from minor leaks, seepage, condensation, and other analyzer or process drains. The sump pumps would not be expected to handle a process flood into the basement level.

*Plant #2 – Sump Pumps with Wiring, Hoses, and Extension Cords*

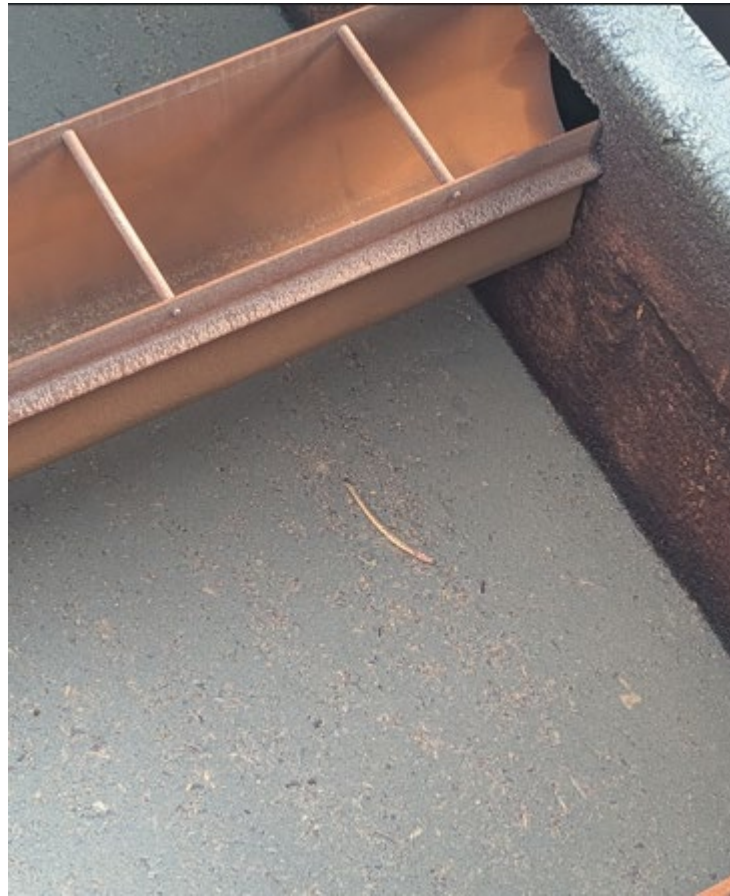
5. During the inspection, SEH observed what appeared to be a dead eel on the surface of Filter No. 11 located in Plant #2, which was currently offline. It is recommended that the facility implements an inspection procedure to periodically drain filter cells and perform visual inspections of the media, troughs, and filter walls. It is recommended that the facility performs annual evaluation of the placement, quantity, and condition of the filter media following the *Filter Evaluation Procedures for Granular Media, Second Edition*, by AWWA (American Water Works Association)

*Filter No. 1 – Dead Eel on Surface of Media*

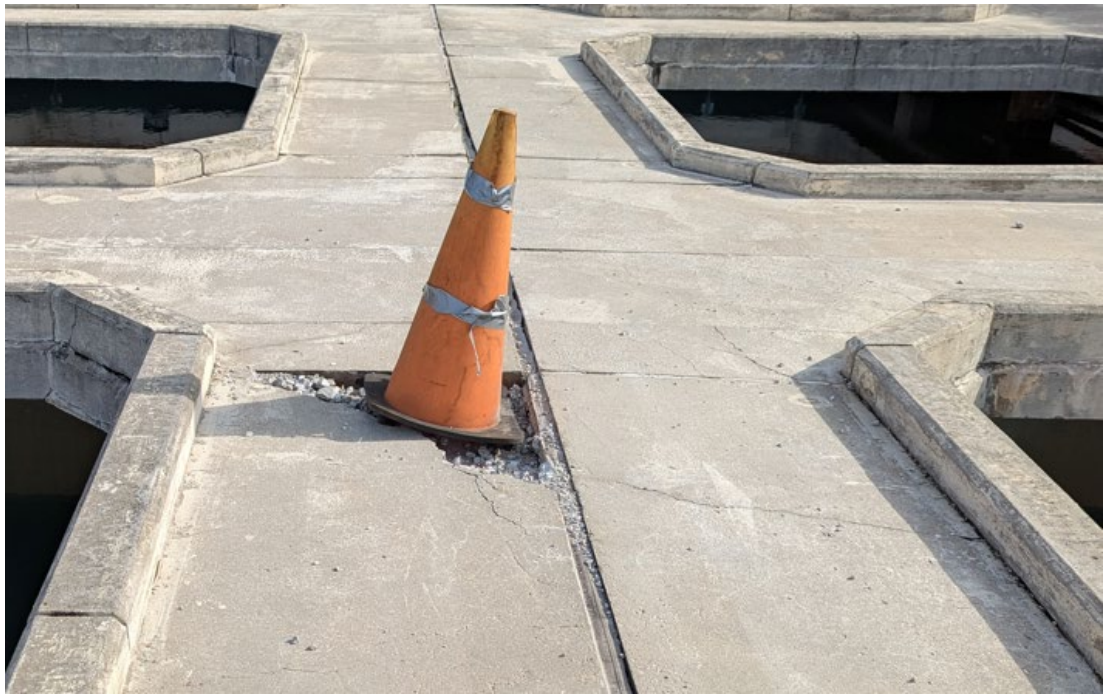
10. There are some concrete failures on the Plant #2 filters that are not covered. Recommend repair.

*Filter Walkway – Plant #2*

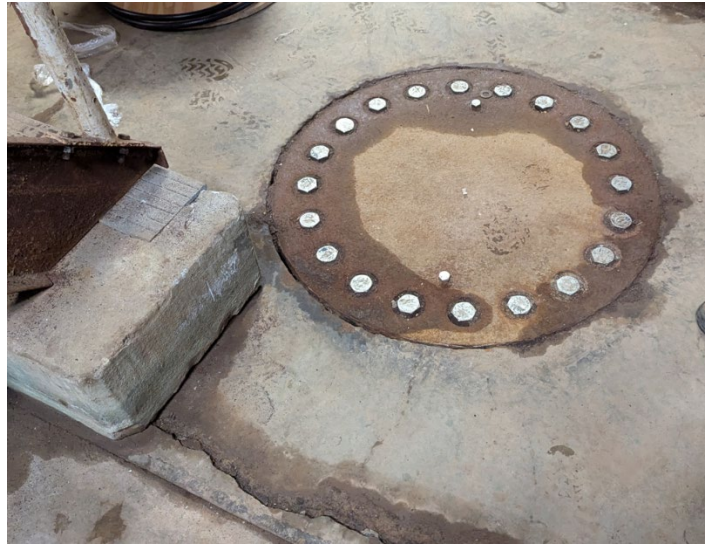
4. In Plant #2, water primarily surcharges out of a bolted access hatch over the pump suction well. DPU staff noted that the hatch is not watertight, and water leaking around the edges of the cover is the first visible sign of the clearwell surcharging. The plan drawings noted a finished floor elevation of 90.0 feet in the filtered water pump room, which results in a normal operating band of 1.0 foot to prevent the pumps from losing prime and not surcharging water into the pump room.

*Bolted Access Hatch and Concrete Crack in Plant #2*

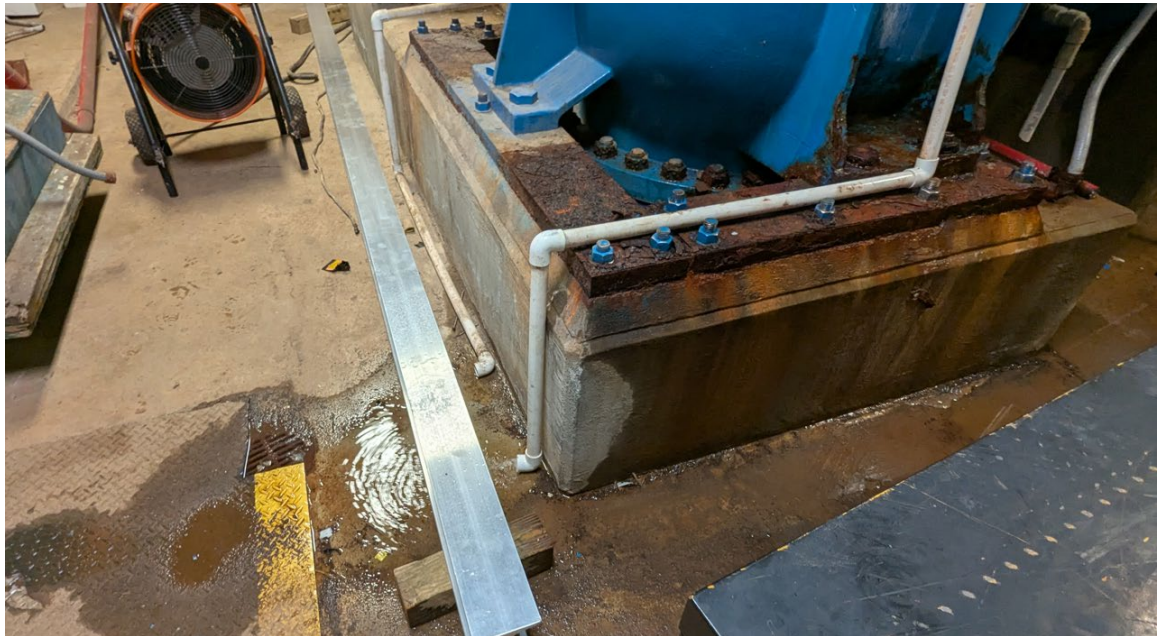
8. There were significant amounts of standing water and actively discharging water within the filtered water pumping areas, some without a nearby process drain. **12VAC5-590-1050A.8.** requires that a suitable outlet for drainage from pump glands be provided without discharging onto the floor. It is recommended that the drains are extended and properly routed to a floor drain.

*Discharging Water – Filtered Water Pump S4 (Plant #2)*

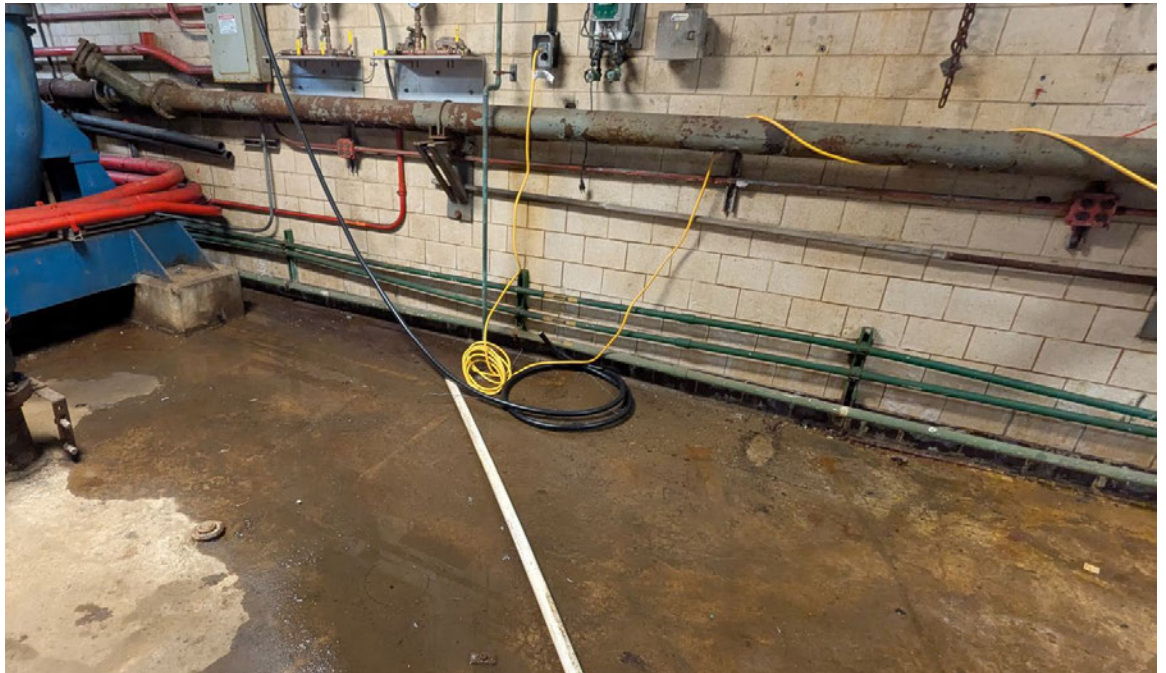
*Standing Water in Plant #1 – Pumping Room*

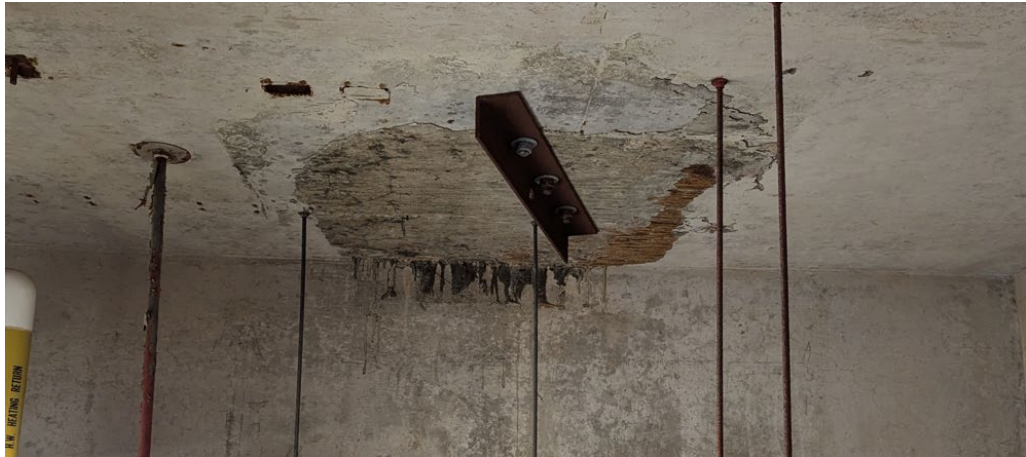
11. There is significant coating failure of the piping and walls throughout the filtered water pumping rooms in both Plants. Recommend blasting, recoating, and repairs. Bolts should be inspected and replaced in both Plants.

*Filtered Water Pumping Room – Plant #2*

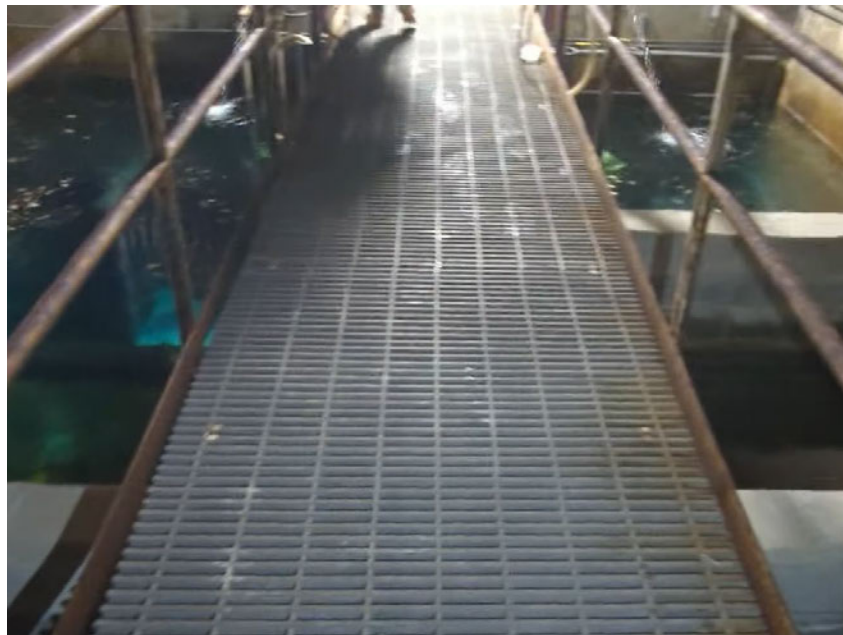
1. There are catwalks in the chlorine contact basins that do not have a solid floor. Shoe scrapings and dirt can fall directly into the water, violating **12VAC5-590-1081**. Recommend installing solid floor with raised edges.

*Catwalks in Chlorine Contact Basin*

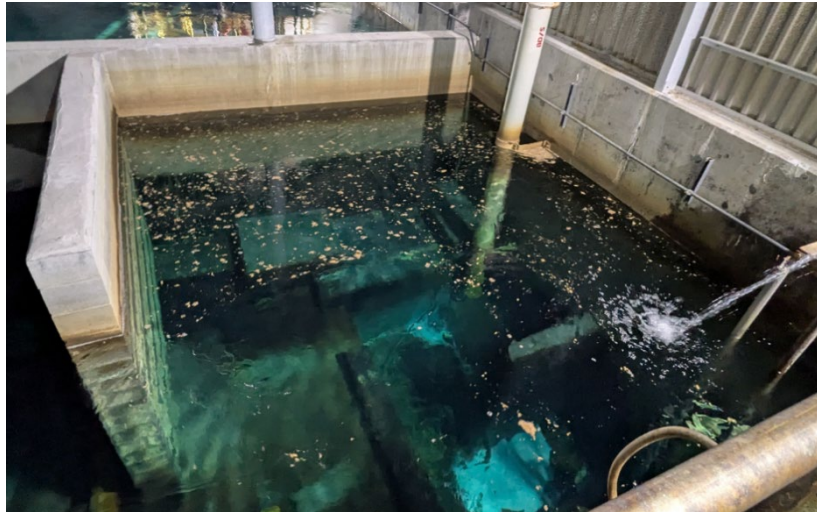
2. SEH observed significant amounts of floating brown scum/foam at the outlet of both chlorine contact basins. Recommend identifying source of contamination and cleaning.

*Chlorine Contact Basin*

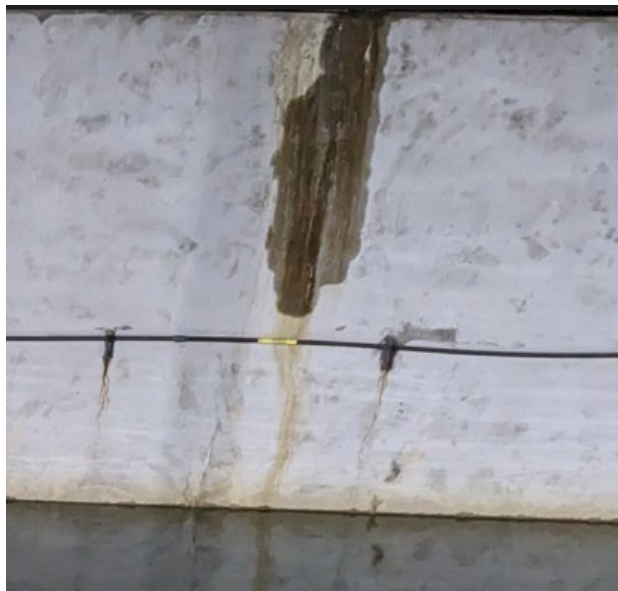
3. The chlorine contact basins showed signs of water intrusion. **12VAC5-590-1081 Section H** notes that roof and sidewalls shall be watertight and that all pipes running through the roof or sidewall should be connected to standard wall castings with flanges imbedded in the concrete. The basins have multiple pipe penetrations which utilize Link-Seal type penetrations. Recommend detailed inspection of structure to identify repairs to seal all penetrations to ensure that the roof and sidewalls are watertight.

*North Chlorine Contact Basin*

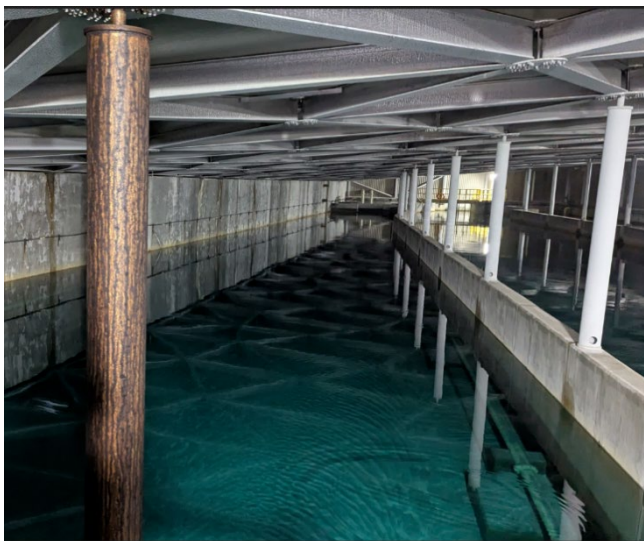
4. The piping and valves within both chlorine contact basins is in moderate condition. Several support beams were observed to have significant damage from chlorine vapors. Recommend the facility implement a monitoring program.

*Chlorine Contact Basin – Plant #1*

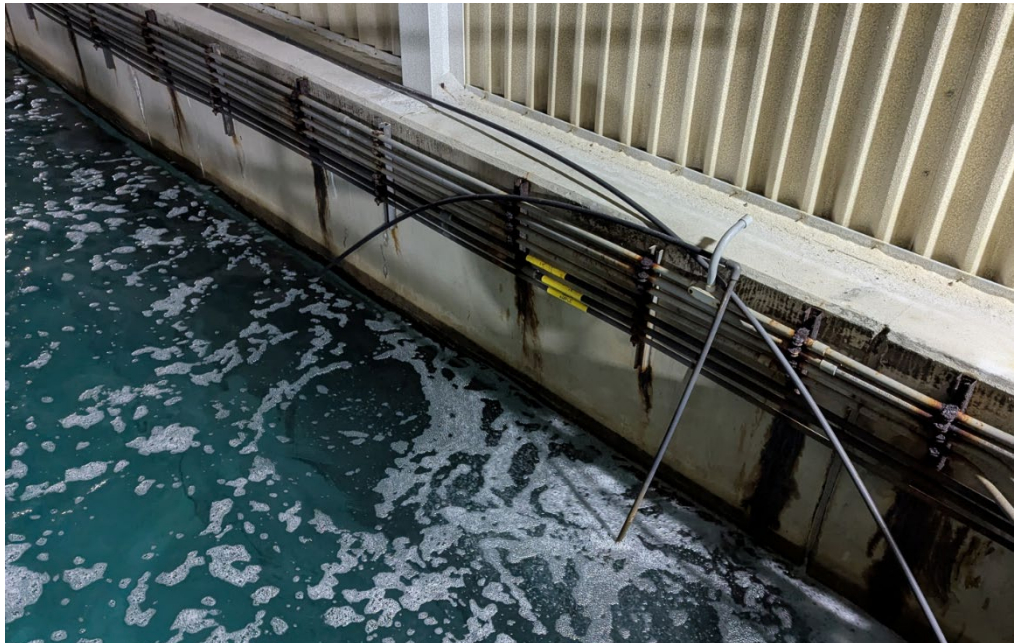
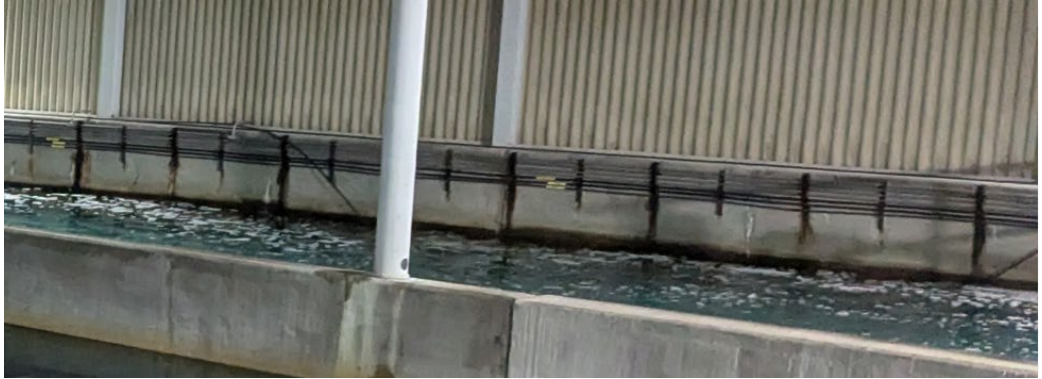
6. Piping supports throughout both basins appeared to be severely corroded and damaged. In Plant #1, several supports were broken, with two sampling or conduits hanging loose. One pipe appeared to have been pulled up onto the concrete wall, while another was found hanging below the water surface. Recommend replacing piping and supports.

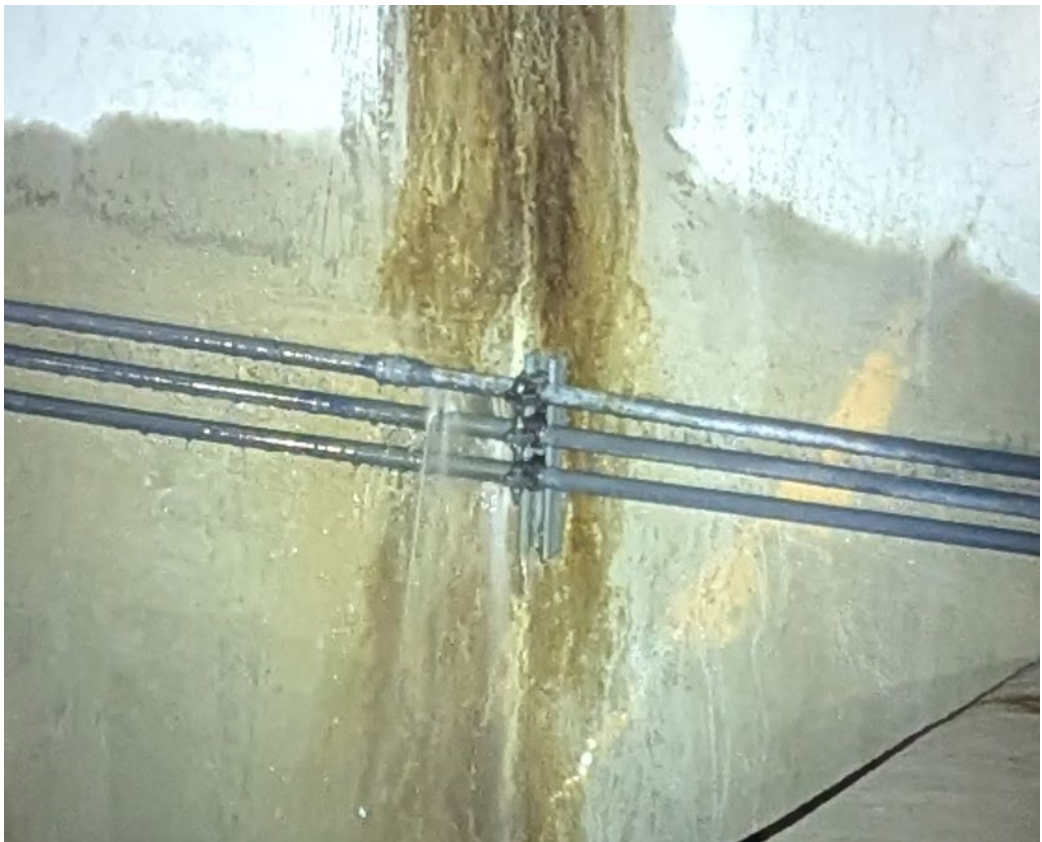
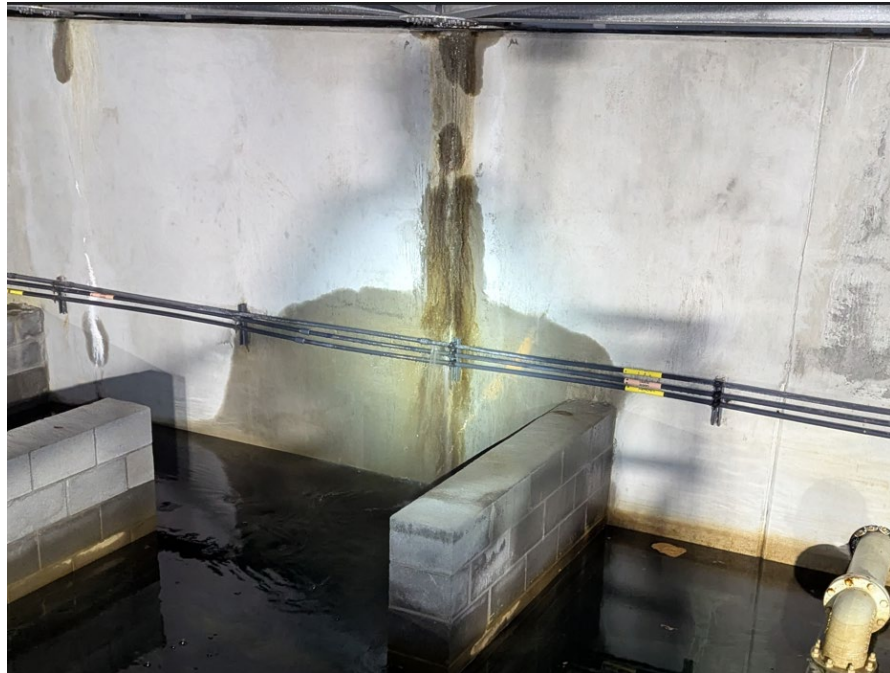
7. A PVC sample line in the north chlorine contact basin appeared to be broken and spraying significant amounts of water. Recommend replacement of the PVC pipe.

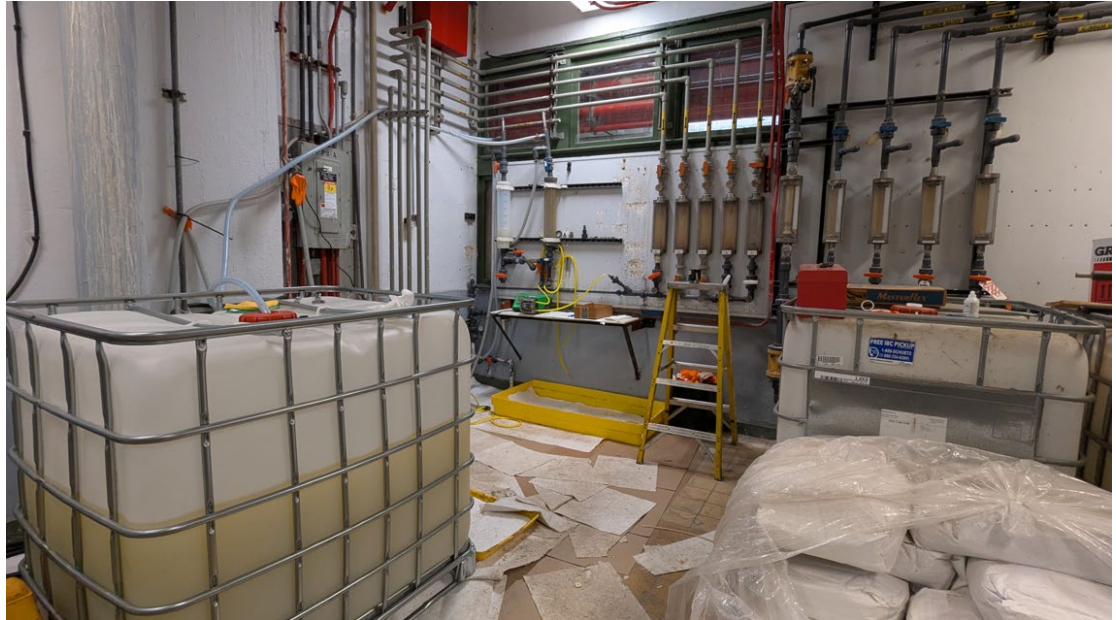
3. The polymer systems are fed from totes without secondary containment walls or pallets. Housekeeping is very poor in both polymer rooms, with significant amounts of debris and evidence of spills. Polymer spills are slippery and pose trip and slip hazards. There is abandoned chemical piping and electrical equipment in both Plant #1 and Plant #2 polymer rooms. Recommend addition of secondary containment and removal of unused piping. **12VAC5-590-470. Waterworks condition.** The waterworks shall be maintained in a clean and orderly condition.

*Plant #1 – Polymer Chemical Storage and Feed*

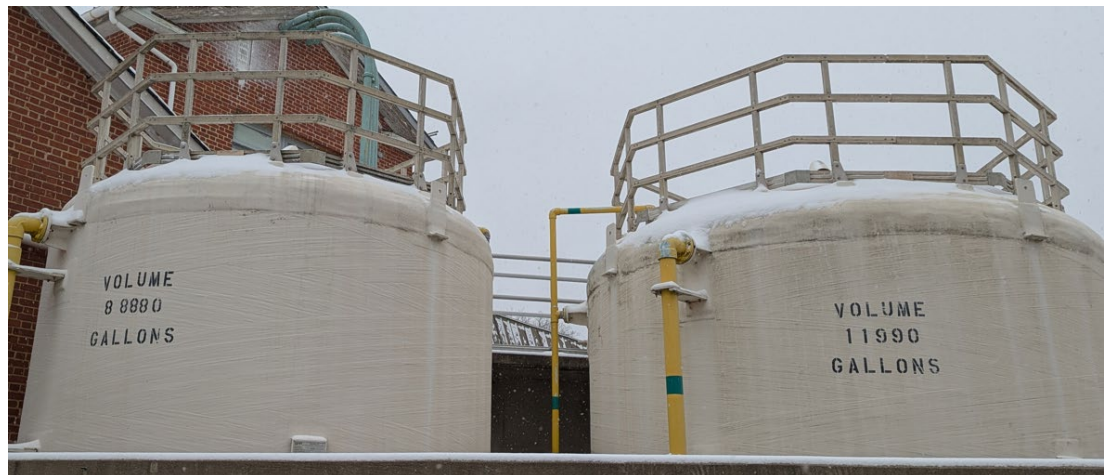
*Caustic Storage Tanks – Left Tank Mislabeled*

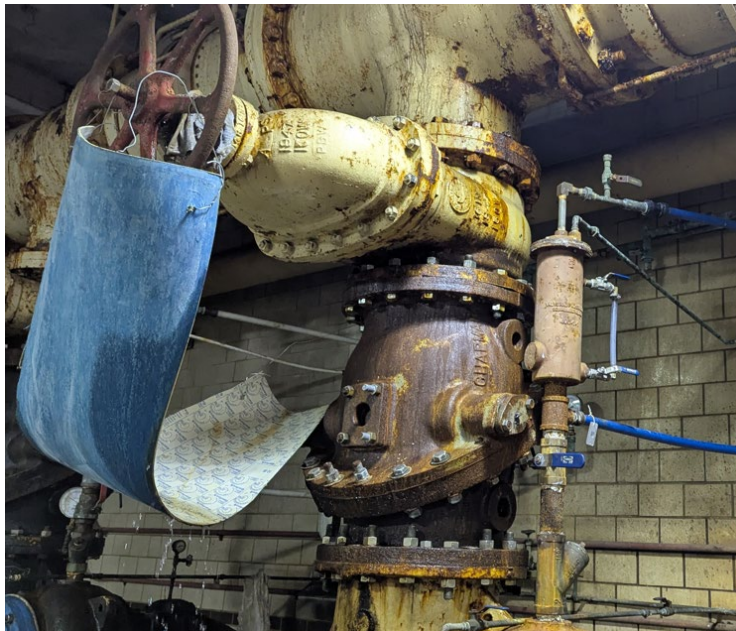
*Leaking Gate Valve with Diverter*

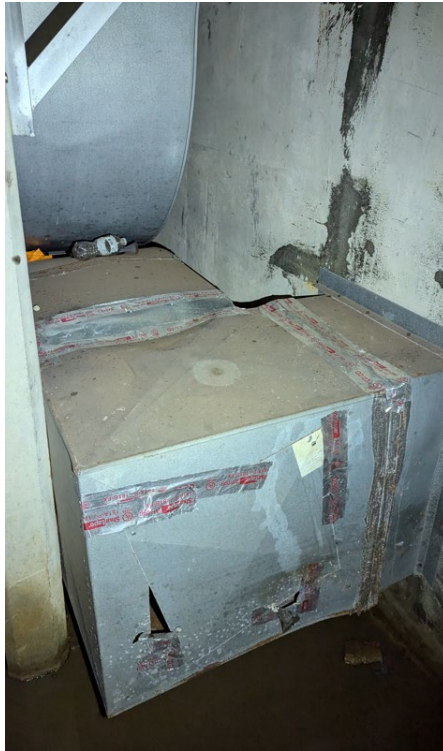
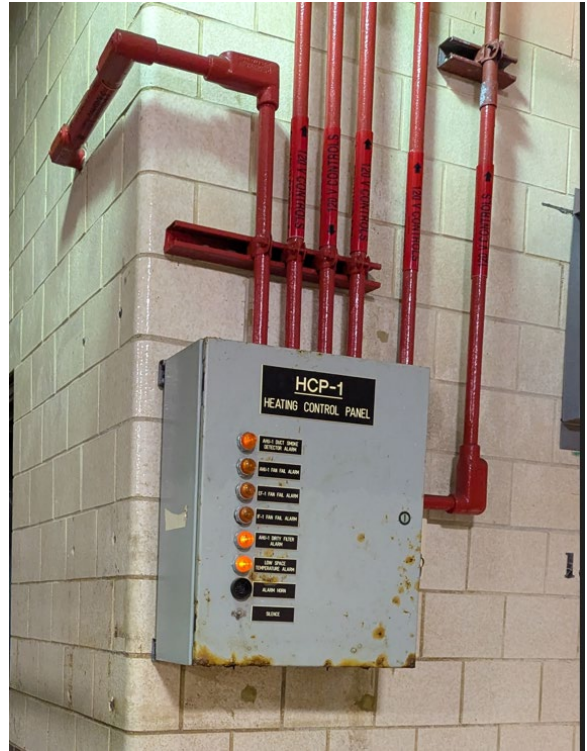
*Wastewater Pumping Station Damaged Ducts and Heating Control Panel*

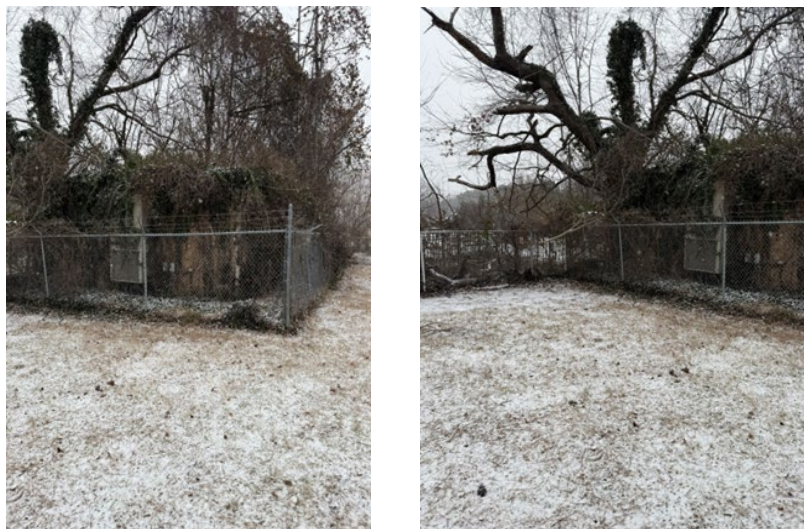
*Vegetation Encroaching on Fencing*
