To: Travis Bridewell (City of Richmond)  
From: Thomas Ruff, PE, PTOE  
RE: Bliley Road Multimodal Study  
Date: September 23, 2019  
Copy: Scott Dunn, AICP, PTP (TG)

Timmons Group has prepared an assessment of Bliley Road and Westover Drive to best determine the location for potential bicycle and pedestrian improvements along the corridors and identify potential solutions for a safer, more accessible neighborhood. Along Bliley Road, the investigation focuses on the section between Jahnke Road and Blakemore Road. On Westover Drive the investigation focuses on the section between Blakemore Road to Forrest Hill Drive, as shown on Figure 1.

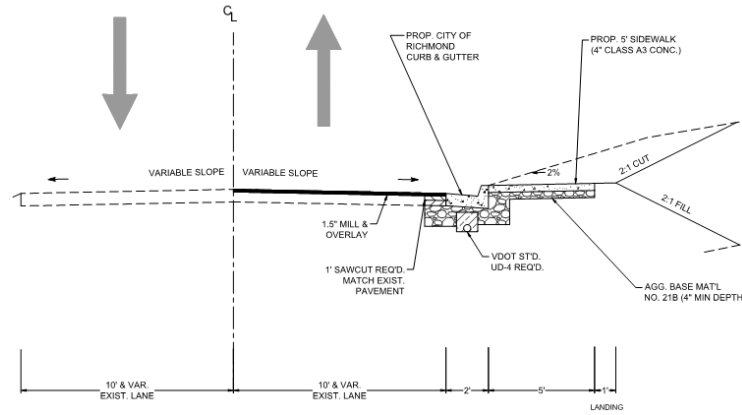
## Option #1 – Install Sidewalk Behind Curb

- \$750 per LF
- Biiley – \$3,000,000
- Westower – \$2,925,000

*Option 1 – Install Sidewalk Behind Curb & Gutter*

The safest option for improving multimodal travel along the Bliley Road and Westower Drive corridors is providing sidewalk behind curb and gutter. This option provides a safe location for pedestrians and bicycles outside of the roadway and the physical buffer of a curb between the roadway and the sidewalk.

This is also the most expensive option as it involves placing large amounts of concrete curb and gutter along the entire corridor, resulting in the need for extensive storm sewer piping and structures to accommodate the drainage. Advantages to the curb and gutter section include (1) limiting the impacts of grading to properties along the corridor and (2) potentially improving the overall drainage along the corridor.

Recent construction costs in the Richmond region have shown prices of approximately \$750 per linear foot for installing sidewalk behind curb and gutter. This pricing includes earthwork, storm sewer, curb/gutter, sidewalk, and basic utility relocations. Any retaining walls, major utilities, or rights-of-way would be additional costs.

The improvements on Bliley Road are approximately 4,000' in length, resulting in an approximate cost of \$3,000,000. The improvements on Westower Drive are approximately 3,500', excluding the 1,500' of curb/gutter already in place, resulting in an approximate cost of \$2,625,000. The 1,500' section with curb/gutter will only have sidewalk installed behind for a cost of \$200 per linear foot, resulting in an approximate cost of \$300,000. The total cost on Westower Drive is approximately \$2,925,000.

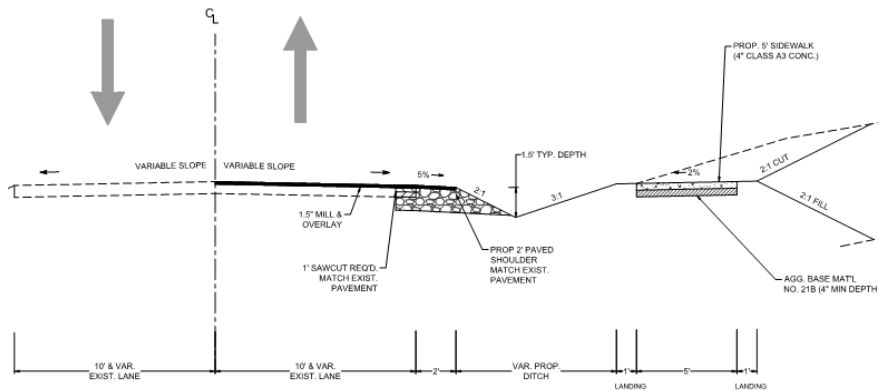
## Option #2 – Install Sidewalk Behind Improved Ditch

- \$600 per LF
- Biiley – \$2,400,000
- Westower – \$2,400,000

*Option 2 – Install Sidewalk Behind Improved Shoulder & Ditch*

The second option to provide a safer roadway for all modes of transportation is to improve the shoulders and ditches along the Bliley Road and Westower Drive corridors and install sidewalk behind the proposed typical section. This option would maintain the use of shoulder and ditch drainage along the entire corridor.

This option takes advantage of the existing ditches as a "natural barrier" between the roadway and the pedestrian/bicycle improvements. There would require some lateral movement to avoid existing utilities and utility poles. In addition, this option is the most impactful with respect to rights-of-way requirements due to severe grading issues along the corridor.

The approximate construction cost for improving the shoulders/ditches and installing sidewalk is \$600 per linear foot. Any retaining walls, major utilities, or rights-of-way are not included and would be an additional cost.

The improvements on Bliley Road are approximately 4,000' in length, resulting in an approximate cost of \$2,400,000. The improvements on Westower Drive are approximately 3,500', excluding the 1,500' of curb/gutter already in place, resulting in an approximate cost of \$2,100,000. The 1,500' section with curb/gutter will have sidewalk installed behind for a cost of \$200 per linear foot, resulting in an approximate cost of \$300,000. The total cost on Westower Drive is approximately \$2,400,000.

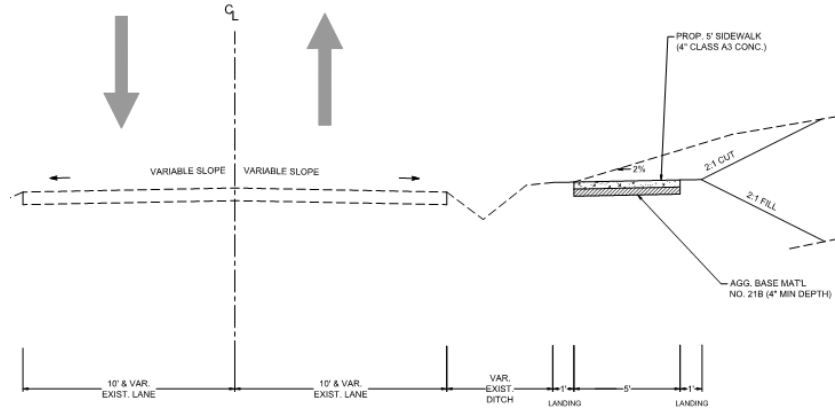
### Option #3 – Install Sidewalk Only

- \$300 per LF
- Biiley – \$1,200,000
- Westower – \$1,350,000

### *Option 3 – Install Sidewalk Only*

The third option to provide a safer roadway for all modes of transportation is to install sidewalks along the back of existing ditch (or existing curb/gutter) on the Bliley Road and Westower Drive corridors. This option would follow the existing contours of the shoulder and ditch sections along Bliley Road and Westower Drive and place the sidewalk in the most advantageous location along the graded back of ditch.

This option takes advantage of the existing ditches as a natural barrier between the roadway and the pedestrian/bicycle improvement location. In many locations, the sidewalk would need to meander along the back of ditch to utilize the existing grading. There would likely need to be some lateral adjustments to accommodate the existing utilities and utility poles.

The approximate construction cost for installing sidewalk only is \$300 per linear foot. Any retaining walls, major utilities, or rights-of-way would be additional costs.

The improvements on Bliley Road are approximately 4,000' in length, resulting in an approximate cost of \$1,200,000. The improvements on Westower Drive are approximately 3,500', excluding the 1,500' of curb/gutter already in place, resulting in an approximate cost of \$1,050,000. The 1,500' section with curb/gutter will have sidewalk installed behind for a cost of \$200 per linear foot, resulting in an approximate cost of \$300,000. The total cost on Westower Drive is approximately \$1,350,000.

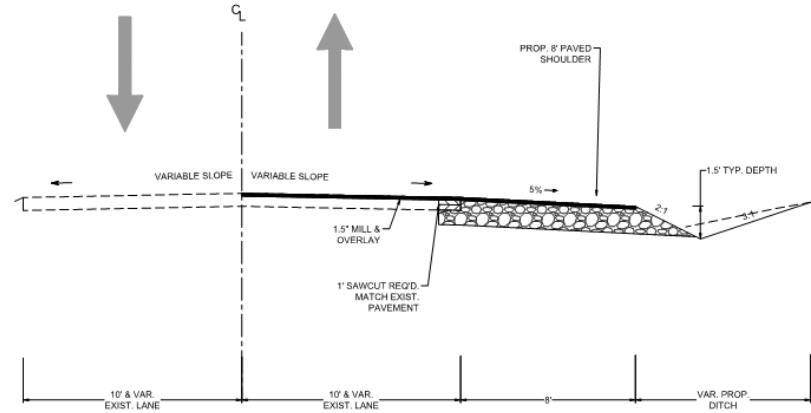
### Option #4 – Widen Shoulders Only

- \$400 per LF
- Biiley – \$1,600,000
- Westower – \$1,400,000

### *Option 4– Widen Shoulders Only*

The fourth option to provide a safer roadway for all modes of transportation is to widen the paved shoulders of the Bliley Road and Westower Drive corridors. This option does not include installing any pedestrian/bicycle centric sidewalk or multi-use path accommodations. One (1) side of the roadway would be widened to a minimum 8' width to allow for a 2' buffer and a 6' pedestrian/bicycle travel area.

This option is not ideal, as there is no physical buffer between vehicles and bicycles/pedestrians. In addition, there would be no designated sidewalk or multi-use path area, only a shoulder.

To install a wider shoulder along one side of the roadway, it will be necessary to relocate the existing ditch a minimum of 8' away from the proposed shoulder. This lateral movement will require additional considerations, such as right-of-way, retaining walls, utilities, and grading, that impact costs.

The approximate construction cost for widening the shoulders is \$400 per linear foot. Any retaining walls, major utilities, or rights-of-way are not included.

The improvements on Bliley Road are approximately 4,000' in length, resulting in an approximate cost of \$1,600,000. The improvements on Westower Drive are approximately 3,500', excluding the 1,500' of curb/gutter already in place, resulting in an approximate cost of \$1,400,000.

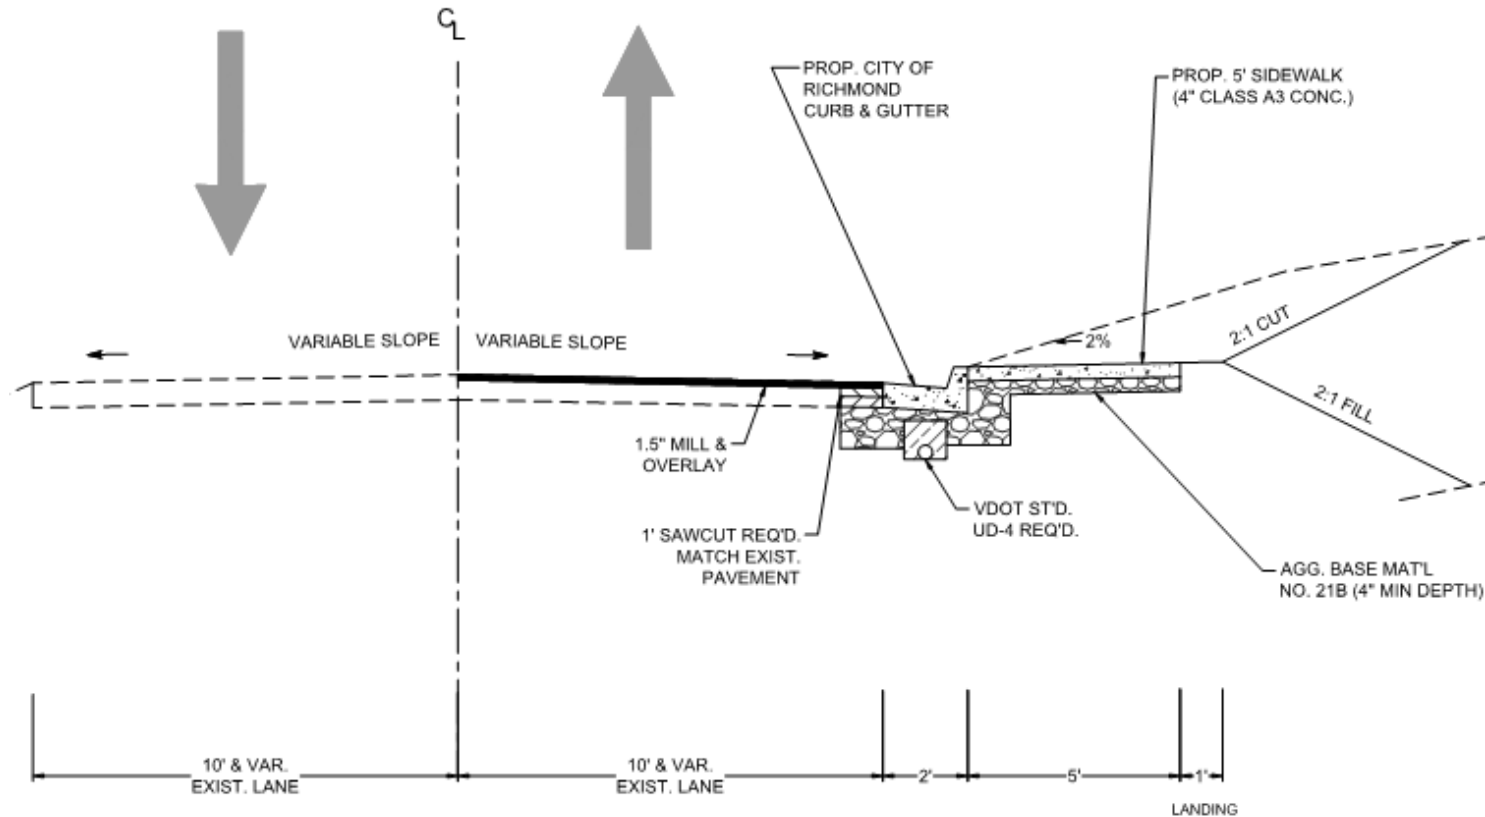
# Option #1 – Install Sidewalk Behind Curb

- \$750 per LF
- Bliley – \$3,000,000
- Westtower – \$2,925,000

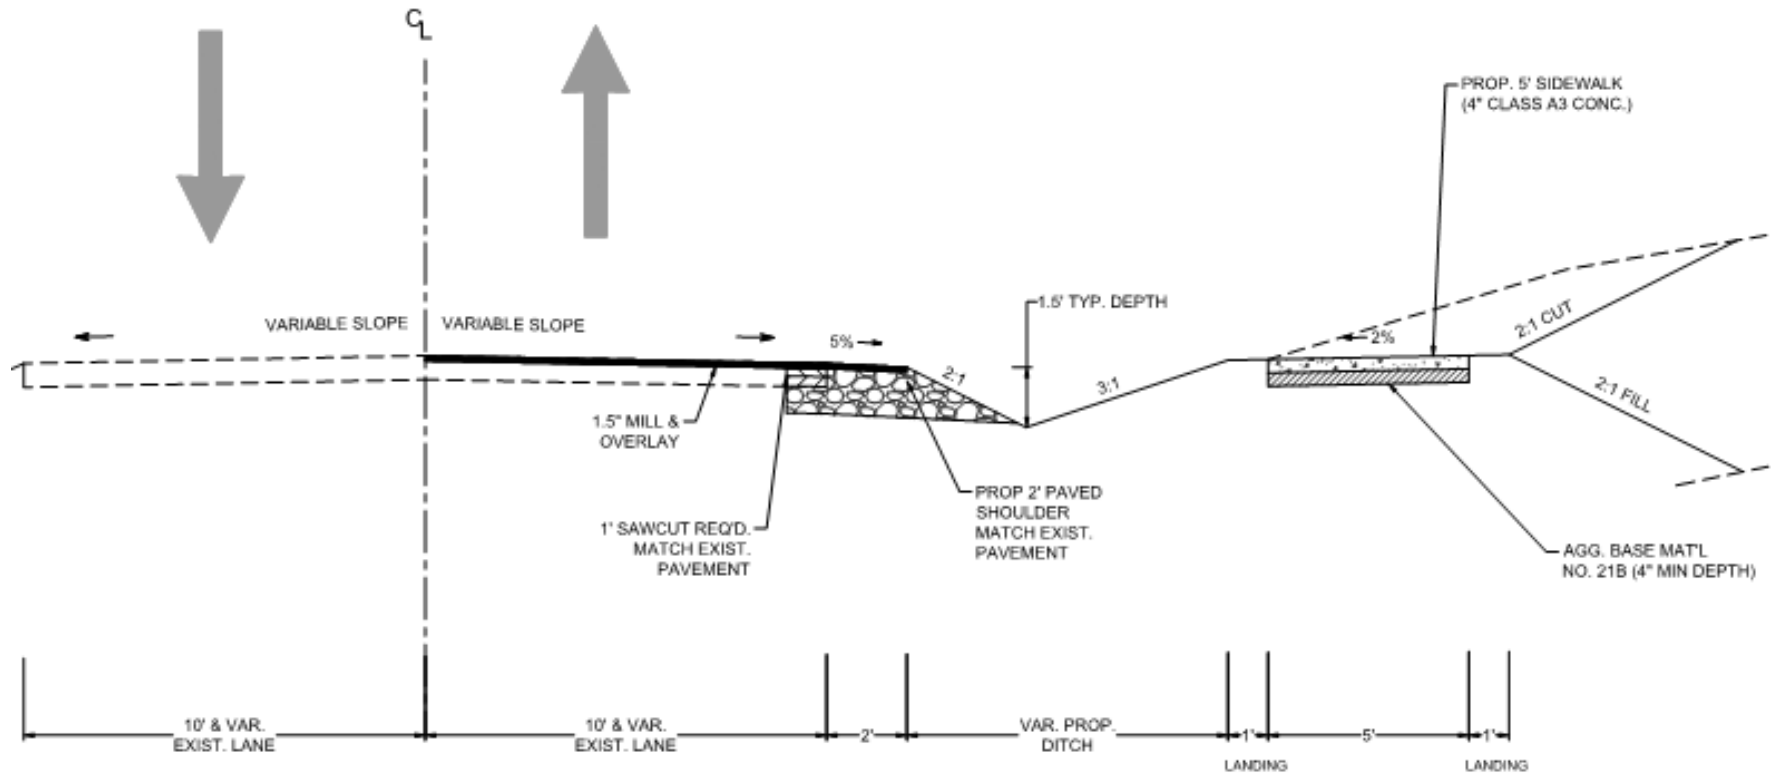
# Option #2 – Install Sidewalk Behind Improved Ditch

- \$600 per LF
- Bliley – \$2,400,000
- Westower – \$2,400,000

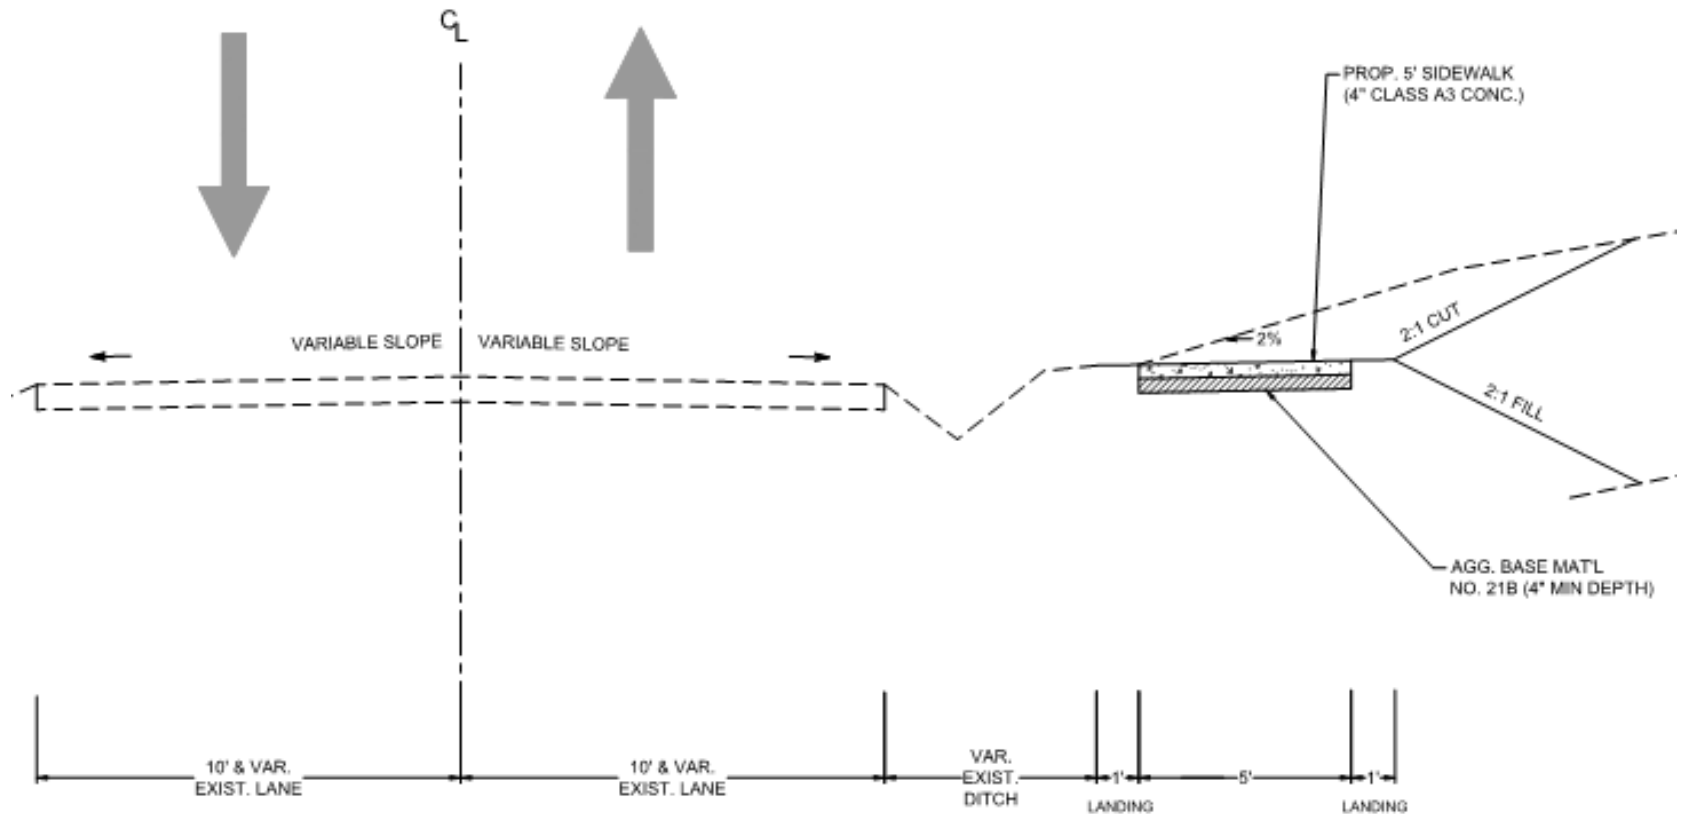
# Option #3 – Install Sidewalk Only

- \$300 per LF
- Bliley – \$1,200,000
- Westower – \$1,350,000

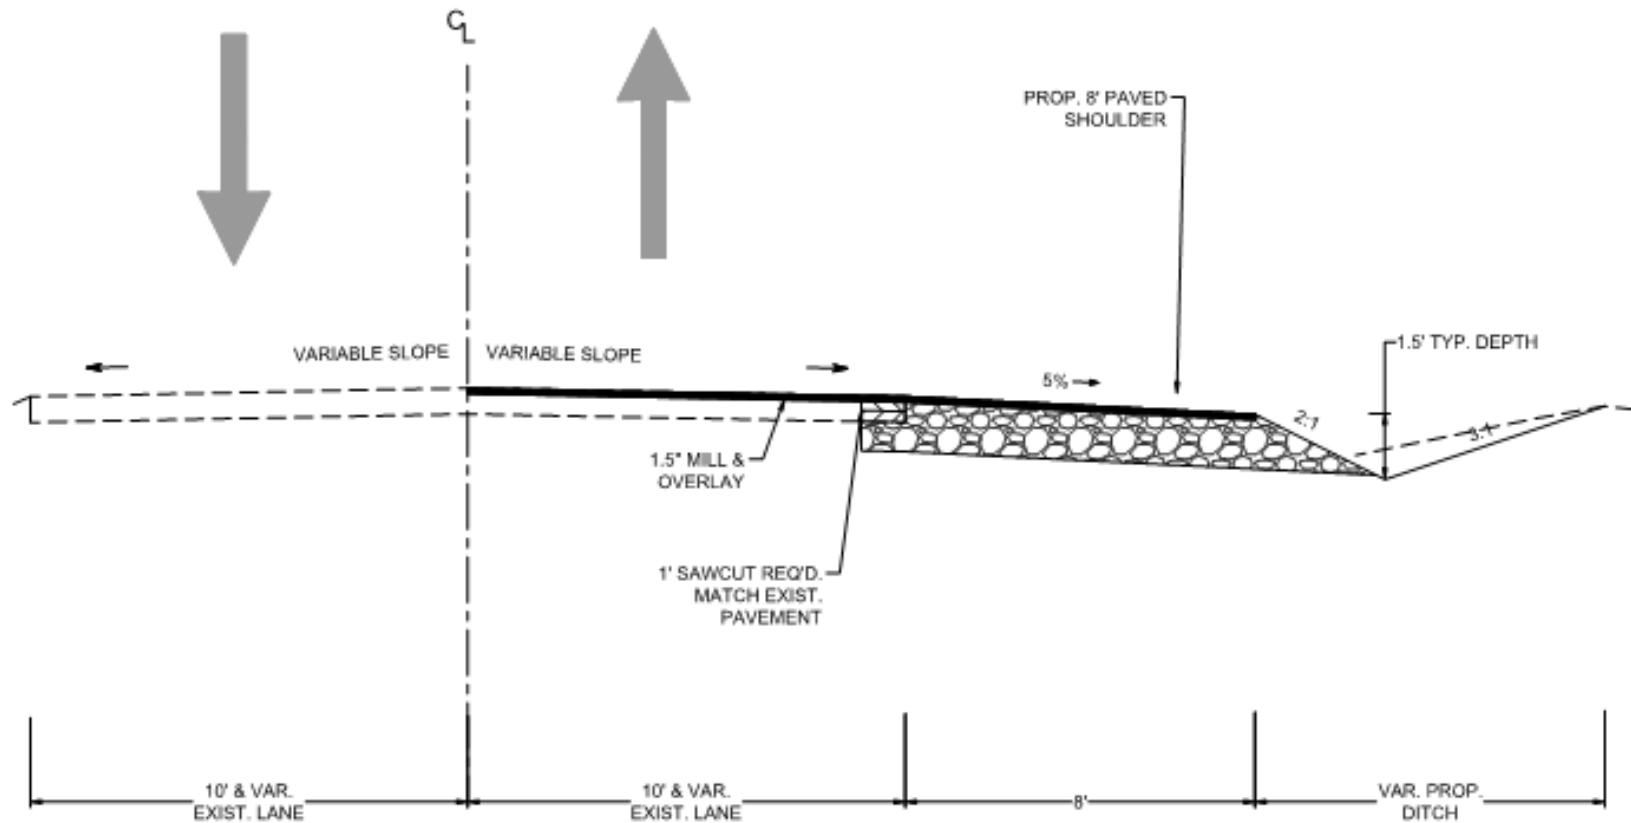
# Option #4 – Widen Shoulders Only

- \$400 per LF
- Bliley – \$1,600,000
- Westover – \$1,400,000
