# Comprehensive Waterworks Evaluation and Cost Estimate

## City of Richmond, VA

Virginia Department of Health, Office of Drinking Water

VADOH 183662 | April 8, 2025

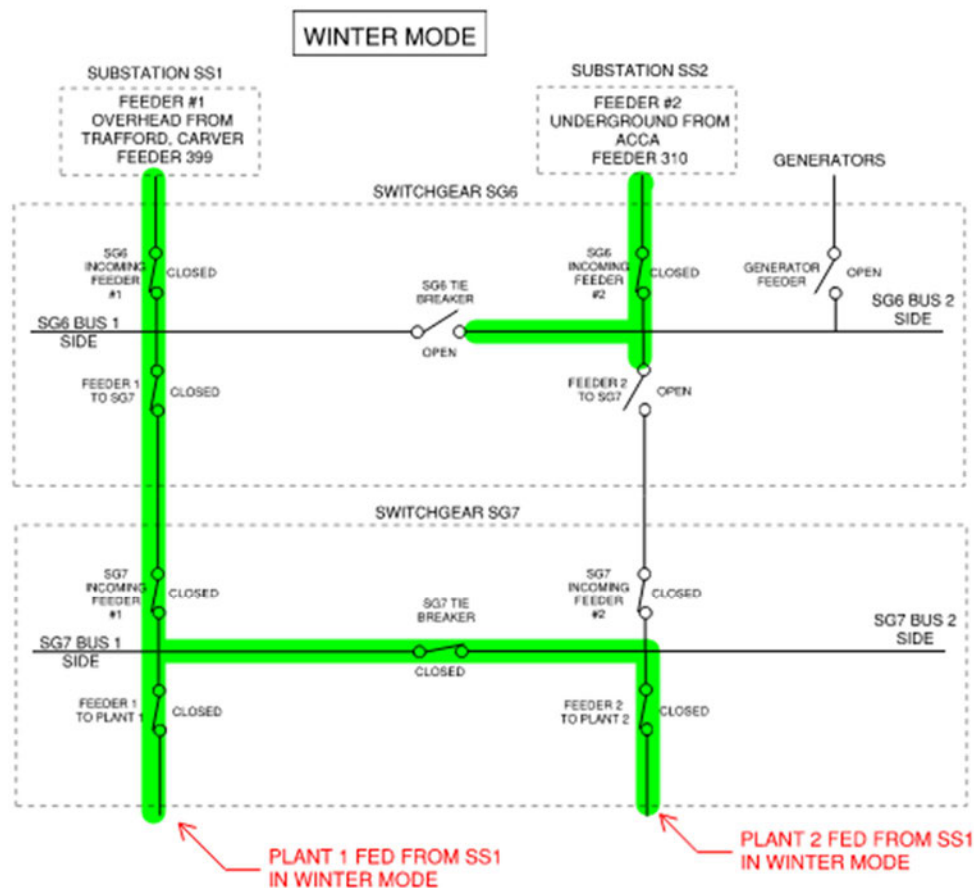
Diagram 2: Winter Mode Electrical Feed

At the time of the power outage, the plant was operating in “Winter Mode.” In Winter Mode, both incoming main feeder breakers from the substations are closed and the tie breaker between the busses is open. The feeder from SS1 to downstream switchgear SG7 is closed, while the feeder from SS2 to SG7 is open. The tie breaker at SG7 is closed. This results in both 4160V-480/277V transformers that provide power to the water treatment plants 1 & 2 being fed from Substation SS1. This mode has been in place for over 20 years as a cost saving measure. See Winter Mode Diagram below for illustration of power flow using Winter Mode.

With the WTP operating in Winter Mode, the SG6 Tie Breaker would normally sense that power is still available on the SG6 Bus 2 upon failure of the feed from SS1 and automatically switch the power feed to the Bus 2 side of the Switchgear. A failure of the SG6 Tie Breaker resulted in the breaker not automatically switching over. This resulted in a loss of power to the entire plant. See Diagram below for an illustration of power flow during the power outage of January 6, 2025. Investigation after the event determined that coil was burned out and the associated fuse was blown.

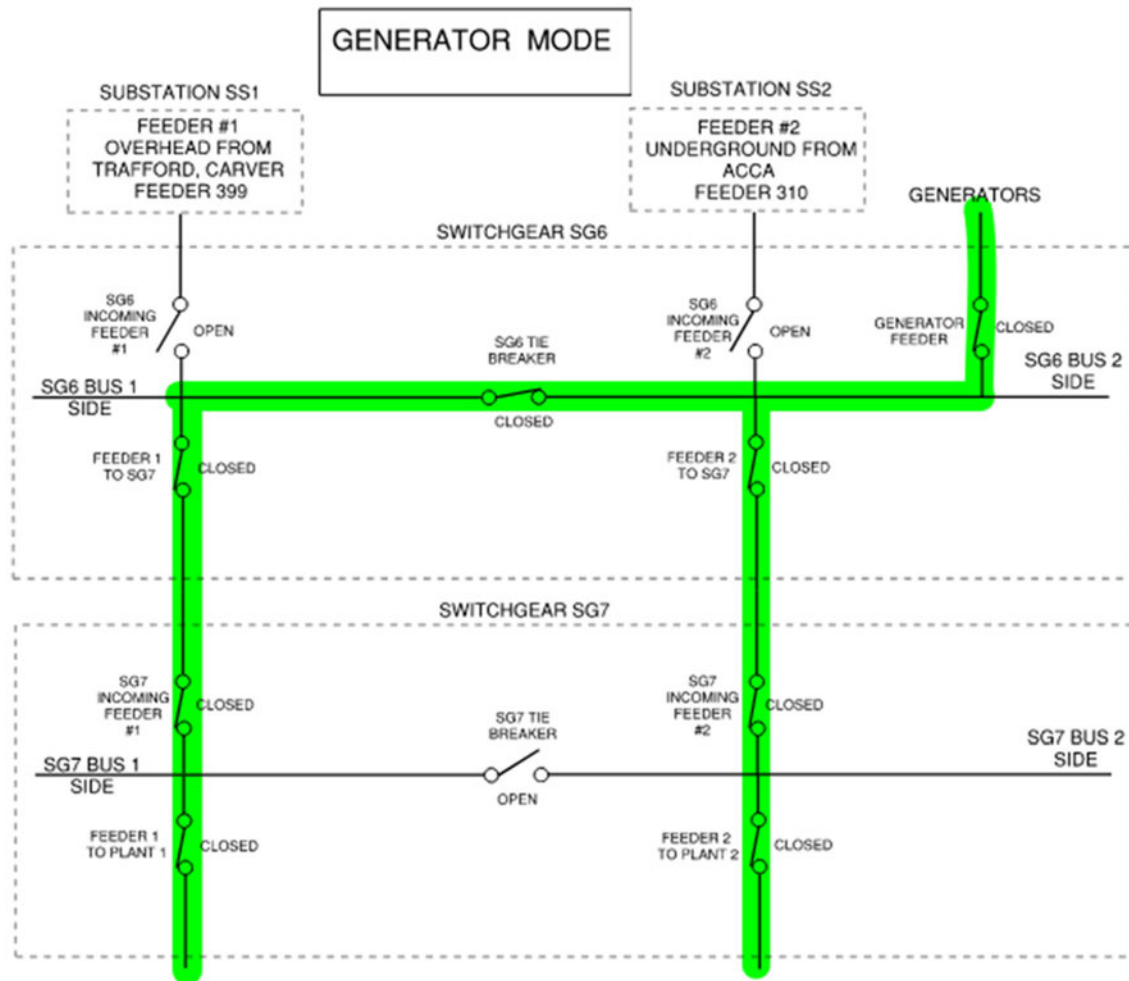
Diagram 3: Backup Generator Electrical Feed

When the Maintenance Supervisor confirmed lack of power at the main feed on January 6, 2025, he had to decide whether to start the generator or diagnose and fix the bus tie. During the SEH site visit, the Maintenance Supervisor explained that it was necessary to diagnose the bus tie equipment failure before starting and connecting the generators to the main power feed to avoid further damage to the electrical equipment.

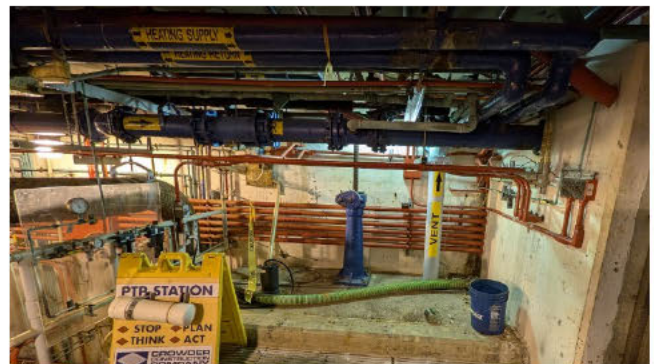
Section 1081 of the Virginia Waterworks Regulations requires new finished water tanks to be equipped with an overflow pipe to convey overflows to a drainage system. The legacy design of the filter plants, which were originally constructed in 1924 and 1950, lacks overflow

Clearwell access hatches are the primary pathway for the clearwell to overflow into the filter gallery in Plant 2.

pipes. This predates the Virginia Waterworks Regulations 12VAC5-590 which were codified and adopted in their current form in 1974.

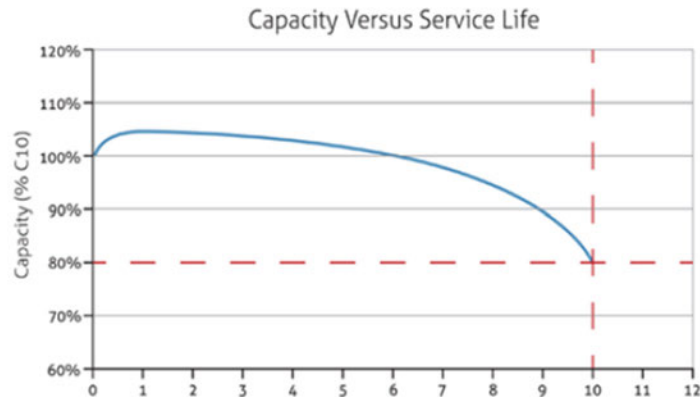
Diagram 3: Batter Life Decay

To further complicate matters, there are no universal standards for UPS batteries, only guidelines, so each manufacturer has wide latitude to design their batteries as they best see fit. According to Riello, the manufacturer of the new 30 kVA UPS installed after the critical event to provide power to close the filter effluent flow control valves in Plant 2 in the event of a power failure, "UPS batteries tend to have either a 5 or 10-year design life." Riello goes on to state: "Even though battery manufacturers will state their battery has a design life of 5 or 10 years, under EUROBAT (Association of European Automotive and Industrial Battery Manufacturers) international guidelines, a battery is considered at the end of its service life when its capacity falls below 80% of its original." Riello then provides the following graphic to illustrate that batteries with a nominal 10-year service life fall below 100% capacity after just 6 years.

In any case, after their useful service life, the storage capacity of VRLA batteries declines to the point that the UPSs containing the batteries can maintain output power for only a few seconds instead of the many minutes of output power they can provide when the batteries are new. Consequently, UPS manufacturers recommend that the batteries in UPSs in critical applications be tested every 6 months to ensure that they can maintain UPS output power for at least the minimum required duration in the event of an incoming line power failure and so that the batteries can be replaced when needed.

New batteries would have allowed the UPSs to have provided sufficient backup power to close the filter effluent valves, but the batteries in the UPSs could not as they were past their useful service life when line power failed on the morning of January 6, 2025. Although the old UPS batteries had been replaced and taken offsite before the SEH site visit, this behavior was deduced from reviewing the SCADA data. SEH reviewed SCADA data of the filter effluent flow meters and valve positions. Following the loss of power, the SCADA data began recording “Bad” data in less than one minute. This shows that the PLCs that were powered by the same UPSs as the filter effluent valve actuators went offline virtually immediately, whereas more than a minute of backup power is required for the filter effluent valves to close.

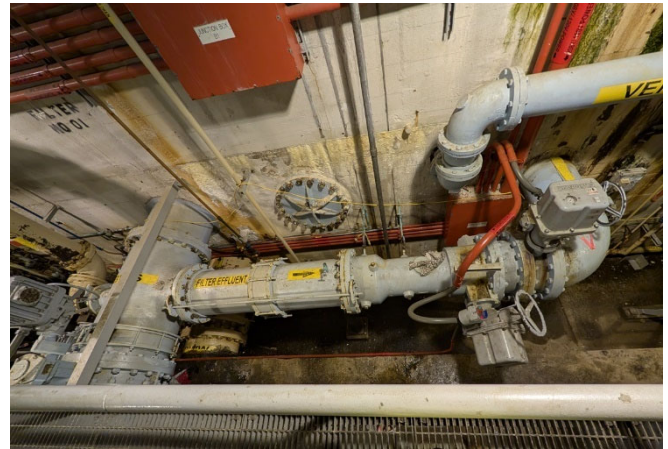
*Filter Gallery Effluent Valves*

SEH notes that historical work orders from 2021 and 2022 describe previous failures of the Plant 2 SCADA and UPS systems. These previous failures seem to indicate a known electrical issue with the UPS system that was never addressed.

- On May 25, 2021, a work order describes the UPS in Plant #2 electrical room “failed again”. Water production was lost for 4 hours. The immediate issue was resolved by resetting a breaker switch. The work order notes that the Maintenance group “will investigate why the breaker and switch was tripping to the UPS system.” No follow-up information was in the work order system.

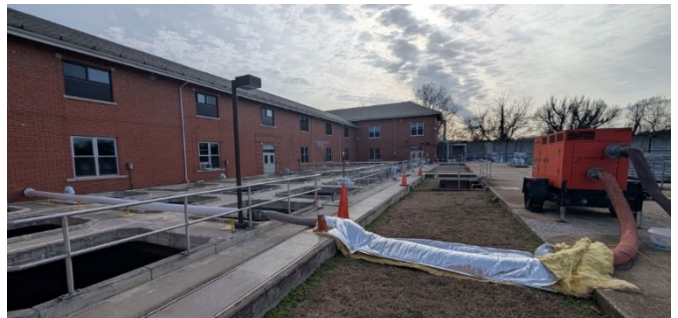
Godwin Pump Suction Piping

These Godwin pumps have permanently installed suction piping from the sump in each filter gallery to the pump suction. A length of flexible tubing is used for the final connection at each pump. Suction lift on each pump is approximately 20 feet, and the length of the 6" suction line for each pump is approximately 100 feet. These suction conditions increase the time needed to prime the pump.

Godwin Pumps  
Prime Slowly  
*Machines*

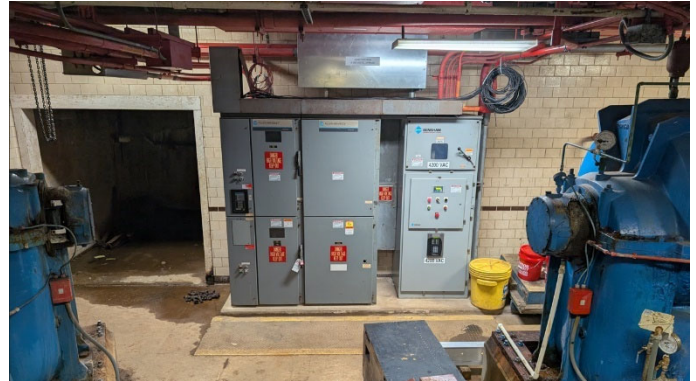
*4160V MCC and Variable Frequency Drive – South Filter Plant*

Critical electrical equipment was located below the WTP hydraulic grade line in the filtered pump rooms and filter pipe galleries. Key equipment included the electric motors, variable frequency drives (pictured), valve actuators, sample pumps, and various sensors. As shown in the picture, the electrical gear is on a very short housekeeping pad so any appreciable amount of water in this area will inundate electrical equipment.

After water was removed from these spaces, the electrical equipment had to be dried, repaired, and/or replaced before being placed into service.

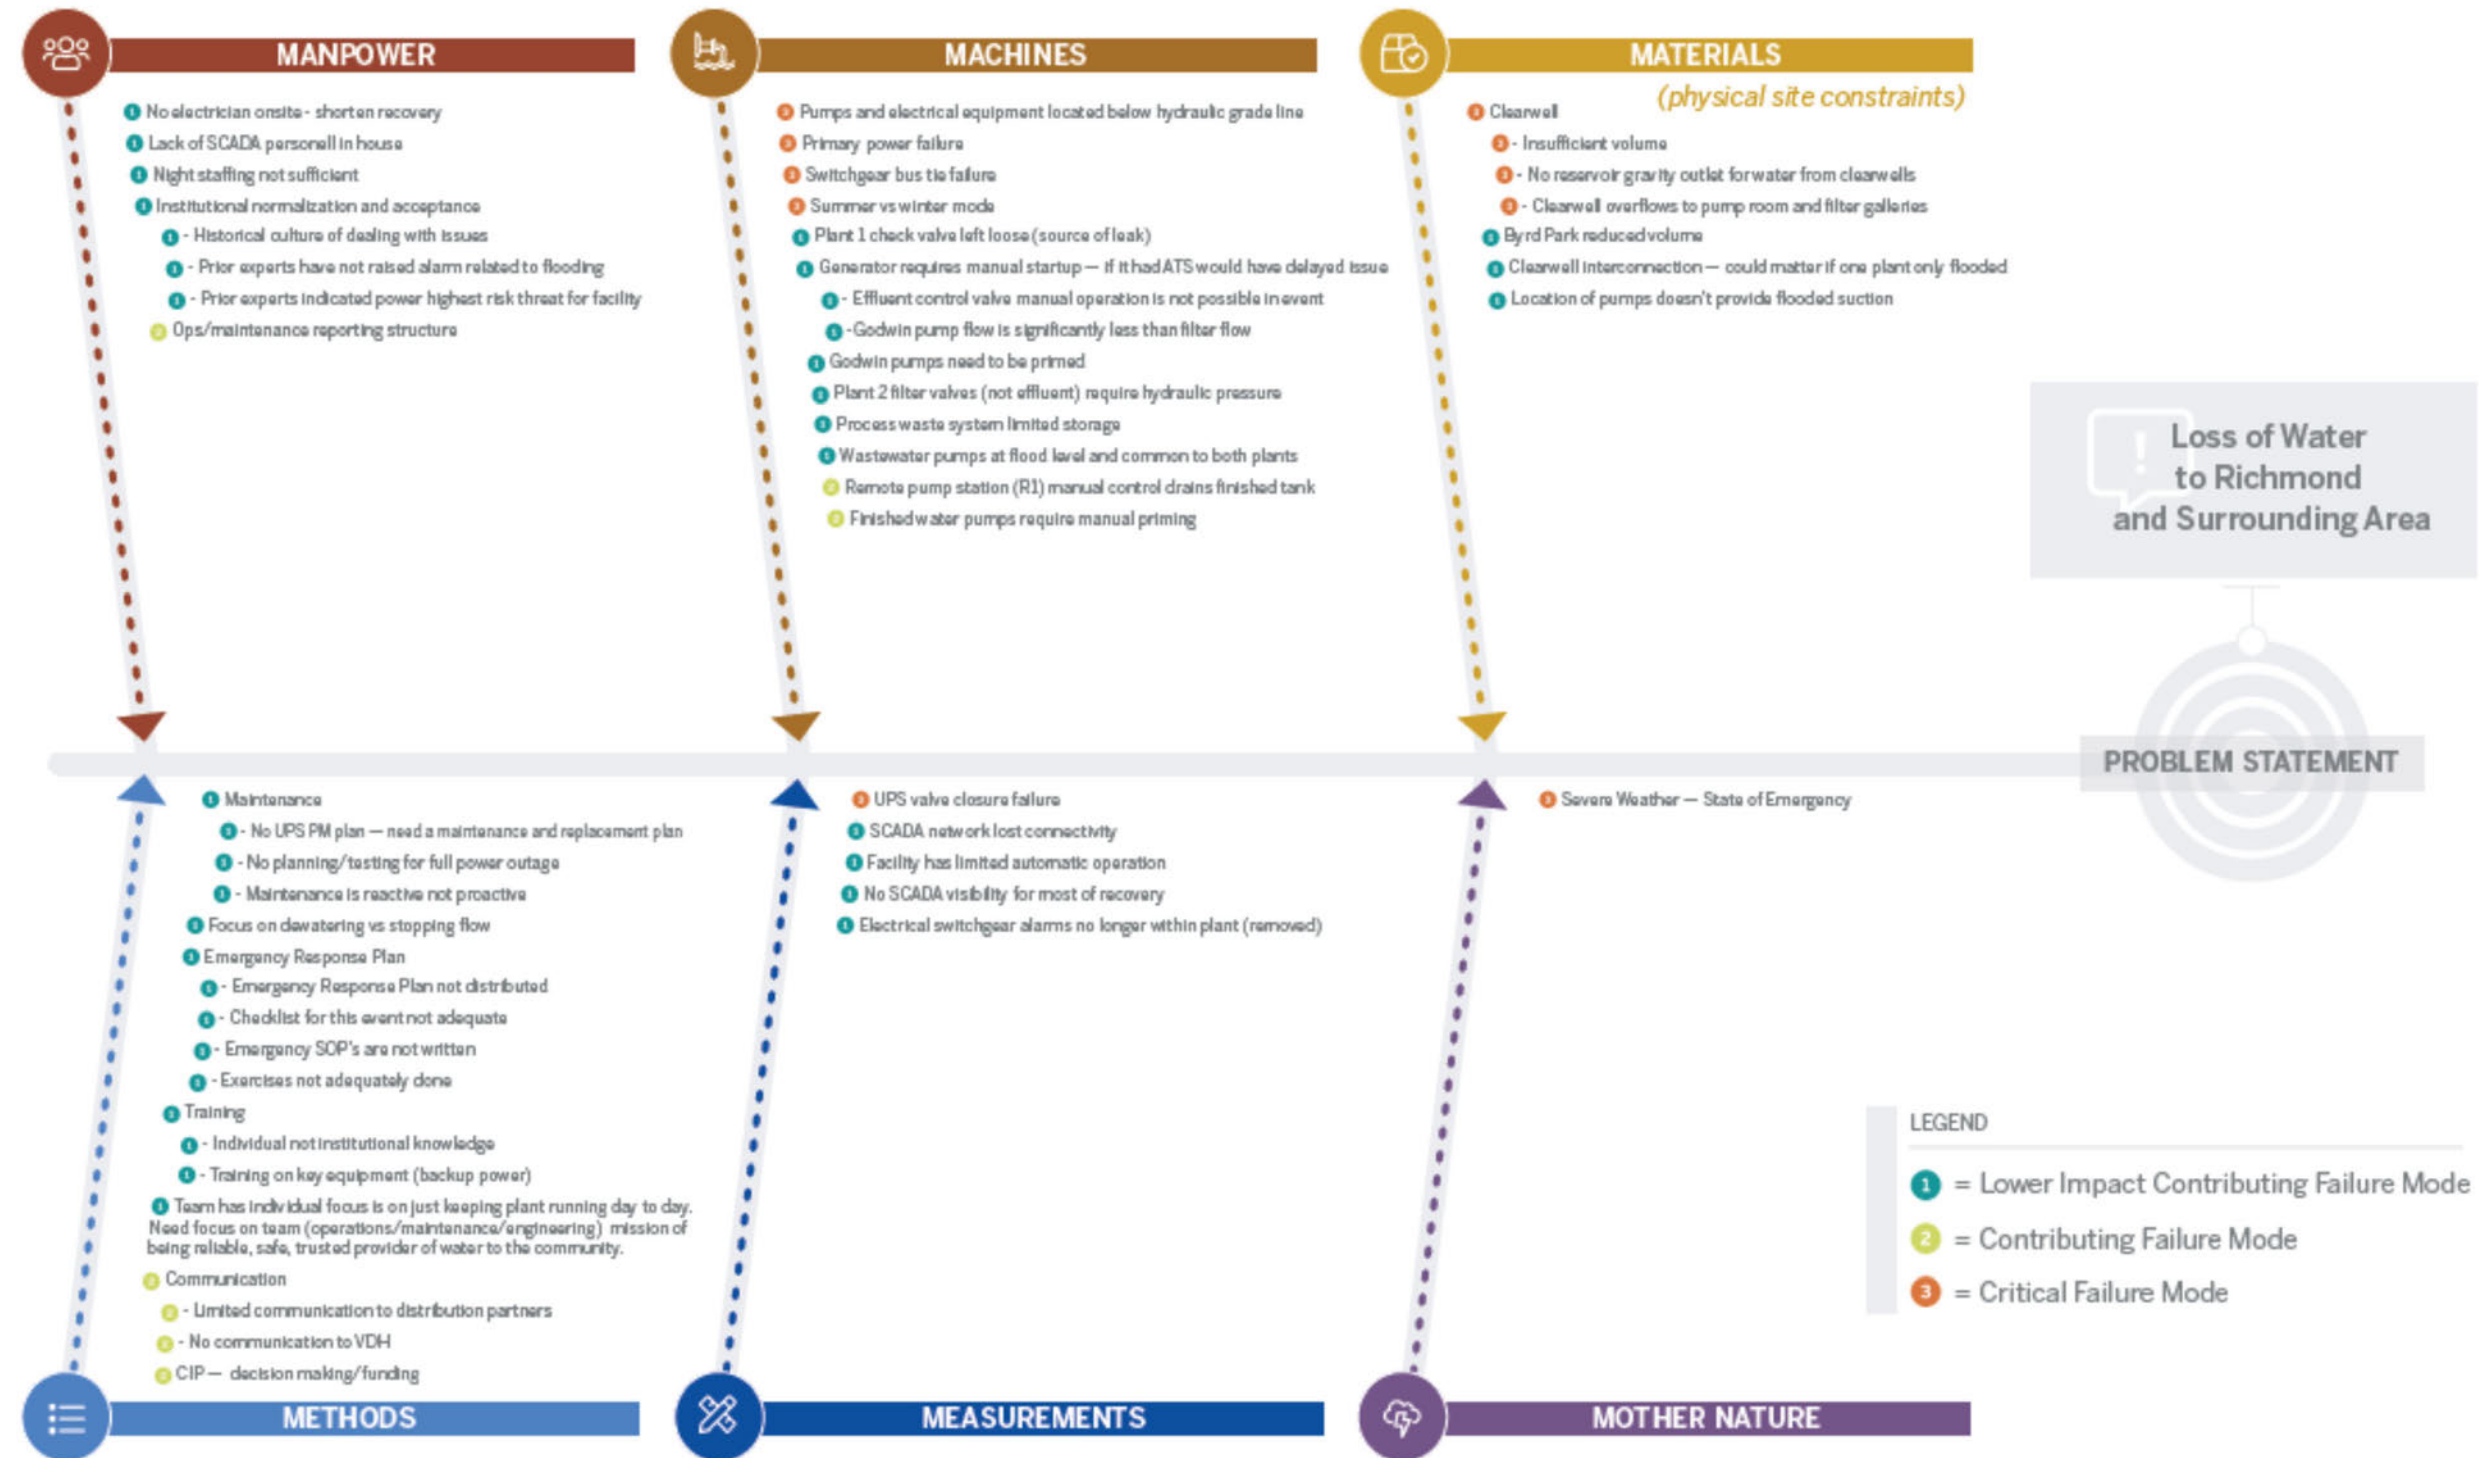
Figure 2 – Root Cause Analysis Fishbone Diagram

Critical Failures were further analyzed using a cascading failure analysis. Critical Failures for the “Loss of Water to Richmond and Surrounding Area” occurred sequentially from top to bottom as follows:

- Severe Weather – State of Emergency;
- Primary Power Failure (Failure of Primary Winter Mode Feed);
- Summer vs Winter Mode (Practice of using Winter Mode);
- Switchgear Bus Tie Failure;
- UPS Valve Closure Failure;
- Clearwell: Lack of Gravity Overflow, Insufficient volume; and
- Pumps and Electrical Equipment Located Below Hydraulic Grade Line (HGL).

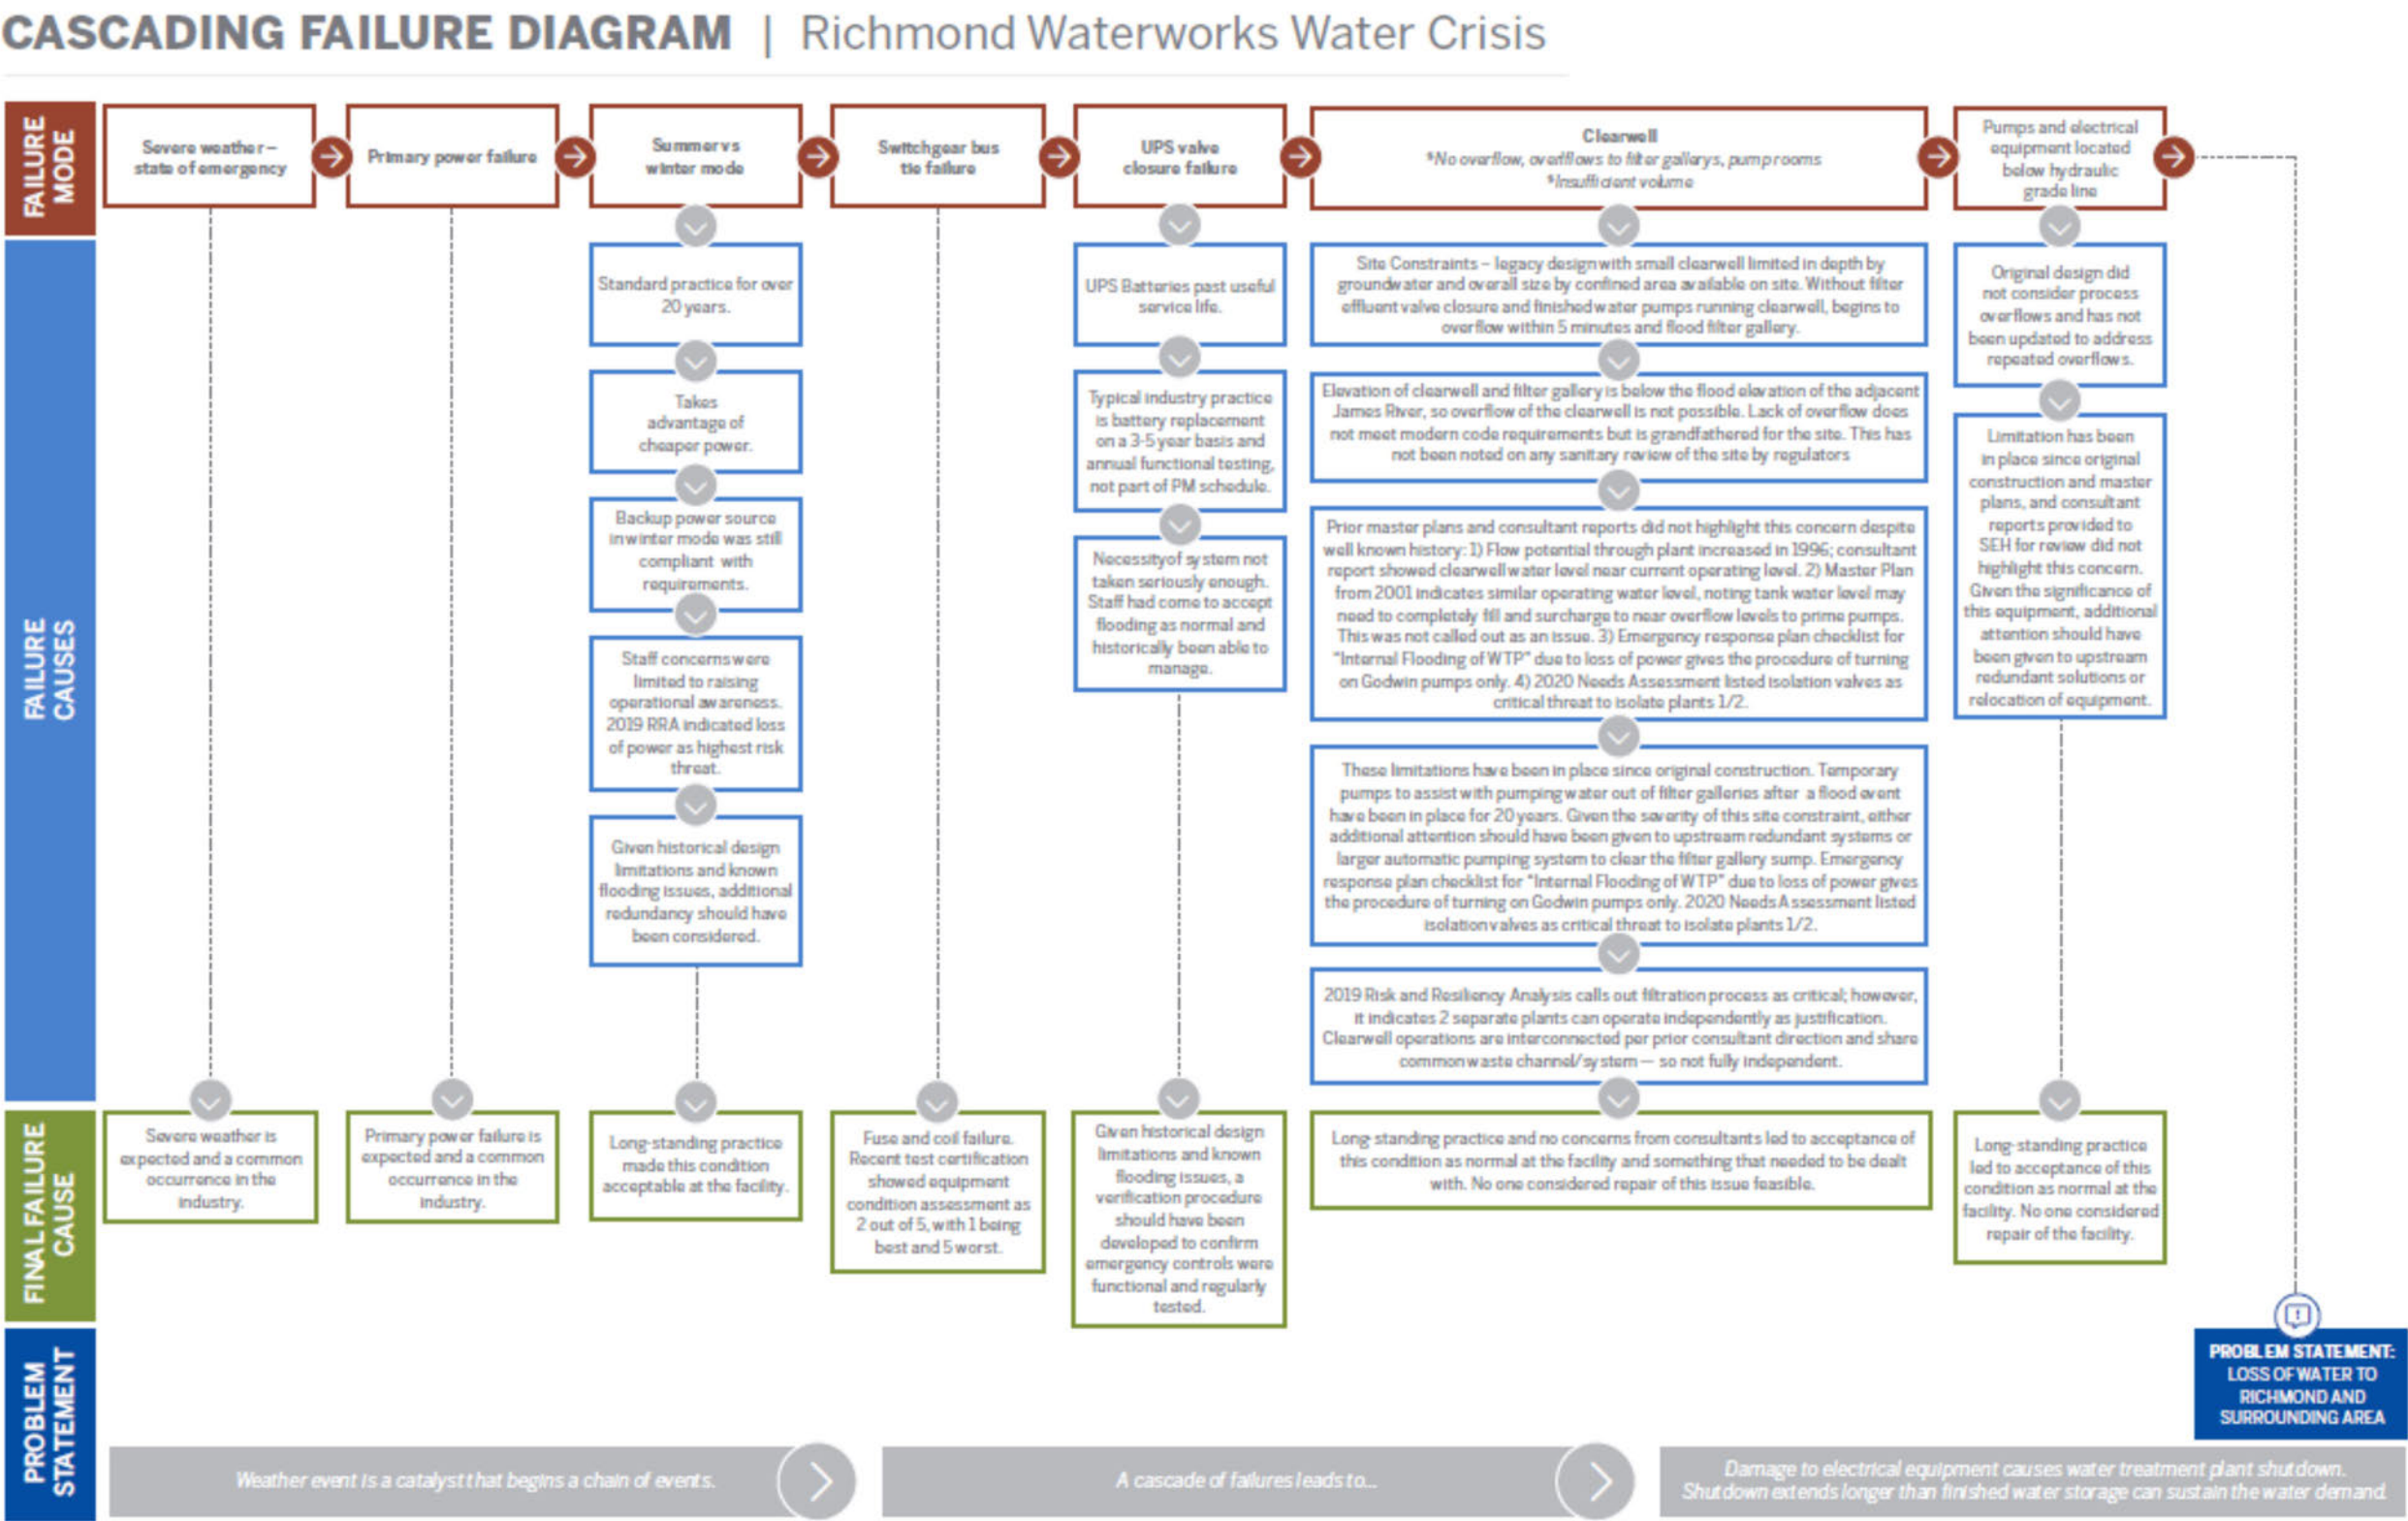
Figure 3 – Root Cause Analysis Cascading Failure Diagram

The following figure is a cascade diagram with failure modes arranged sequentially left to right in a cascading manner with results of “why” analysis under each failure mode arranged sequentially top to bottom.

To summarize the overall failure and Root Cause Analysis, “Loss of water to Richmond and surrounding area” was caused by a production outage at the City’s main water supply, the Richmond Water Treatment Plant. The WTP outage occurred because key electrical equipment was submerged by a process water overflow. The production outage lasted 66 hours before full production flow was leaving plant, which was longer than the capacity of the distribution system to maintain adequate pressure in the system.

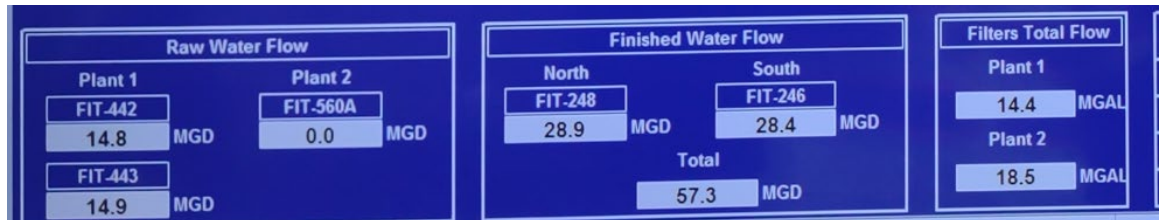
7. One of the critical issues repeatedly noted throughout multiple discussions with plant staff is with flow metering instrumentation. Some flow meter transmitters were upgraded in 2016 but newer flow metering instrumentation was reported to be unreliable and the equipment that was not replaced is past its useful life. Plant staff reported that in-channel raw and applied water flowmeters struggle with flow variations, with large discrepancies reported between the channel and venturi meters in Plant #1. The online raw water flow meter for Plant #2 is an insertion style meter and was noted to be largely unreliable. Operations and maintenance staff repeatedly noted that flow monitoring has been a known and on-going issue for several years that has not been properly resolved. As a result, there is a general mistrust in the SCADA data. The lack of reliable flow instrumentation is a major issue in reliably operating the plant and ensuring accurate chemical dosage to produce high quality drinking water.

- a. As an example, the image below was captured on February 6, 2025 which shows flow rates displayed on the WTP SCADA. The partial screenshot shows a discrepancy between the raw water flows, finished water flows, and filtered water flows.

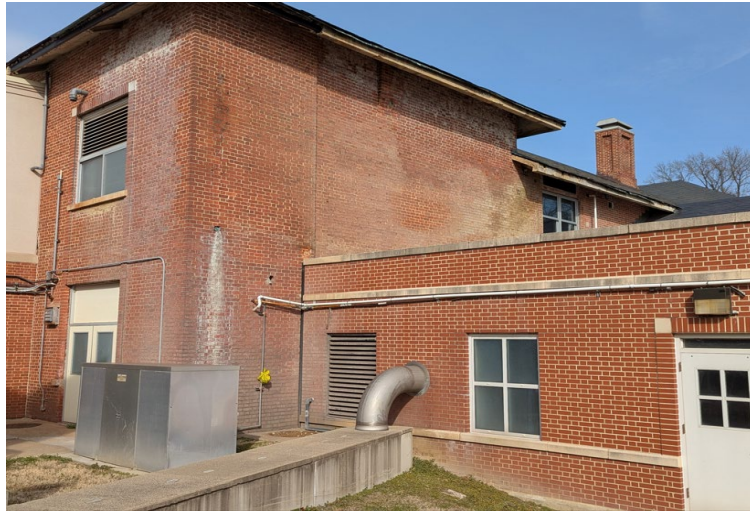
11. The exterior of Plants 1 and 2 are in fair condition. There are areas with apparent damage to the wooden fascia/soffits. Recommend further roof assessment and general exterior repairs, including selective roof repairs, exterior tuckpointing, weather stripping, and roof drain/leader selective replacement.

It was noted that the roof decking and roof is in critical disrepair, with replacement options currently underway for Plant #1 and Plant #2.

*Plant #1 Exterior*

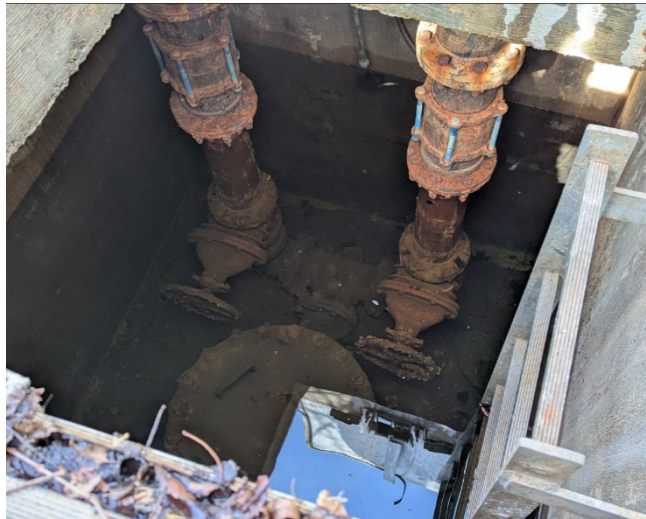
The discharge piping in the vault was submerged at the time of inspection and appeared to contain air blowoff piping.

*Discharge Piping*

4. Air relief/blowoff valve piping at 5-Mile Intake shows sign of heavy corrosion, likely due to being submerged. It is recommended that the access cover is repaired and sealed to try to limit water intrusion. It is unclear if the structure was designed to be watertight, so preventing the piping from being submerged may be difficult without additional inspections and repairs.

5. Air relief/blowoff valves at 5-Mile Intake are not screened as required by **12VAC5-590-1160E.1**. It is recommended that screens are installed. .
6. Korah K3 discharge piping is exposed in the Kanawha Canal and shows visual signs of damage and repairs. The piping also does not meet **12VAC5-590-1140. Installation and testing of water mains**. A. Adequate supports and restraints shall be provided for all pipes. There is potential for damage due to riverbed movement. DPU staff noted that a previous break in the prestressed concrete cylinder pipe (PCCP) line buried in the Kanawha Canal was extremely difficult and costly to repair and required a third-party contractor and extensive excavation work. Recommend further inspection and evaluation of the transmission piping along with repairs as required.

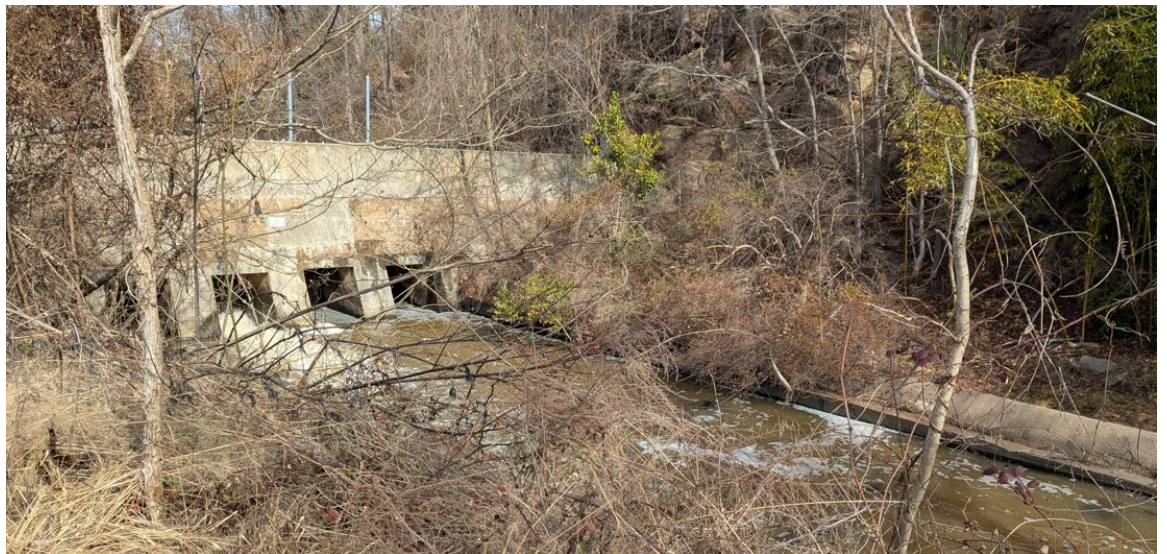
*5-Mile Lock Dam (Downstream) and Korah 3 Discharge Piping*

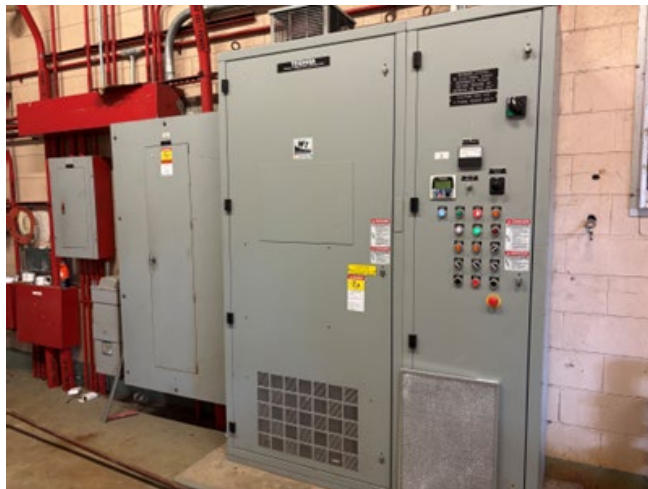
Raw water pump #3 is fed from MSB-HDP-1 in Plant #1. PPA-3 is a 400A General Electric Panelboard and distributes power to the RWP-3 VFD, associated spray wash pumps and 120/240V panel LPA-3. All electrical equipment and is over 30 years old and past its expected life. Replacement is recommended within 5 years.

*RWP 3 Electrical Equipment*

- Perform annual routing maintenance on electrical distribution equipment
- Replace Panelboard PPA-3 within 5 years.
- Replace Panelboard LPA-3 within 5 years.
- Replace RWP-3 VFD within 5 years.
- Replace Panelboard PPA-4 within 5 years.
- Replace Panelboard LPA-4 within 5 years.
- Replace RWP-4 VFD within 5 years.

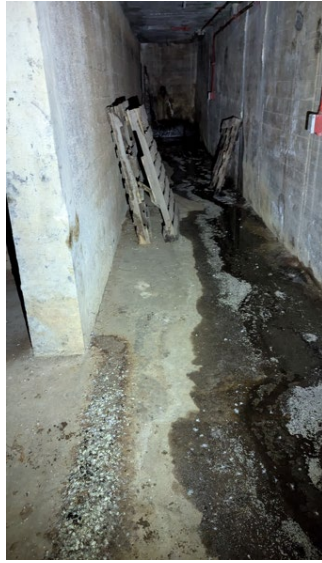
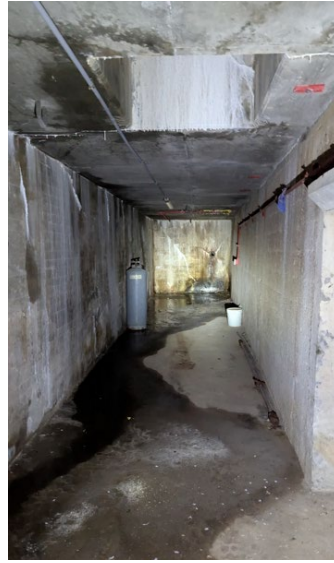
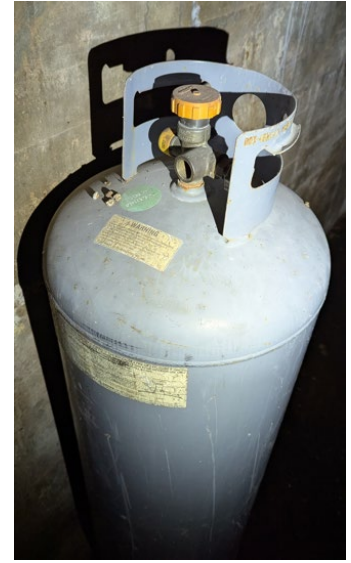
3. Between the sedimentation basin control building for Plant #1 and 2, there is a below grade structure that previously housed the motors for horizontal style flocculators. The area appears to be abandoned, with multiple birds observed along with debris, hoses, stagnant water, and an old propane cylinder. The concrete walls show signs of efflorescence. Recommend removal of debris and periodic visual inspection of the area for further signs of deterioration.

*Old flocculation motor areas*

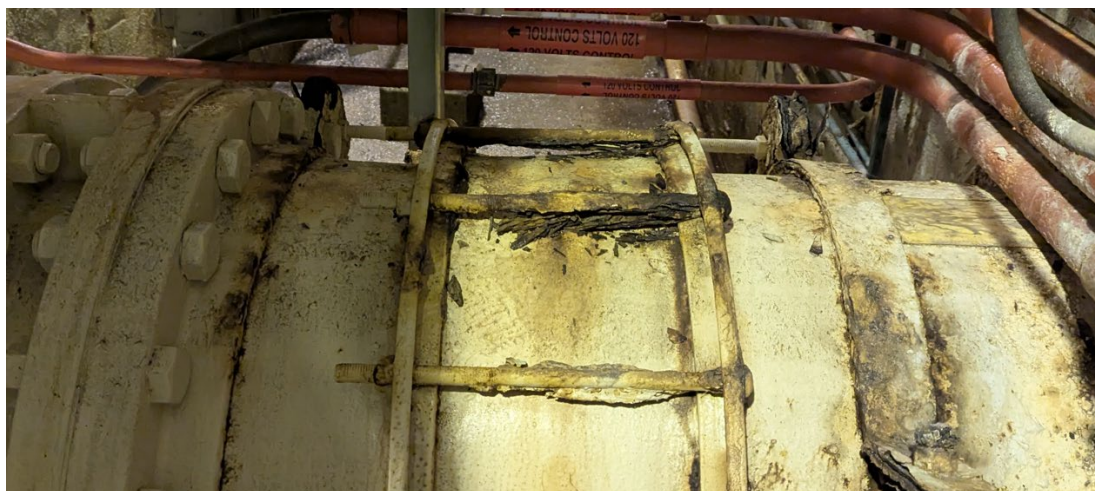
1. The filter piping, bolts, and lower-level structures of Plants 1 and 2 show signs of severe corrosion and damage and are in very poor condition. The stainless-steel air scour piping show signs of severe chlorine induced corrosion and pitting. The facility previously used chlorine gas for disinfection which would have accelerated the damage. The piping gallery in Plant #2 is in noticeably worse condition than Plant #1. Due to the age of piping and severe damage, SEH recommends rehabilitation of filter piping in both Plants 1 and 2. The piping should be blasted, thickness verified, and recoated. All corroded bolts should be replaced. The walkway in Plant #2 should be replaced as the supports are severely corroded with minimal material remaining.

*Plant #1 – Filter Piping Gallery*

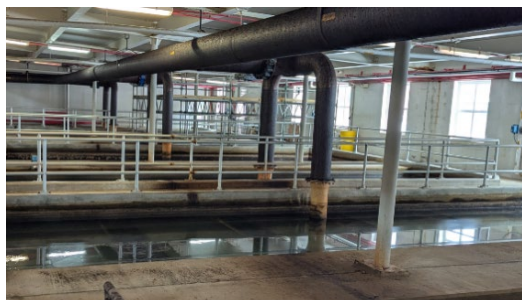
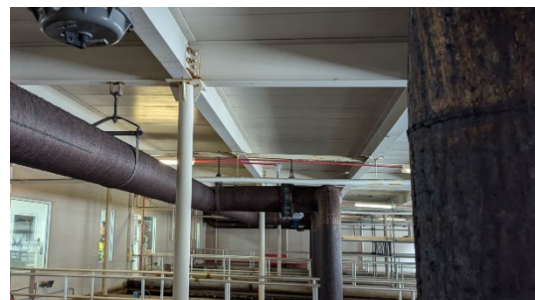
*Plant #1 – Stainless Steel Air Scour Piping*

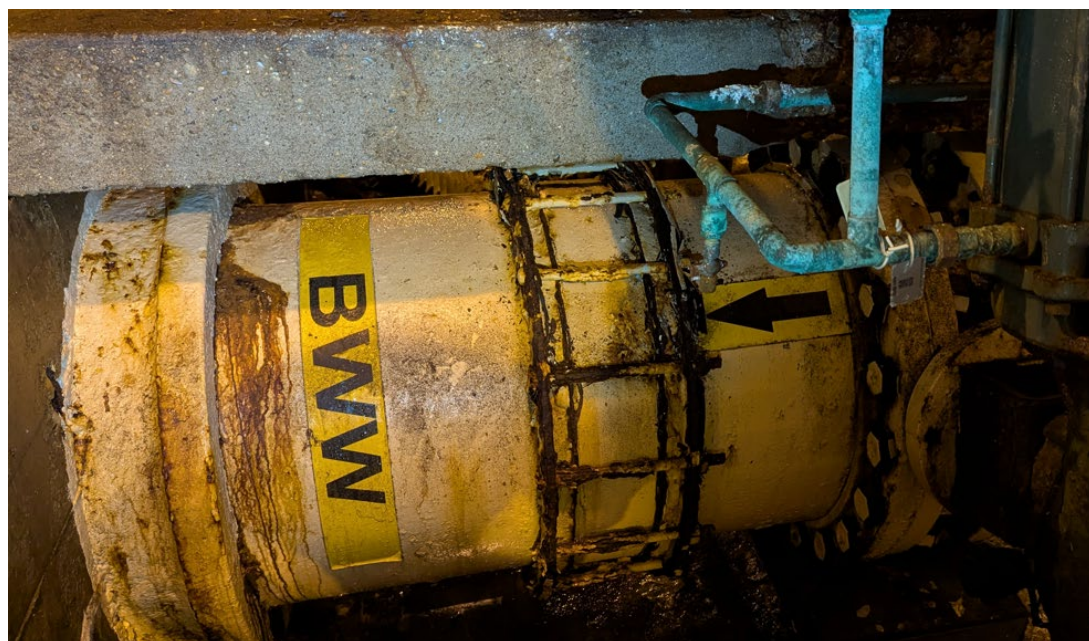
*Backwash Waste Water Piping in Plant #2*

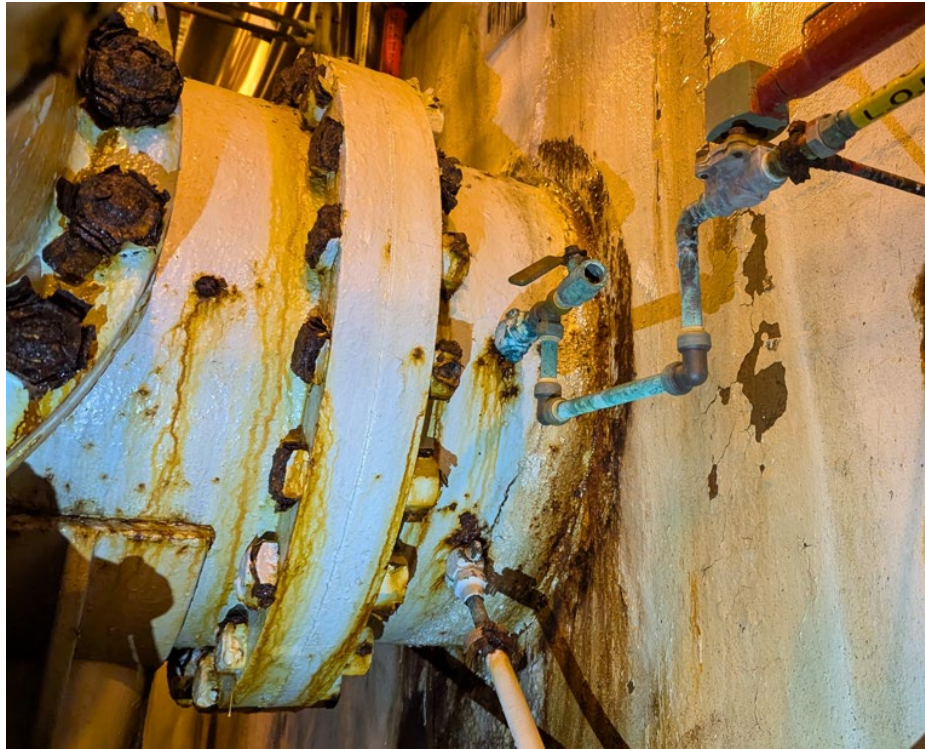
*Piping and Filters – Plant #2*

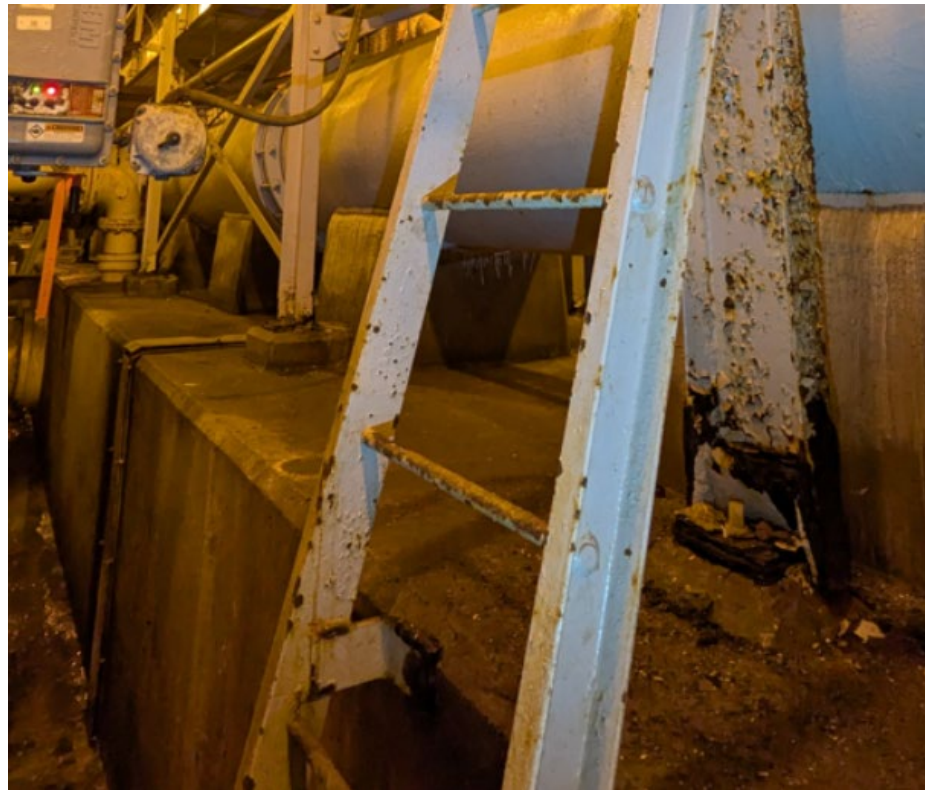
*Walkway Supports – Plant #2*

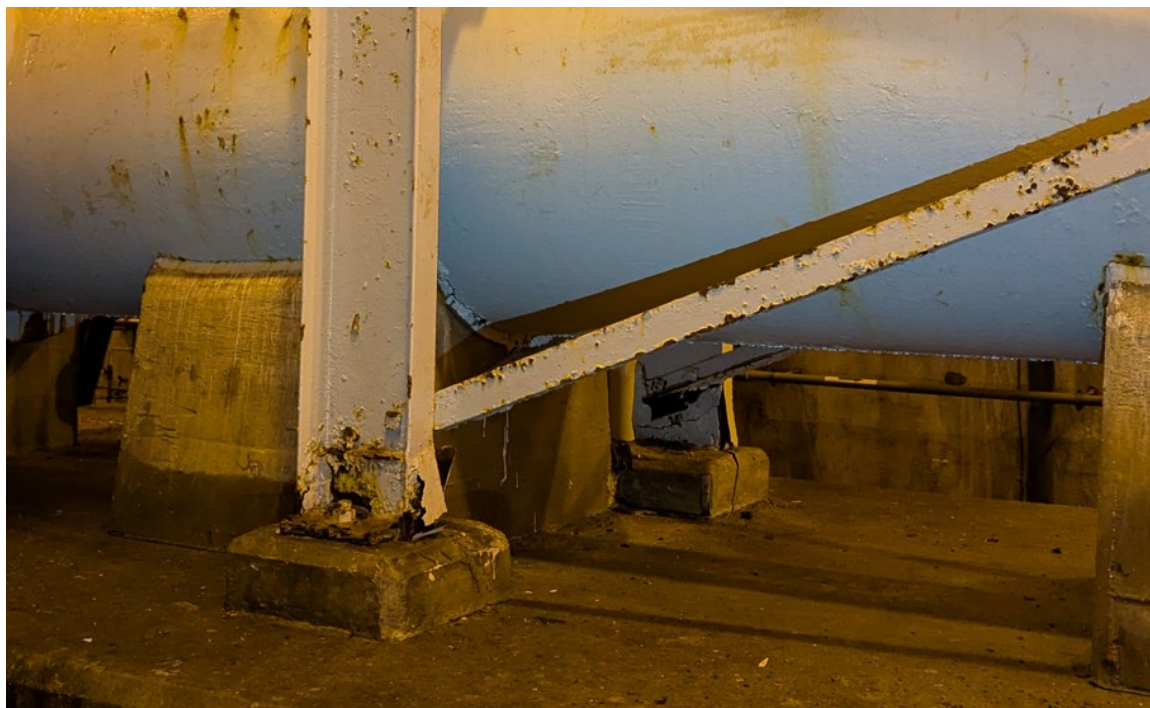
*Walkway Supports – Plant #2*

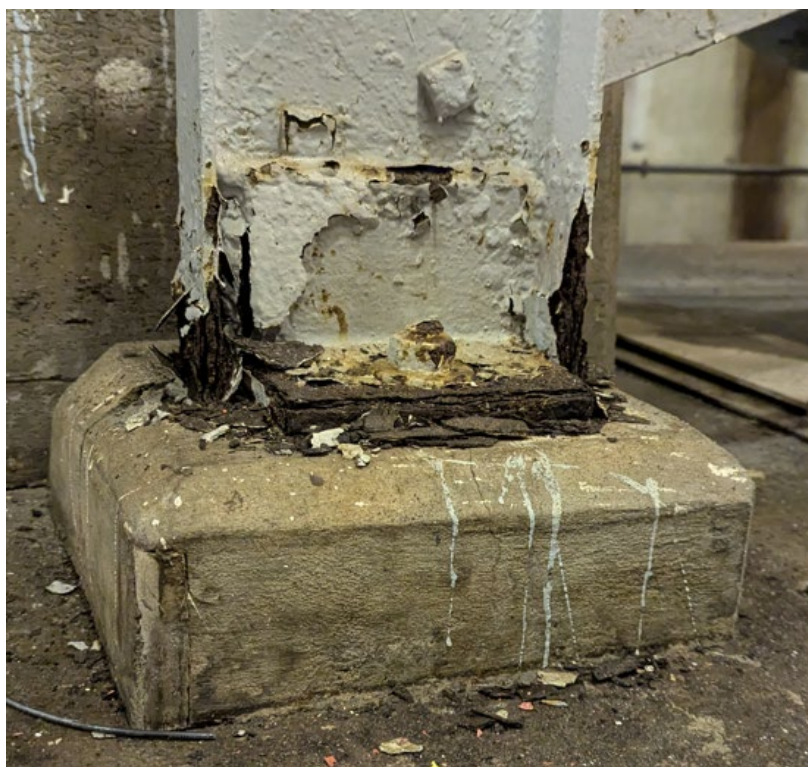
*Walkway Supports – Plant #2*

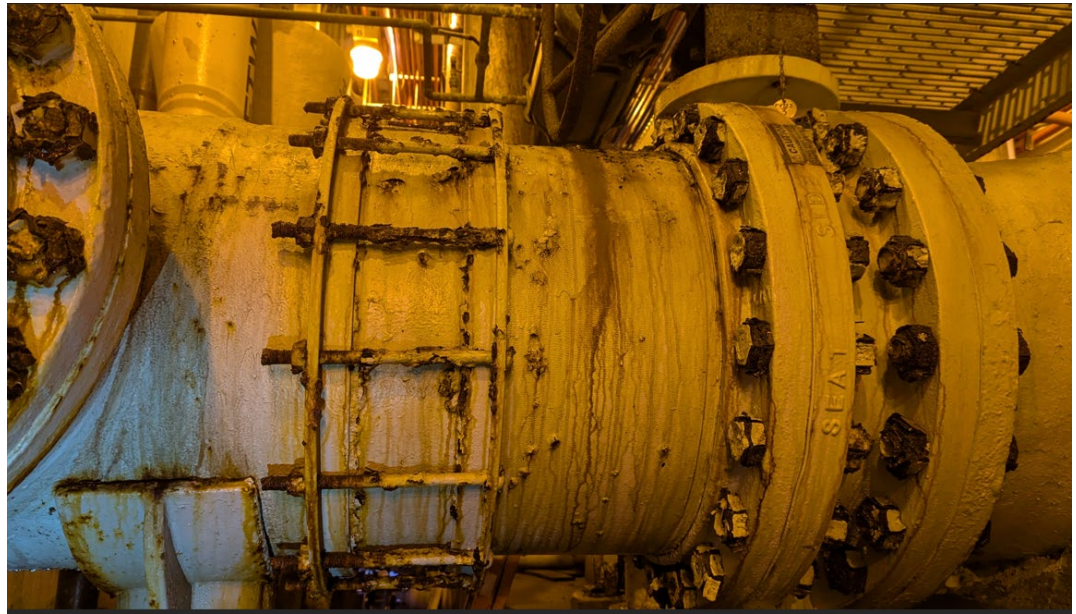
*Filter Piping – Plant #2*

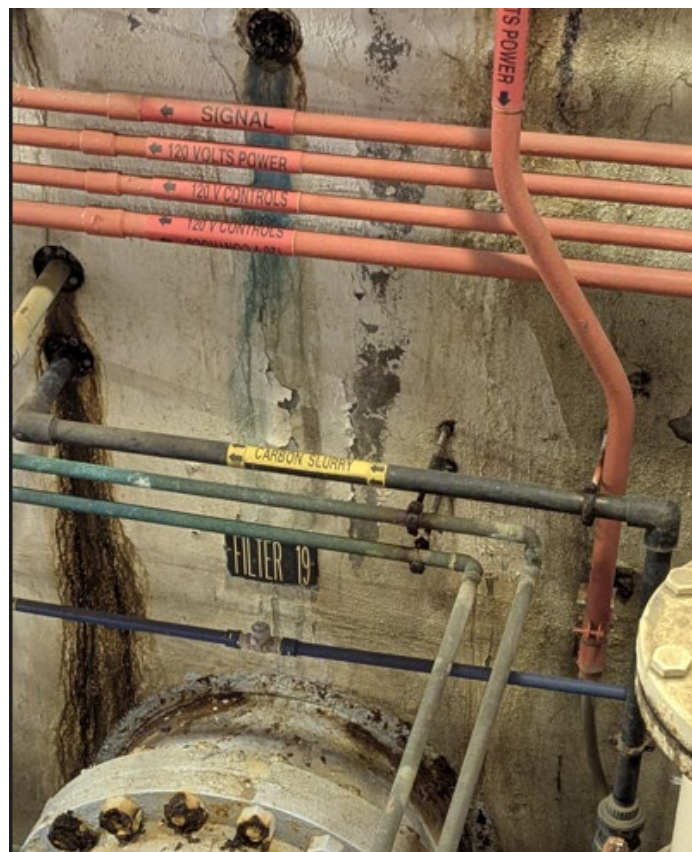
*Filter 19 – Plant #2*
