# Comprehensive Waterworks Evaluation and Cost Estimate

## City of Richmond, VA

Virginia Department of Health, Office of Drinking Water

VADOH 183662 | April 8, 2025

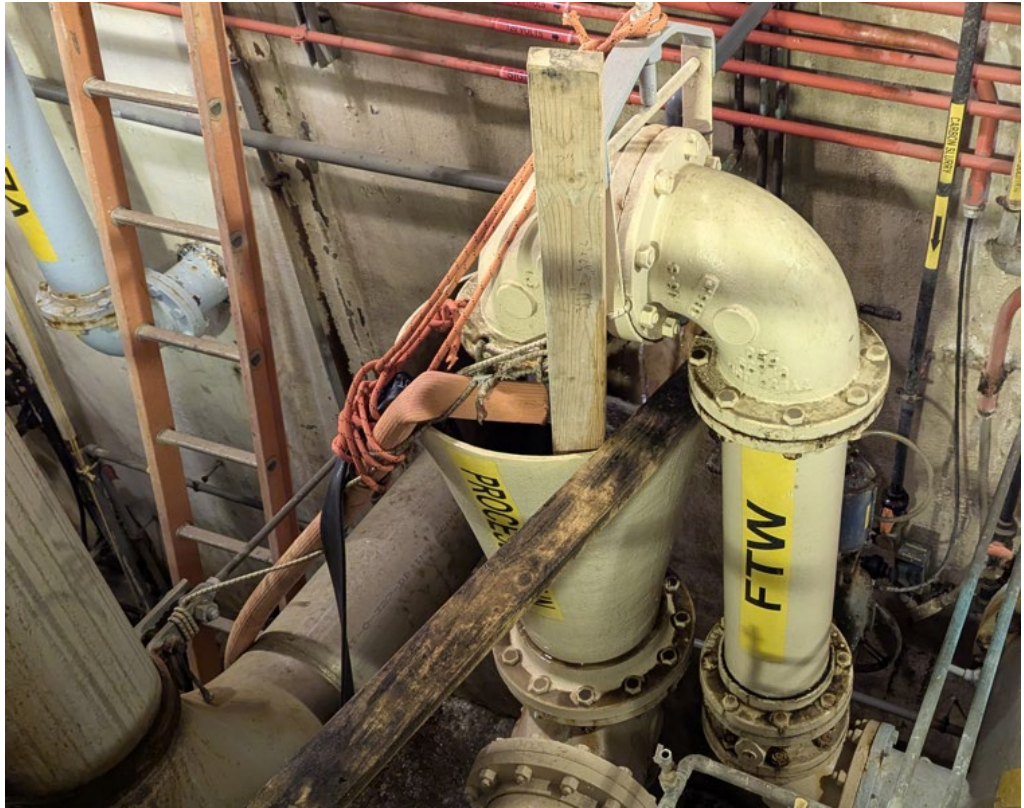
3. There are significant amounts of standing water in the lower level of both filter galleries (Plants 1 and 2) along with significant amounts of leaking water from the filter walls and piping. There were multiple sump pumps throughout the basement that were constantly discharging water to various process drains, with hoses and extension cords running throughout the area. The amount of water present contributes to very high humidity levels which is harsh on electronics and coating systems. Recommend that all source of leaks are identified and repaired, and all wall penetrations sealed. Once repairs have been completed, recommend installation of permanent sump pumps capable of removing water from minor leaks, seepage, condensation, and other analyzer or process drains. The sump pumps would not be expected to handle a process flood into the basement level.

*Sump Pump Hoses Routed to Additional Process Drains – Plant #2*

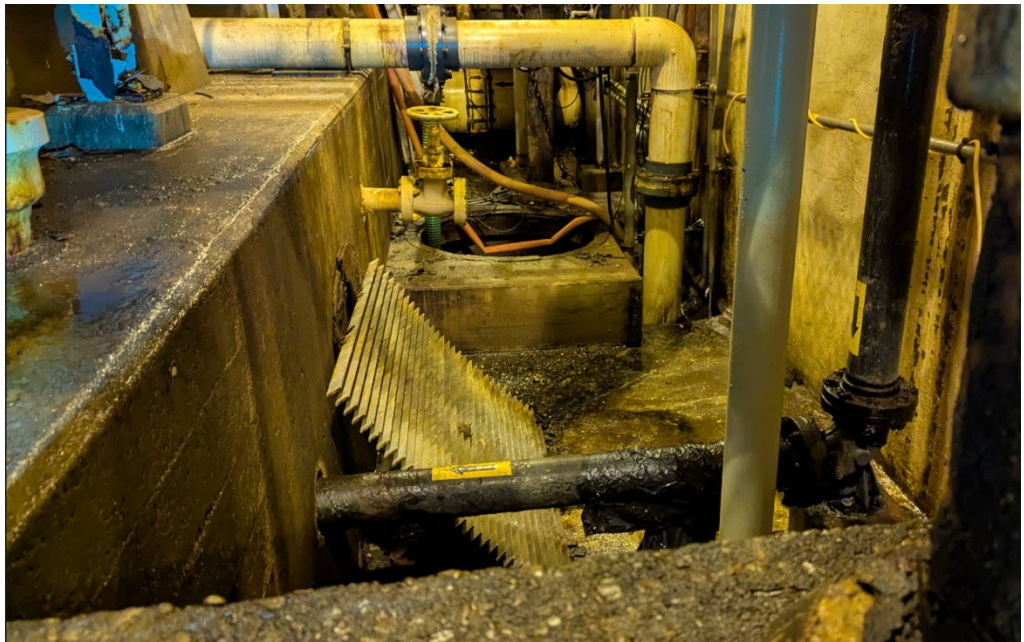
*Plant #2 Piping Gallery. Sump with Permanent Dewatering Suction Pipe and Standing*

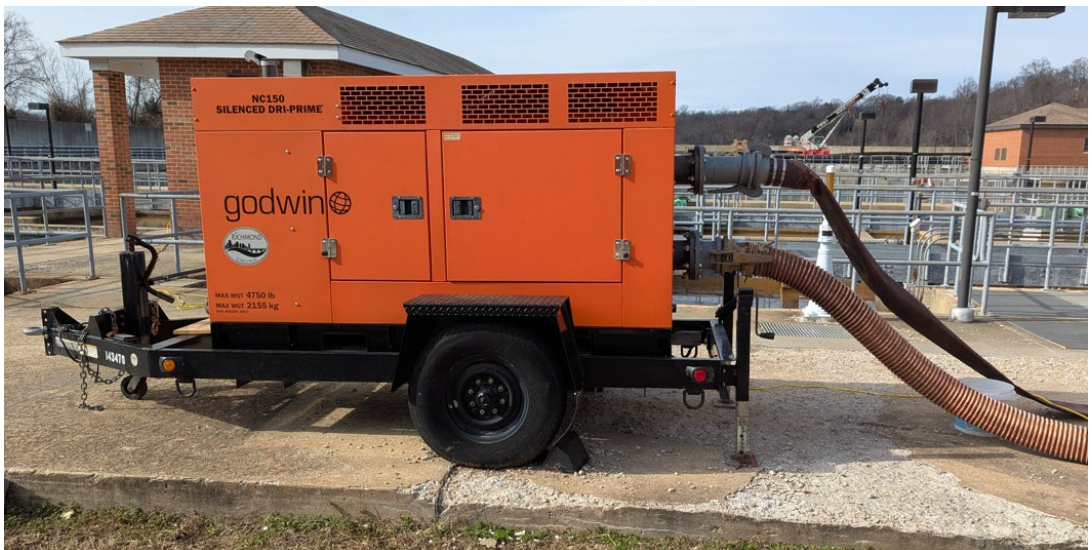
9. Due to frequent flooding in the filter pipe galleries, the facility has semi-permanently installed portable, diesel powered dewatering pumps. At Plant #1, a Godwin CD150M unit installed in 2006 provides a max pumping capacity of 2,290 GPM (3.3 MGD). At Plant #2, a Godwin NC150s series installed in 2014 provides a max pumping capacity of 1,770 GPM (1.7 MGD) was installed in 2014. The facility has installed rigid piping from the lower level piping gallery up to a quick-connect hose connection. These dewatering pumps are not designed nor capable of handling a full overflow condition at each plant (60 MGD and 72 MGD respectively). Due to the distance suction height required, the facility notes that priming the pumps can be difficult and takes several minutes.

*"Godwin" Portable Dewatering Pump – Plant #2*

- a. It is recommended that the facility increase the dewatering pump capacity, including the ability to handle full overflow conditions in the filter clearwell. Hydraulic submersible style dewatering pumps (flood pumps) may be one such method. However given the limited physical space and elevation constraints at the facility, this may not be feasible without extensive site work such as a below grade overflow structure. Further studies should be performed.

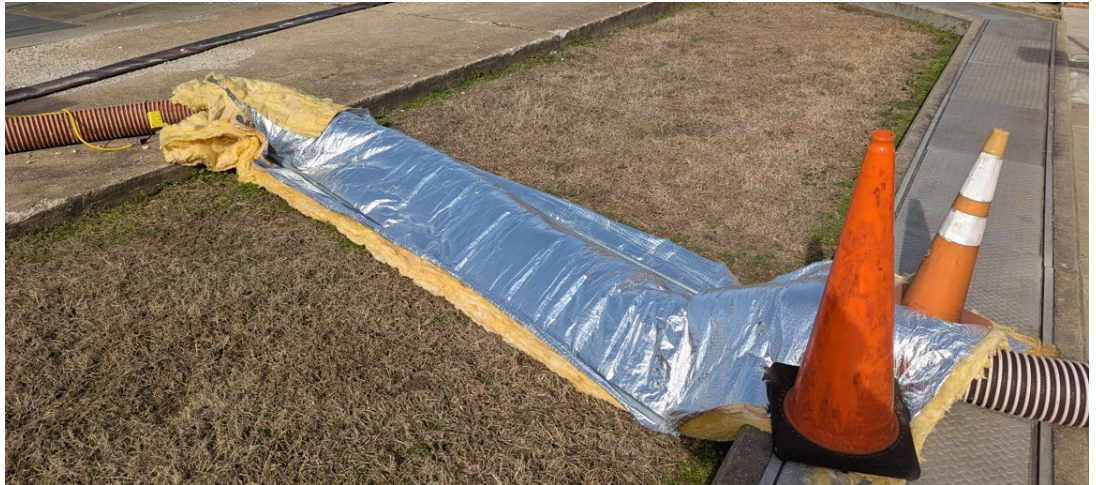
*"Godwin" Portable Dewatering Pump Suction – Plant #2*

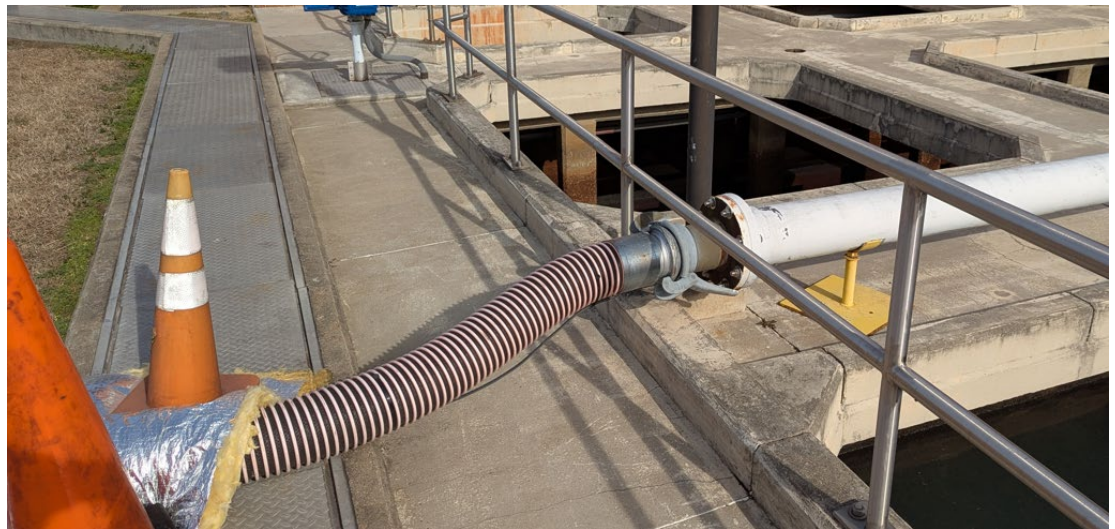
*"Godwin" Portable Dewatering Pump Suction – Plant #2*

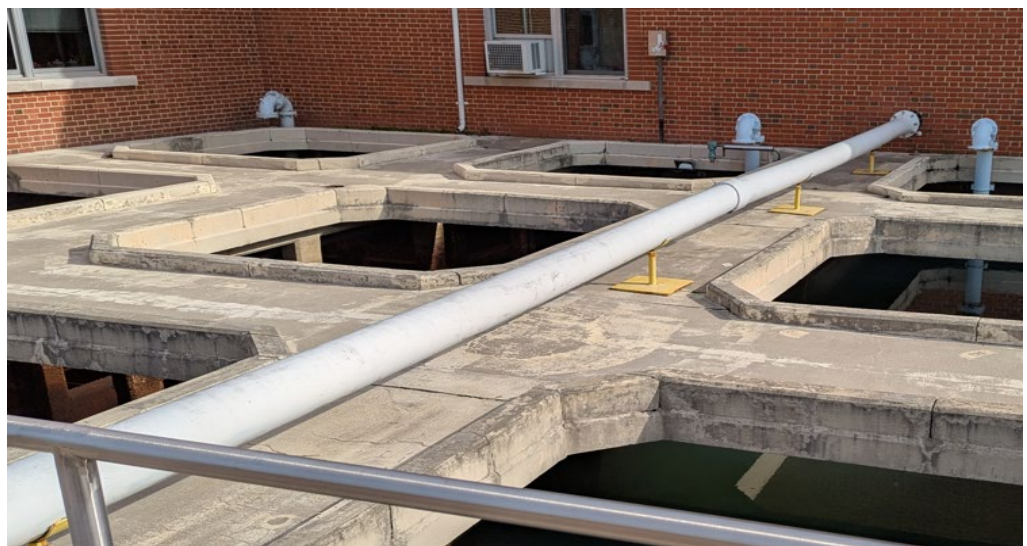
*"Godwin" Portable Dewatering Pump Suction – Plant #2*

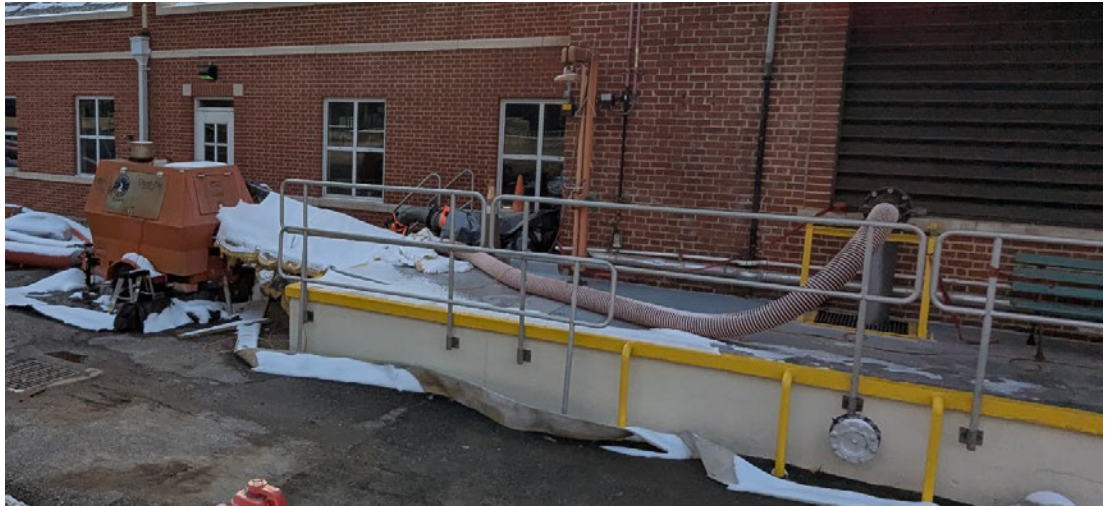
*"Godwin" Portable Dewatering Pump – Plant #1*

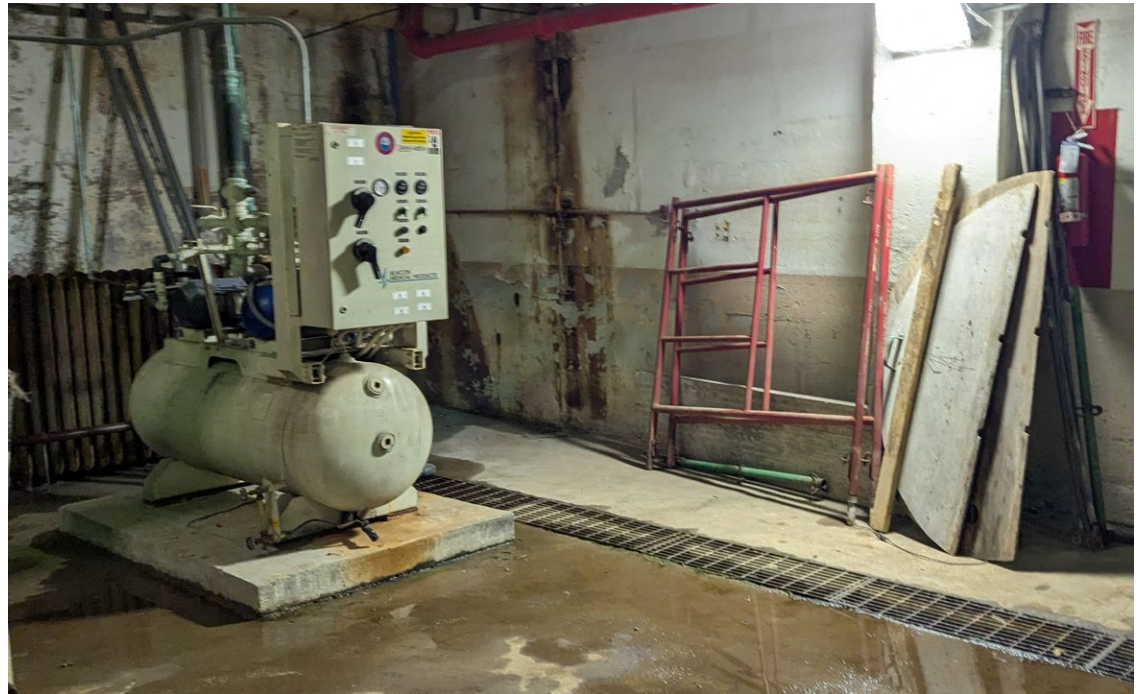
All plant operations and maintenance staff reported that the vacuum priming system is a highly unreliable, complicated, and manual process that has been an issue for many years. To start a pump, operators must first initiate the vacuum priming system located in the filtered water

*Plant #1 – Vacuum Priming System*

start the vacuum priming system, wait 3-5 minutes, and then start the pump from the SCADA system. Operators reported that the priming system often failed, and that they had to manually “trick” and bypass the priming system to start the pump. DPU staff noted that the facility has replaced the vacuum priming systems throughout the years and reported constant issues.

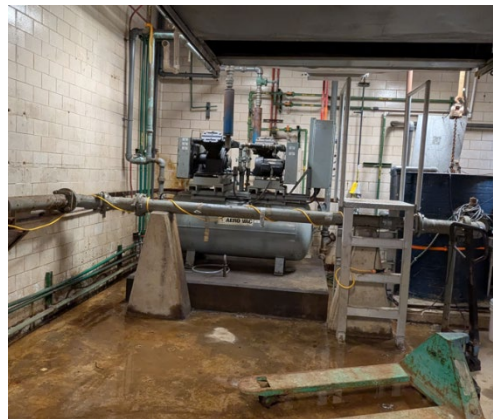
*Plant #2 – Vacuum Priming System*

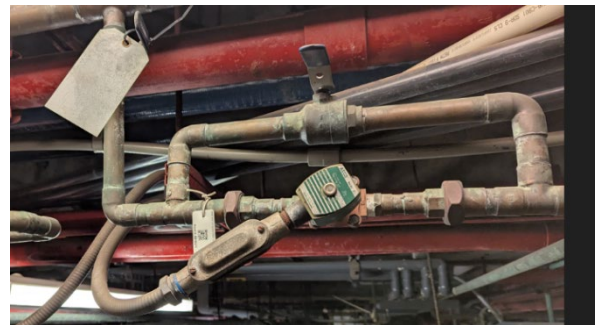
*Plant #2 – Vacuum Priming Solenoid and Bypass*

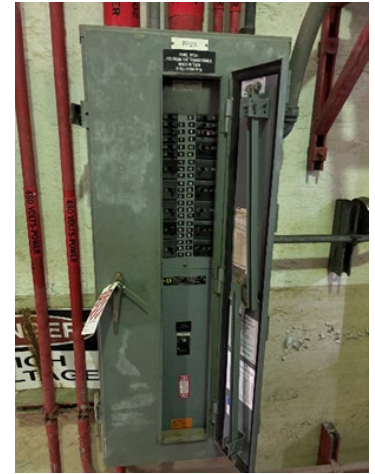
*Panel PP-2A*

Panelboards PP1A, PP2A and LP2A are located on the pump floor and are over 30 years old and have reached their expected life. In addition, water levels during the recent flood event reached above the bottom levels of PP1A and PP2A and accelerated corrosion can be expected. Replacement of these panelboards is recommended within the next 3 years.

1. Perform annual routine maintenance on electrical distribution equipment
2. Replace 480V, 800A MCC-1 within 5 years.
3. Replace two 150HP soft starters for N1 & N2 within 5 years
4. Replace 480V panelboards PP1A and PP2A within 3 years.
5. Replace 120/240V panelboard LP-2A within 3 years
6. Replace and relocate Medium Voltage MCC
7. Replace and relocate S4 VFD
8. Replace 480V panelboards PP-1 and PP-2
9. Replace 120/208V panelboard LP-1

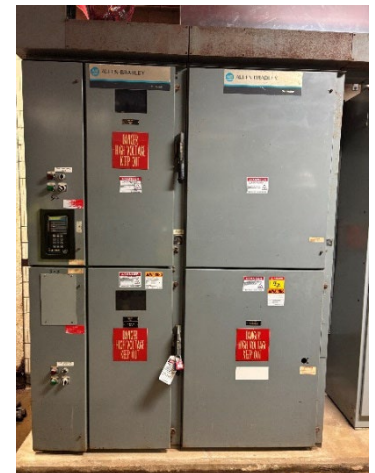
*Medium Voltage MCC*

In Plant #2, outdoor switchgear SG7 feeds the 4160V load breaker switch that in turn feeds the medium voltage MCC powering Filter Pumps S2, S3 and S4. Filter Pump S1 VFD is fed from 480V switchboard HDP-2. 480V Filter Pump S-1 VFD and 4160V S-3 VFDs are located on the main level and were not subject to water damage during the recent flood event. These VFDs are less than 10 years old and are in good condition. The medium voltage MCC controlling pumps S2, S3 and S4 is located on the pump floor and did experience partial flooding during the flood event. This MCC houses the starter for Filter Pump S2 and the breakers for S3 VFD and S4 VFD. The Benshaw VFD is mounted on the pump floor level next to the MCC. The Benshaw VFD dates from approximately 2005 with the rest of the gear over 30 years old. In addition to flood damage, this gear is past its expected life. Replacement and relocation to an upper level as soon as practical is recommended.

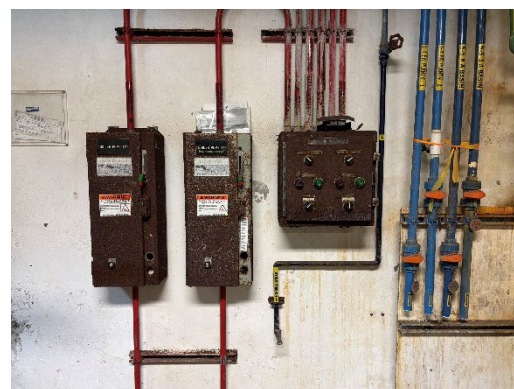
There is abandoned electrical equipment in the boiler room in Plant #2. Removal of this equipment is recommended.

*Abandoned Electrical Equipment*

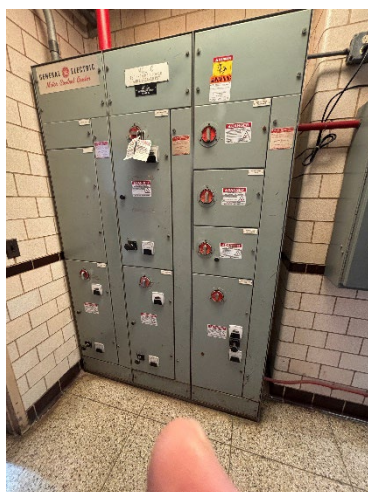
*MCC-C*

MCC-C provides power to the sanitary waste pumps is fed from a manual transfer switch located in the electrical room of Plant #2. This switch allows MCC-C to be fed from either switchboard HDP-2 in Plant #2 or HDP-1 in Plant #1. MCC-C has reached its expected life and is reportedly scheduled to be replaced. In the Waste Pump Room, Panel WHH1-1 is highly corroded and replacement is recommended. In addition, Panel WHH1, which feeds WHH1-7, is located on the level above and has reached its expected life. Panel F, mounted next to Panel WHH1, is also highly corroded. Replacement of Panelboards WHH1, WHH1-7 and Panel F is recommended.

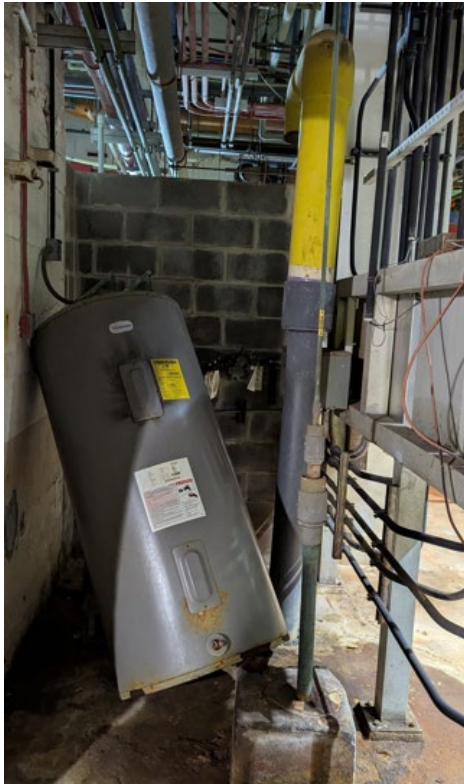
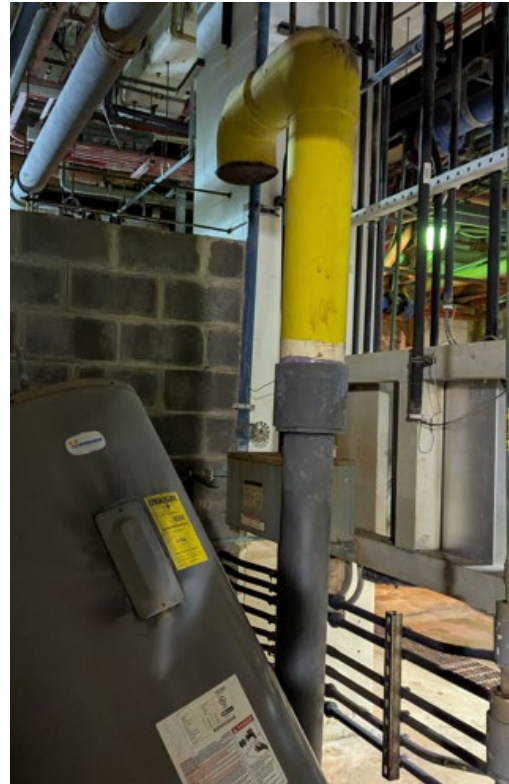
3. The lack of designed overflows for the plant clearwell is a critical issue. DPU staff reported that filtered water frequently surcharges and floods the filter gallery and pumping rooms which are connected. In Plant #1, DPU staff note that water has surcharged out of a PVC vent pipe located approximately 8' above the finished floor, discharging into the pump room. It appears that the vent pipe was previously raised. It is unlikely that a larger overflow pipe could be installed and extended further up out of the plant. During a surcharge event, the pump room floor slab may be subject to imbalanced water pressure forces that it may not

*Vent Pipe in Plant #1*

have been designed for. There is a large visible crack in the concrete adjacent to the clearwell hatch which may have resulted from such surcharge events.

2. The design clearwell water level in Plant #2 is 92.41' and 92.13' in Plant #1. These elevations are above the floor elevation of the filtered water pumping room. Recommend review of the structural design and condition of the pump room floor slab to resist imbalanced water pressure forces.

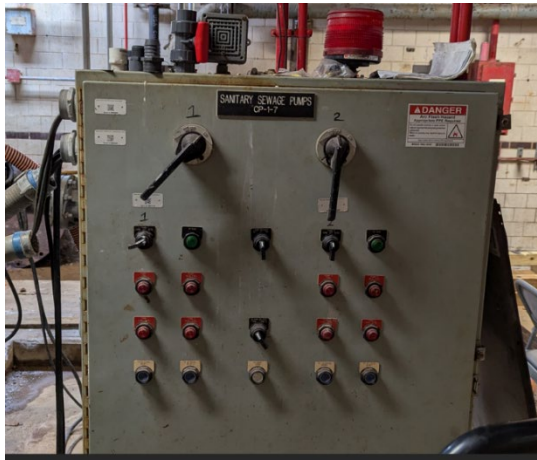
*Sanitary Sewage Control Panel*

5. At the north end of the Plant #2 filtered water pumping room, there is a sanitary sewage ejector system consisting of two fiberglass tanks with sewage pumps that collect sanitary waste along with laboratory drains. The sewage pumps operate on floats to send sanitary wastewater to the Douglasdale Road Pump Station. While the tanks do not sit directly above the filtered water clearwell, there is no containment wall. There is potential for domestic waste to enter the clearwell through pipe penetrations and the bolted covers in the pump room as noted. It is recommended that the condition of the domestic wastewater system is further evaluated, and a containment wall is constructed to prevent contamination. The system should be relocated if possible, to eliminate the risk of cross contamination with filtered water storage and piping.

- a. There is an on-going project to replace the sanitary sewer equipment, reported to be in the design phase.

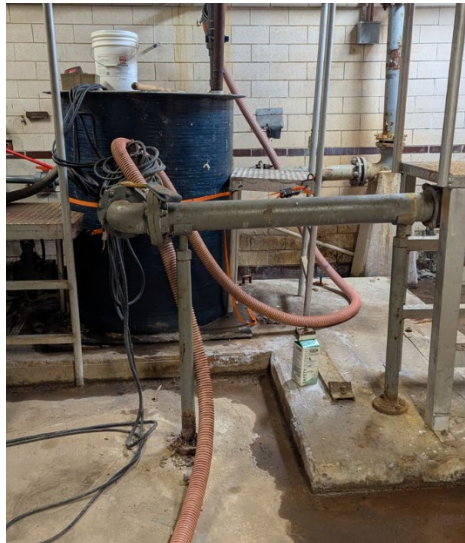
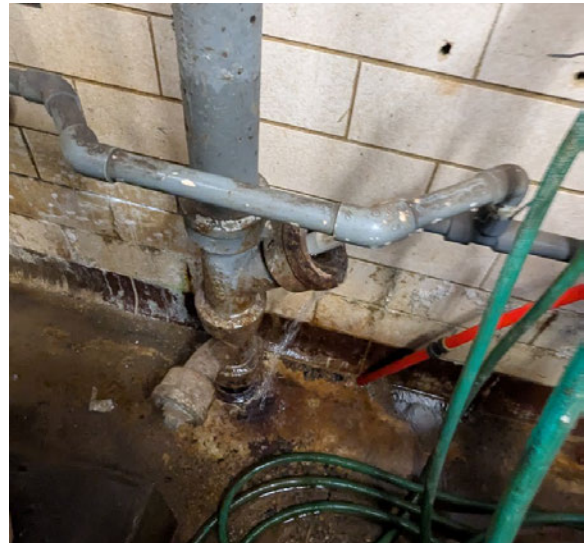
*Sanitary Sewage Tank and Drains*

6. Significant amounts of standing water was present in the vicinity of the sanitary waste system, along with laboratory drains that were discharged through hoses lying directly on the ground. Recommend properly routing process drains with air gaps.

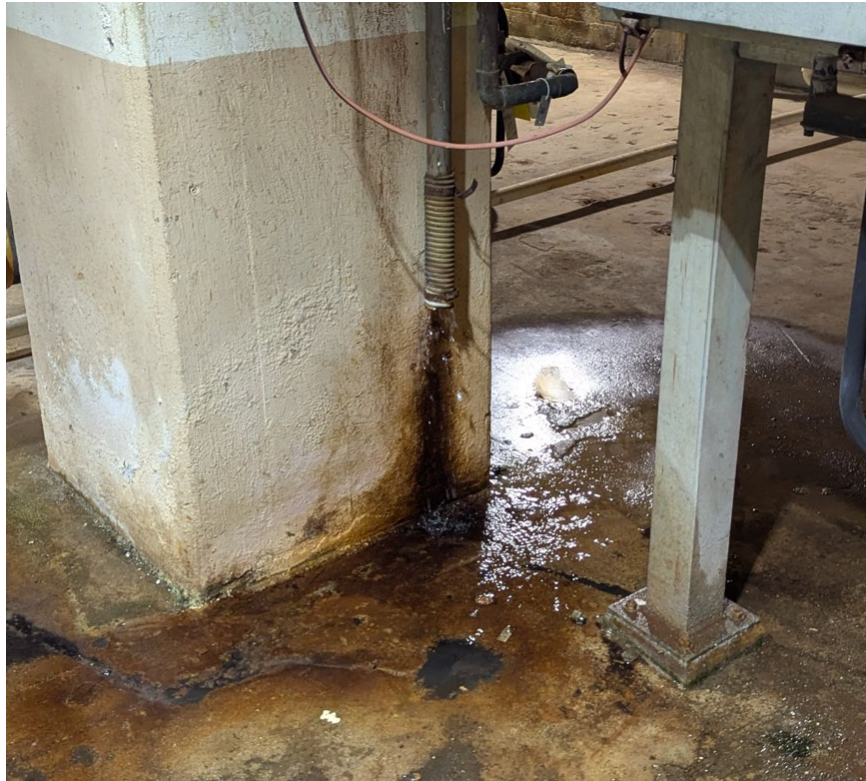
8. There were significant amounts of standing water and actively discharging water within the filtered water pumping areas, some without a nearby process drain. **12VAC5-590-1050A.8.** requires that a suitable outlet for drainage from pump glands be provided without discharging onto the floor. It is recommended that the drains are extended and properly routed to a floor drain.

*Discharging Water – Unknown Source – Plant #1 Pumping Room*

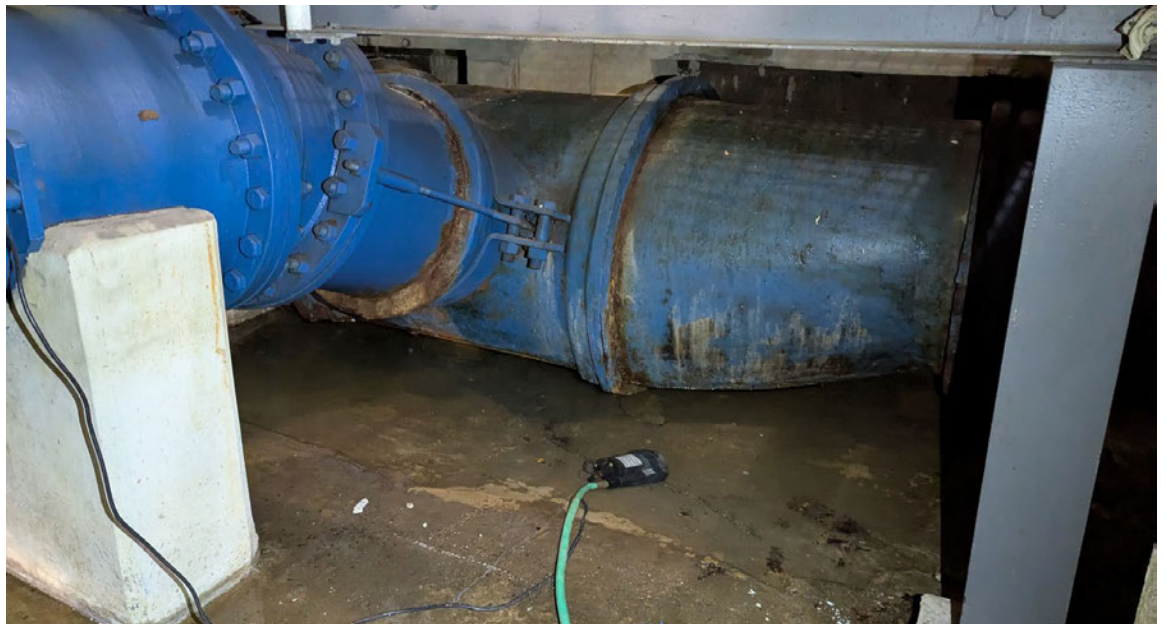
*Standing Water and Temporary Sump Pump in Plant #1 – Pumping Room*

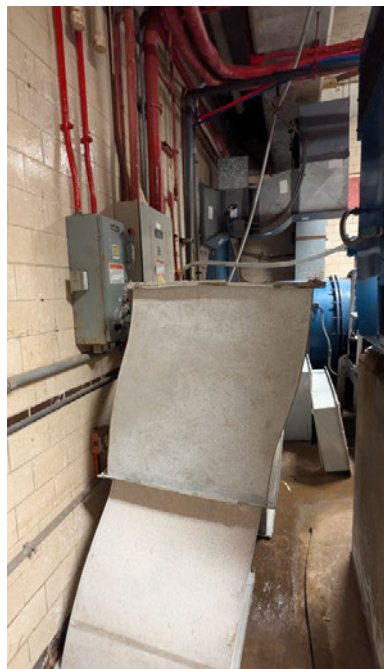
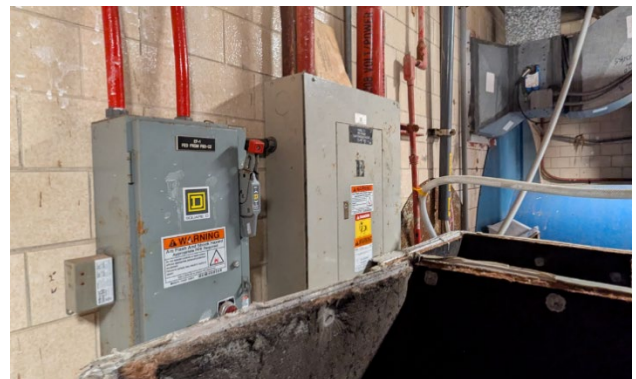
9. General housekeeping in the Plant #2 filtered water pumping room is poor. SEH observed abandoned and disconnected HVAC ducts that prevents safe access around filtered water pump S4, valves, electrical equipment, and the discharge header. Recommend removal and disposal of abandoned equipment to comply with **12VAC5-590-470. Waterworks condition.** The waterworks shall be maintained in a clean and orderly condition.

*Abandoned HVAC Ducts – Plant #2*

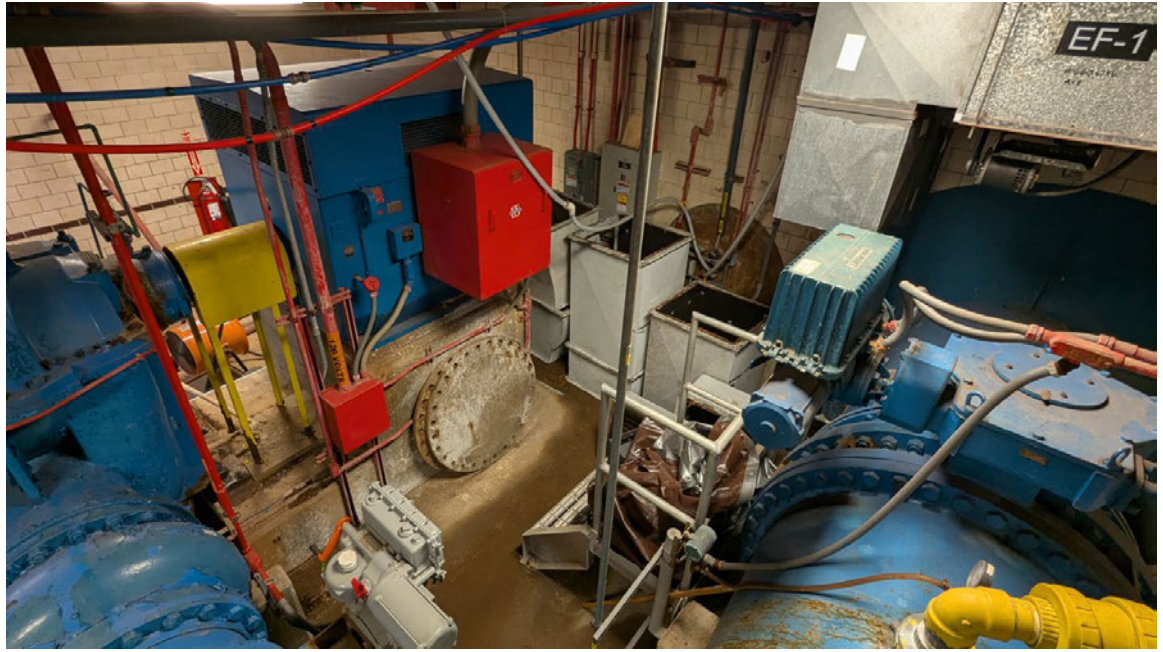
*Filtered Water Pump S4 – Plant #2*

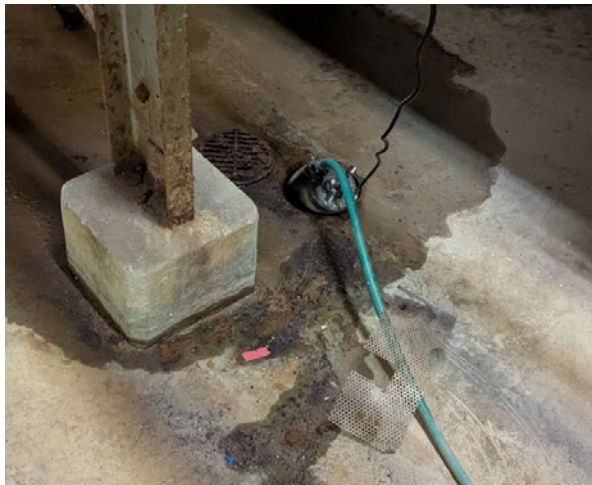
10. Several floor drains within the filtered water pumping room in Plant #2 were reported to be clogged, with temporary sump pumps installed. Recommend floor drains to be cleaned and further inspected.

*Standing Water and Temporary Sump Pump in Plant #1 – Pumping Room*

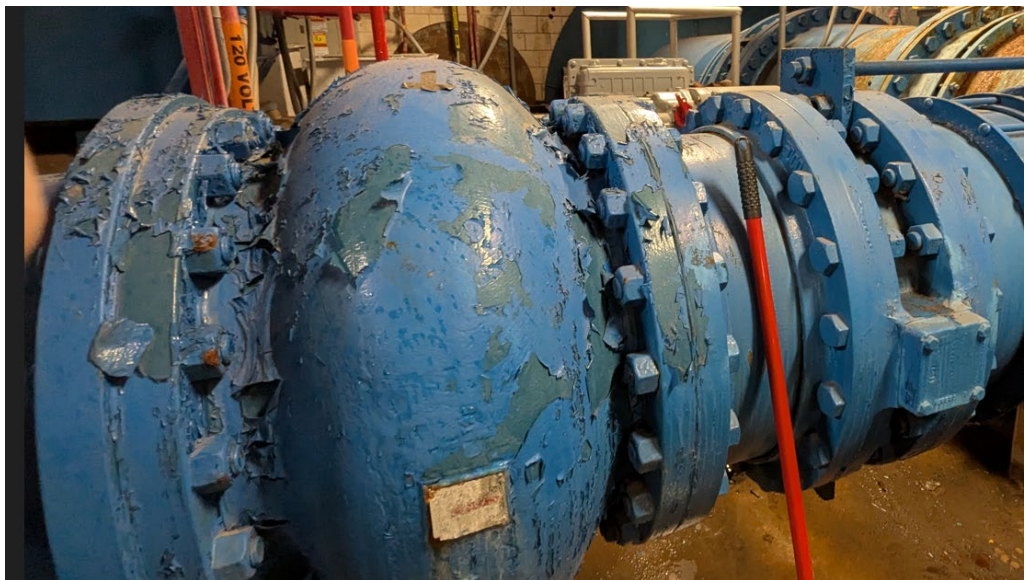
11. There is significant coating failure of the piping and walls throughout the filtered water pumping rooms in both Plants. Recommend blasting, recoating, and repairs. Bolts should be inspected and replaced in both Plants.

*Filtered Water Pump Discharge – Plant #2*

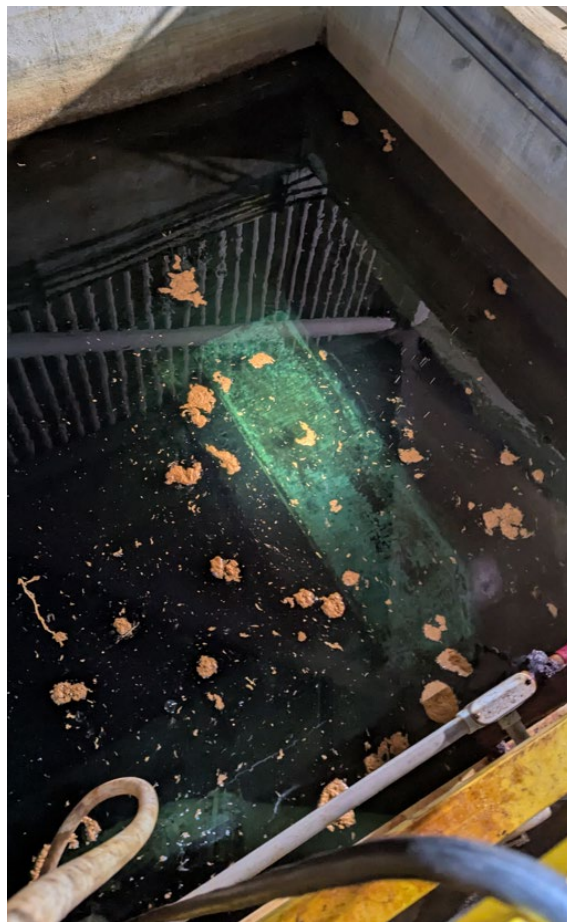
2. SEH observed significant amounts of floating brown scum/foam at the outlet of both chlorine contact basins. Recommend identifying source of contamination and cleaning.

*Chlorine Contact Basin*

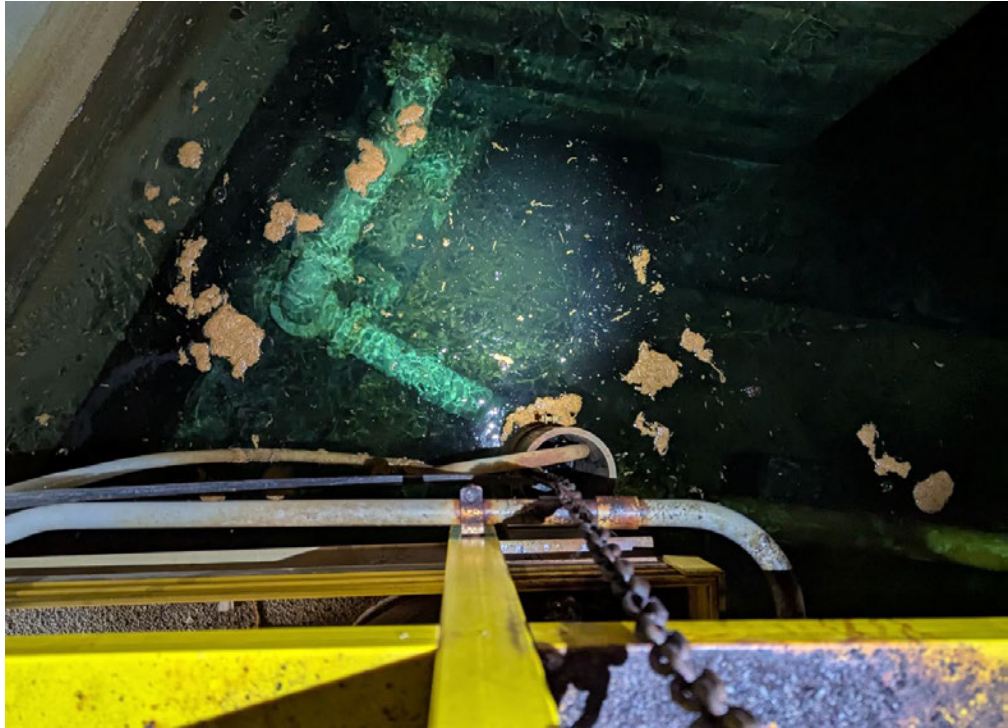
*Plant #2 – North Chlorine Contact Basin*

3. The chlorine contact basins showed signs of water intrusion. **12VAC5-590-1081 Section H** notes that roof and sidewalls shall be watertight and that all pipes running through the roof or sidewall should be connected to standard wall castings with flanges imbedded in the concrete. The basins have multiple pipe penetrations which utilize Link-Seal type penetrations. Recommend detailed inspection of structure to identify repairs to seal all penetrations to ensure that the roof and sidewalls are watertight.

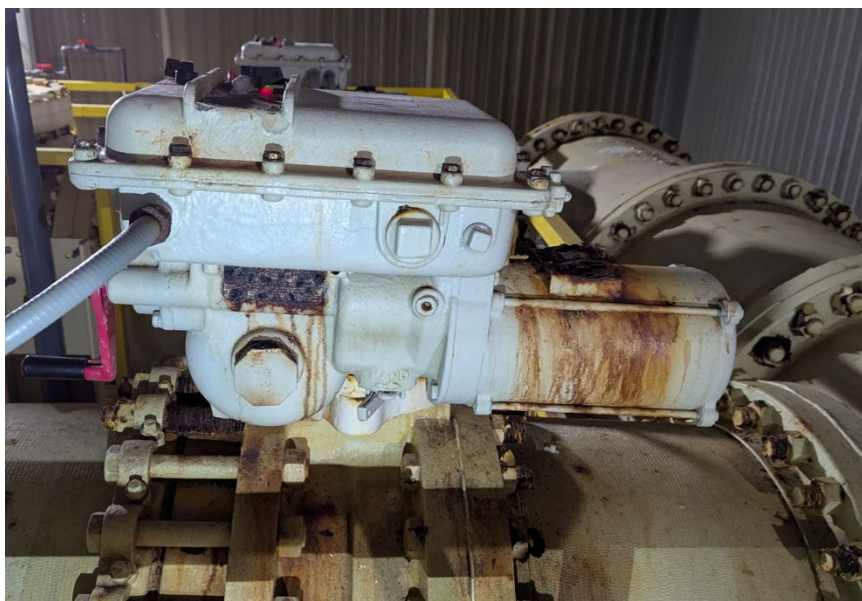
4. The piping and valves within both chlorine contact basins is in moderate condition. Several support beams were observed to have significant damage from chlorine vapors. Recommend the facility implement a monitoring program.

*Piping in Chlorine Contact Basin 1*

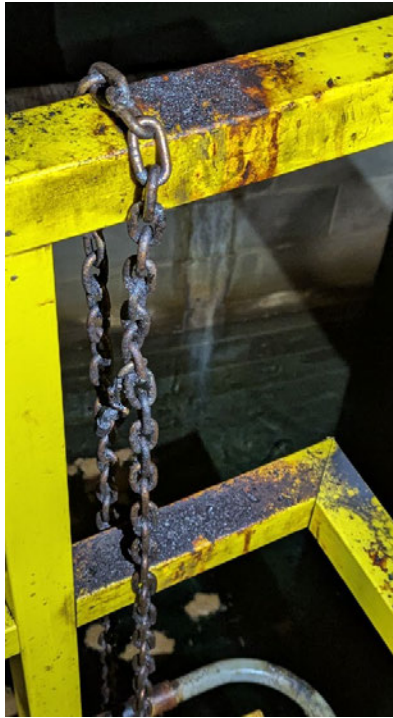
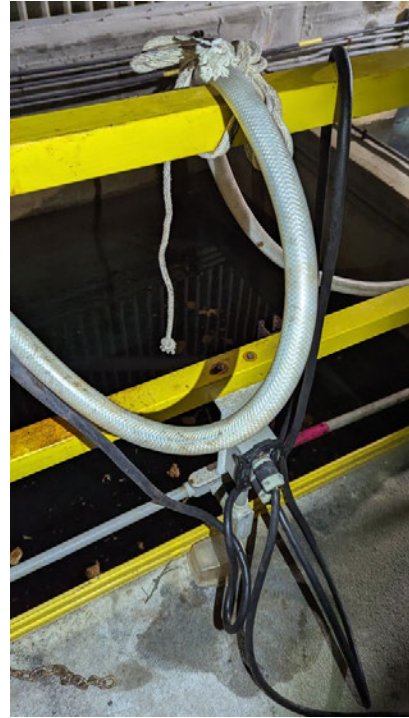
5. General housekeeping in the chlorine contact basins is poor. Sampling pumps are installed with corroded chains and dangling cords and hoses, which poses safety hazards and contamination risks. **12VAC5-590-470. Waterworks condition.** The waterworks shall be maintained in a clean and orderly condition.

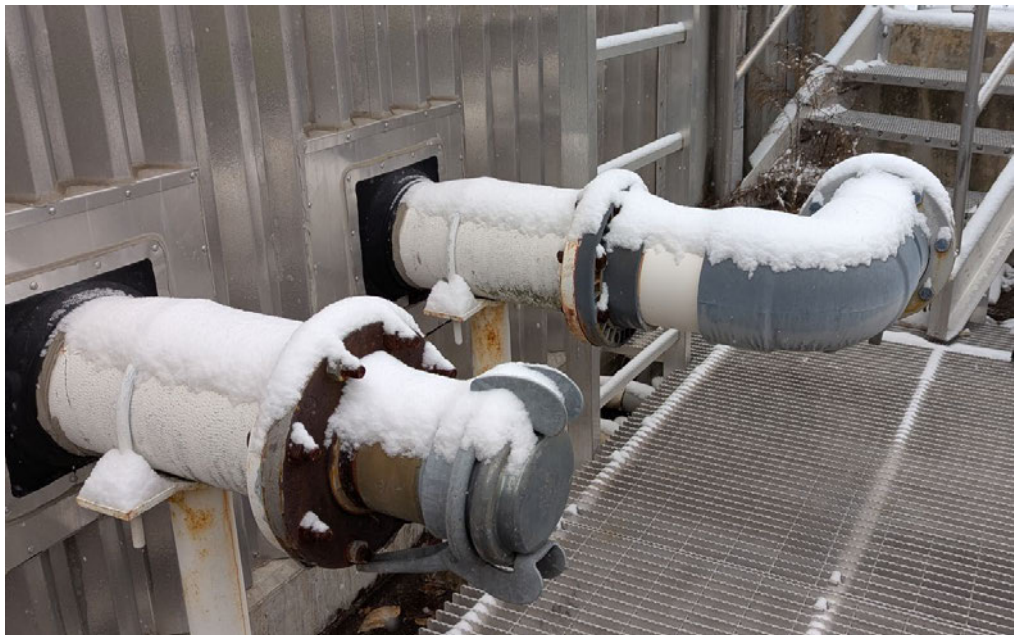
8. The chlorine contact basins utilize suction and discharge connections that allow portable dewatering pumps to be connected when the basins must be drained and cleaned for maintenance. Recommend proper signage on the connections.

*Plant #1 – Drain Suction and Discharge Connection*

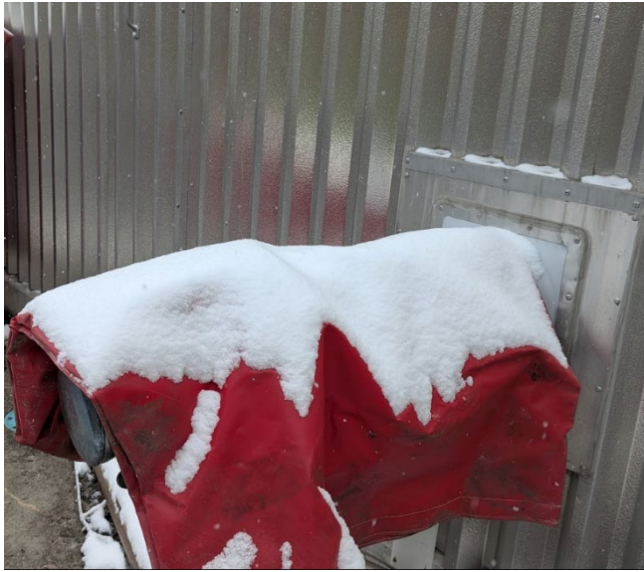
*Plant #1 – Drain Suction Connection*

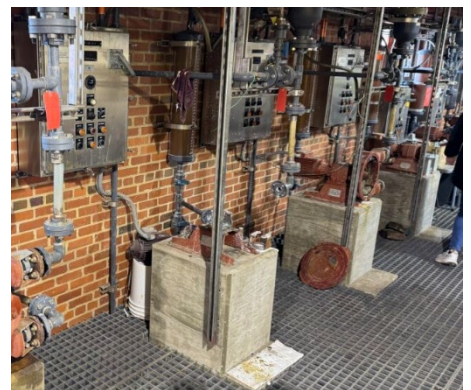
2. There were multiple sodium hypochlorite and alum dosing pumps that were in various stages of dis-assembly or missing.

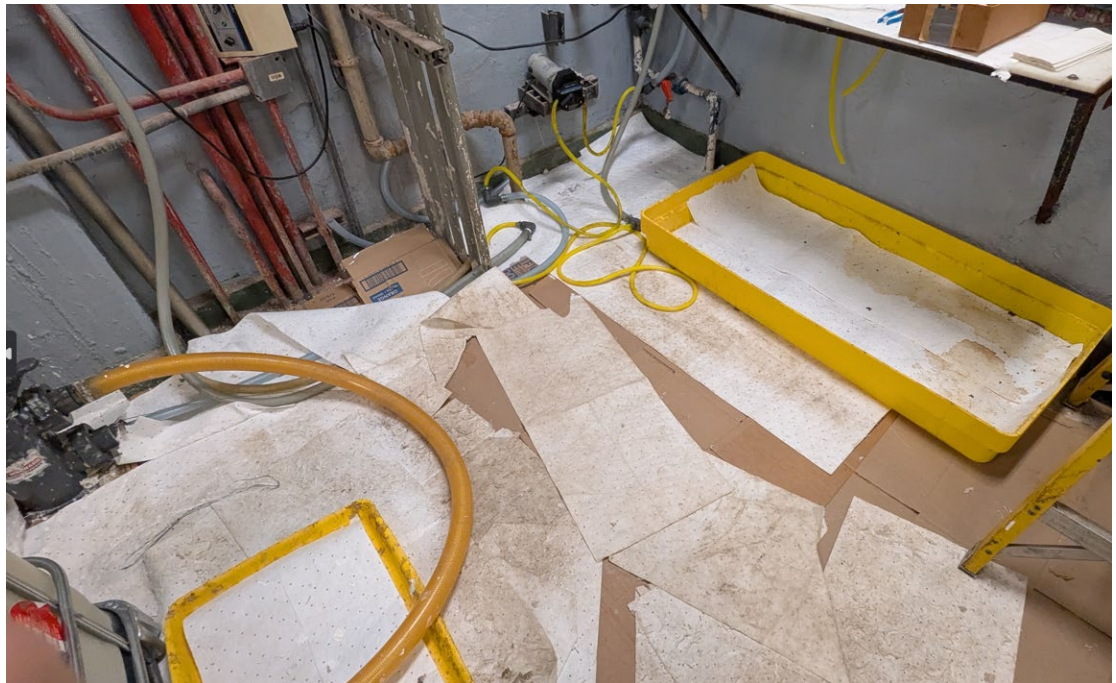
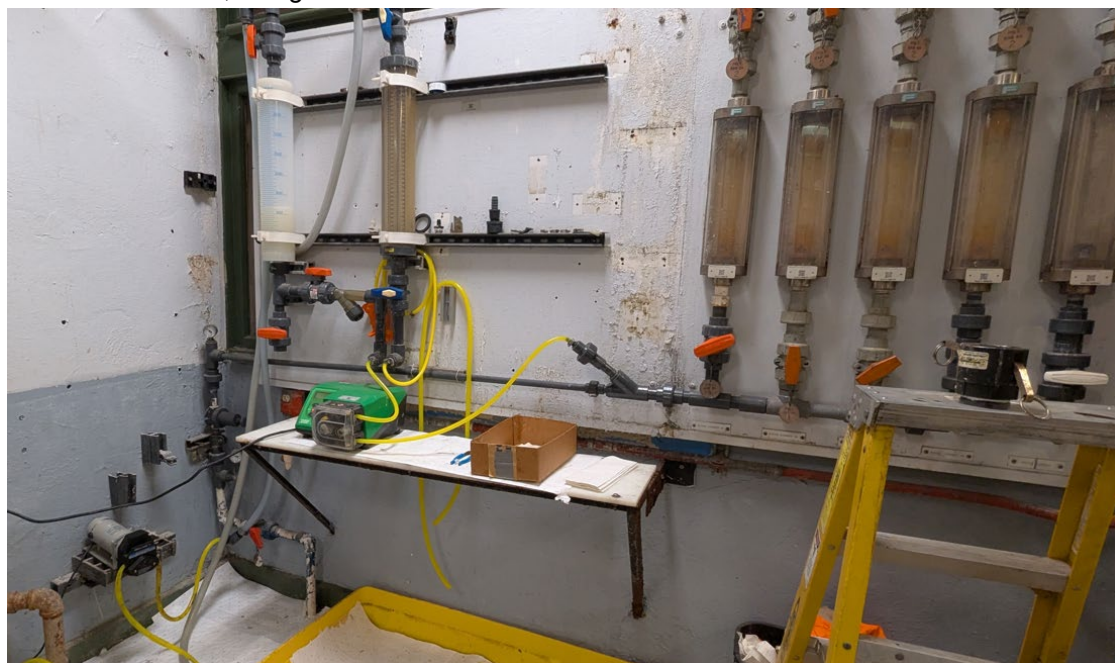
4. Polymer in each plant is injected into a common dilution/motive water header using a single metering pump without a static mixer. The header then immediately splits to each flocculation basin through the use of manual ball valves and a rotameter. There is no means for the facility to accurately ensure proper chemical feed. It is recommended that the facility construct a common polymer storage and feed room in Plant #2. A polymer blending/makedown system should be installed with dedicated dosing pumps for each flocculation basin, along with static mixers.

*Plant #1 – Polymer Chemical Storage and Feed*

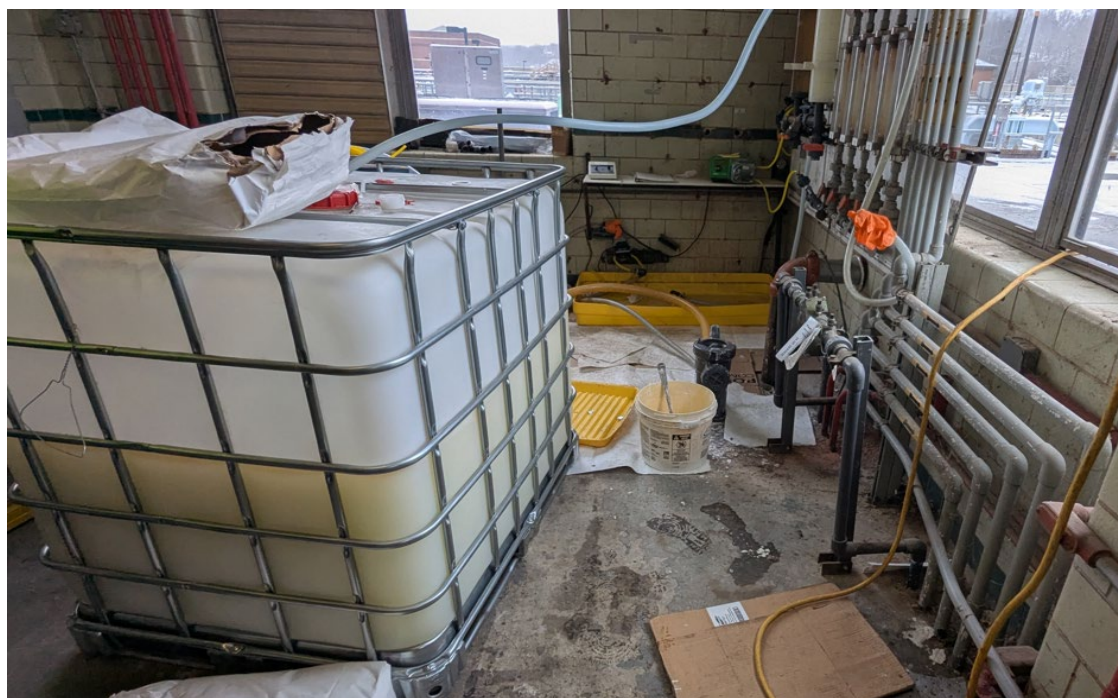
*Plant #2 – Polymer Feed*

5. The polymer feed system is not flow-paced and must be manually adjusted. The rotameters displaying diluted polymer flow to each basin do not have markings and appeared to be maxed out. Recommend replacing rotameters and adding flowmeters so that polymer feed to each basin can be controlled.

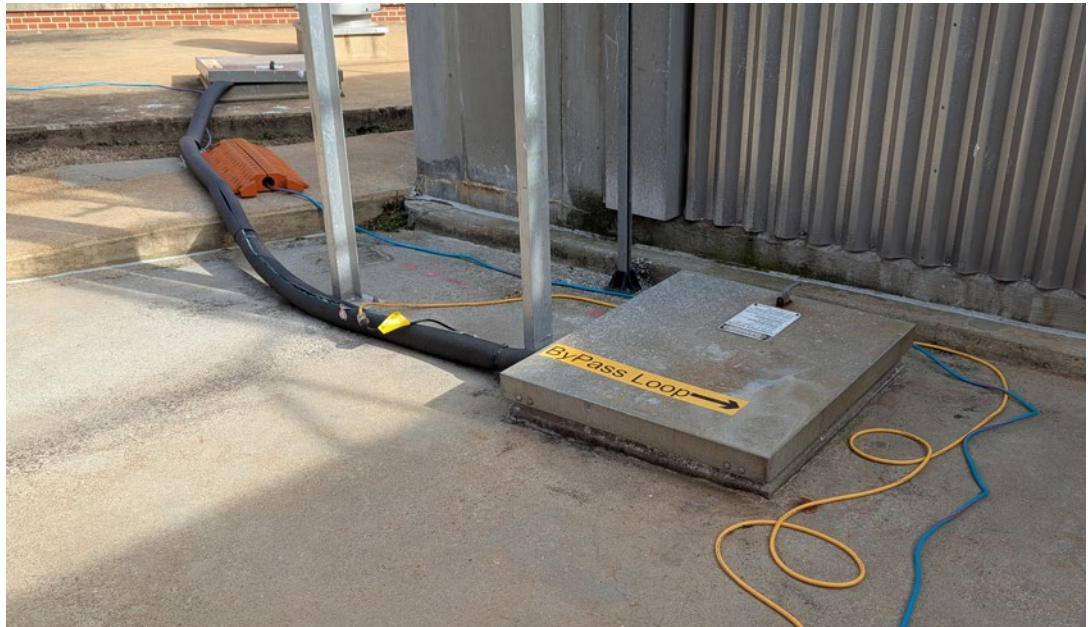
8. The chemical tubing for lime feed at the filtered water meters are routed along the ground, wrapped in electrical heating tape and insulation. Recommend permanently installing chemical feed lines in such a manner to protect them from freezing and damage and minimize trip hazards. (**12VAC5-590-860 – Chemical Application**)

*Lime Chemical Hose*

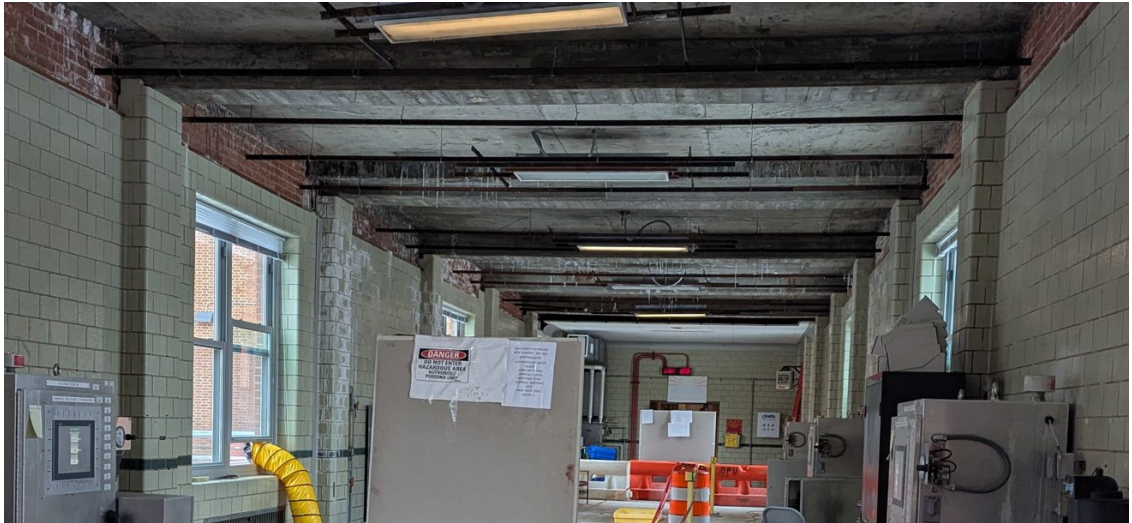
9. At the time of inspection, the west half of the entire Plant #2 main level was cordoned off due to a major chemical leak in the sodium hypochlorite day tank in the floor above. A previous EPA inspection in 2022 noted active leaking and chemical crystallization on multiple chemical tanks. Chemical leaks pose significant hazards to staff as well as operational interruptions. Recommend the facility add routine chemical tank inspections to its operating procedures.

*Plant #2 – Main Level Corridor*
