# Comprehensive Waterworks Evaluation and Cost Estimate

## City of Richmond, VA

Virginia Department of Health, Office of Drinking Water

VADOH 183662 | April 8, 2025

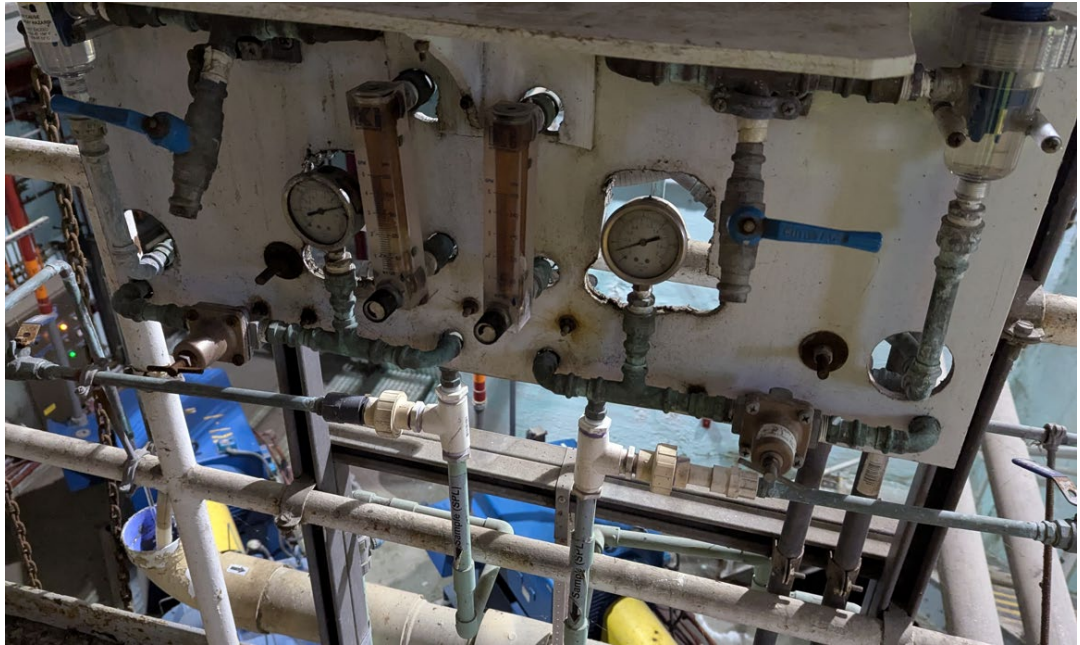
11. The caustic soda sampling panel is in poor condition. The sampling flow rate, pressure gauge, and pH readings were not similar between the north and south chlorine contact basins, which showed pH readings of 8.03 and 7.60 s.u. respectively. The pH of the north chlorine contact basin reading of 8.03 s.u. does not meet **12VAC5-590-1002.C**, which states when chloramination is used for disinfection that “pH adjustment facilities shall be provided to maintain pH in the range of 7 to 8”. It is unclear what pH range the facility targets. Recommend calibration and/or replacement of the sampling instrumentation and sampling pump.

*pH Sampling Panel*

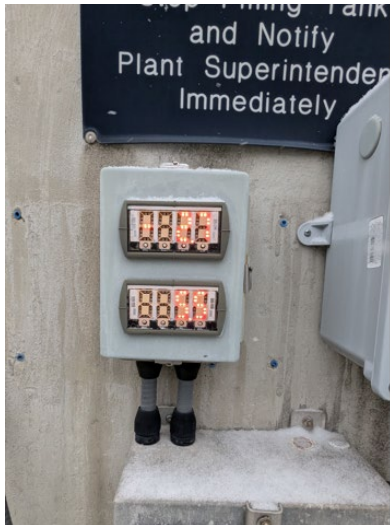
13. The caustic tanks were noted to be constructed in 1999 and may be approaching their end of life. Consider replacement within 5 years.
14. At the caustic loading panel, one of the level transmitter readings appeared to show a negative value. At the top of both caustic storage tanks, bricks were observed supporting the electrical conduit for level transmitters. An incorrect level reading poses potential overflow hazard when chemical deliveries are made. Recommend providing proper conduit support to prevent damage. Replace level instrumentation.

*Caustic Storage Tank Level Indicator*

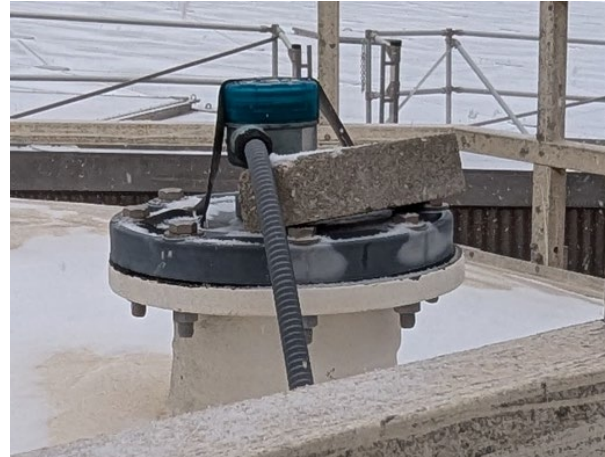
*Caustic Storage Tank Level Transducer*

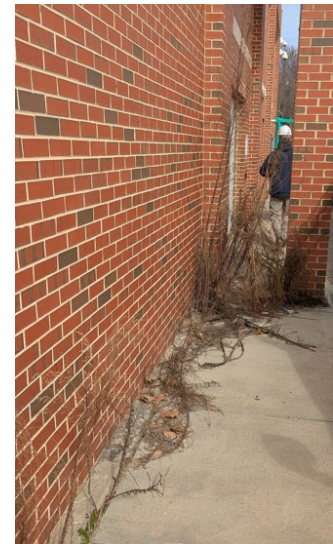
15. The fluoride pumping equipment including control panels are located in the lower level of Plant #1 below the plant hydraulic grade line, and subject to damage during a surcharge event. The facility is currently undergoing a project to replace the existing fluoride pumps. It is recommended that the pumping equipment is relocated to the main floor or higher.
16. There is a significant amount of unused and abandoned chemical feed equipment and piping throughout the facility. Recommend demo and removal of unused equipment.
17. During the evaluation, operations staff were not confident in all the available chemical feed locations, as the plant has been modified and upgraded throughout the years. Some feed points been abandoned in place.
18. Vegetation was observed growing alongside the West Chemical Facility.

*West Chemical Facility*

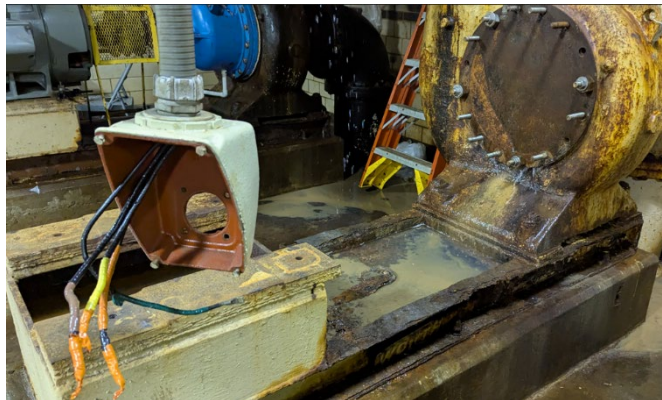
3. The motor for wastewater Pump No. 2 was missing, with exposed wiring. Recommend sealing the wiring properly in a junction box. Recommend replacing the equipment as soon as possible, given the critical nature of the wastewater pumping station noted above.

*Wastewater Pump No. 2 Motor Missing*

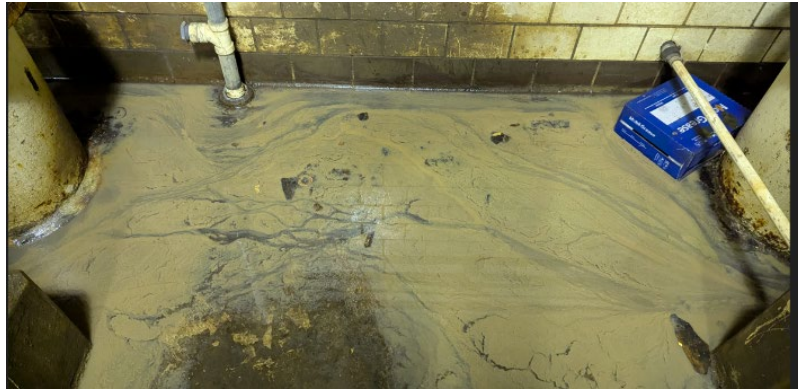
4. The wastewater piping and valves are in poor condition. Recommend cleaning and recoating.
5. There is a significant amount of standing water in the pumping station (room). The floor did not appear to be sloped properly to floor drains located in the center of the room. Recommend fixing floor drainage.

*Wastewater Pump Station Floor*

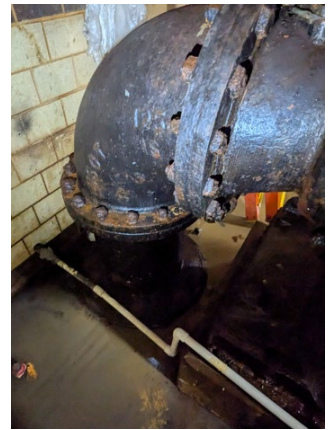
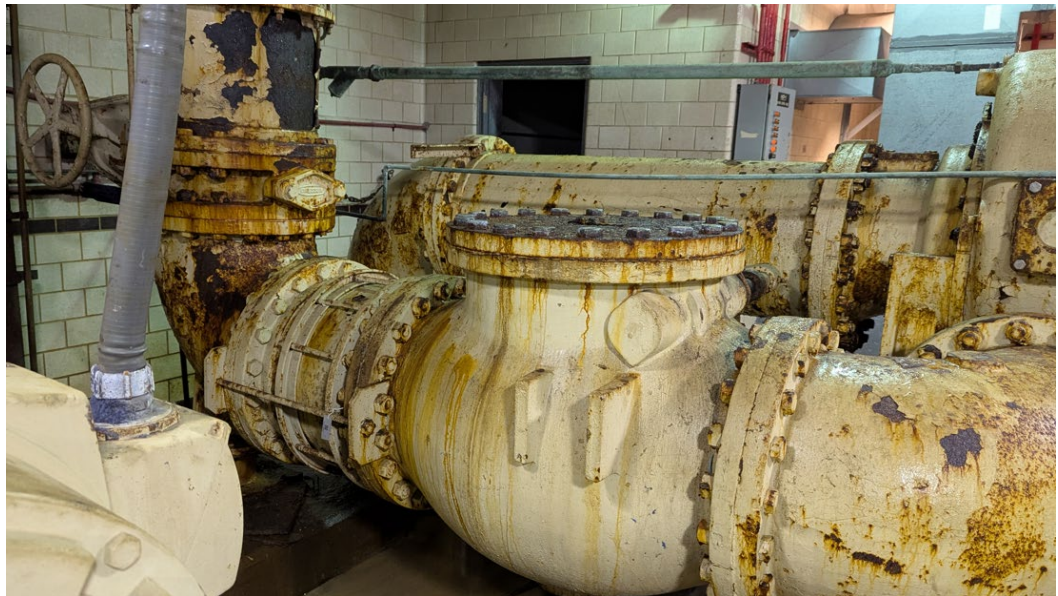
*Wastewater Pump Station Piping*

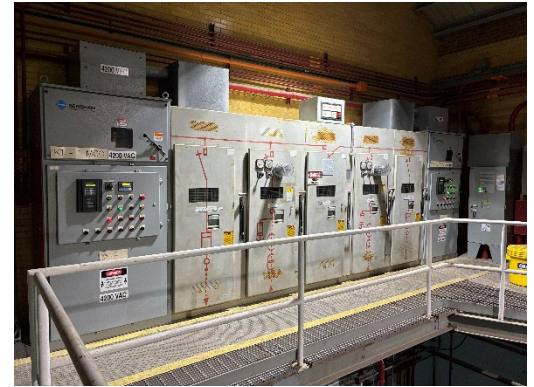
Switchgear SG9 serves Korah #1 and is fed from outdoor switchgear SG6. This 4160V switchgear dates from the early 1990s and is over 30 years old. Overall, the equipment is well maintained but is showing signs of corrosion. Replacement within 5 years is recommended due to the age of the equipment, corrosion and its critical role in the operation of the WTP. The following routine maintenance items are recommended to ensure that the equipment is functioning properly and to extend its lifespan:

*Switchgear SG-9*

- The equipment is currently tested and maintained every three years. Maintenance was last performed in 2022 and is expected in 2025. Continue with routine maintenance schedule.
- Clean any dirt or dust accumulation from the equipment.

- Perform annual routing maintenance on electrical distribution equipment
- Replace 4160V Switchgear SG-9 within 5-10 years.
- Replace Panel K1 within 3 years

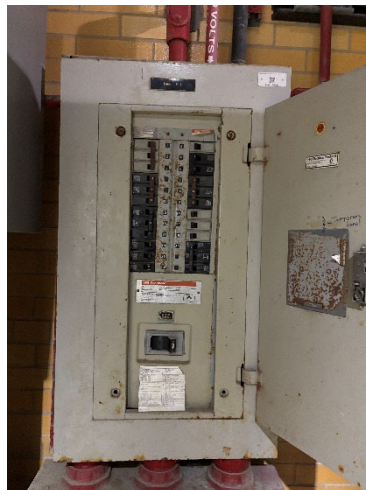
*Panel K1*

Two 4160V Benshaw Variable Frequency Drives, (VFDs), control pumps K1-1 and K1-2. These drives were installed around 2012 and are in good condition. A bypass isolation automatic transfer switch, (ATS), allows the 120/208V distribution to be fed from either of two 112.5kVA 4160V-120/208V transformers. The ATS was installed in 2024 and is in excellent condition. The 400A, 120/208V Panel K1 and sub-panel K1-B provide house power, and the Limehouse Panel Main Breaker feeds 120/208V to the Limehouse Panel. Except for Panel K1-A, which was replaced in 2012, all the 120/208V equipment has reached its expected life and is showing sign of corrosion. Replacement is recommended.

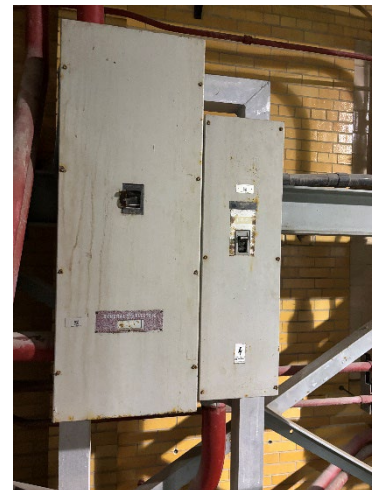
*Xfmr Secondary Breaker and  
Limehouse Panel Breaker*

- Replace Transformer Secondary Breakers and Limehouse Feeder Breaker

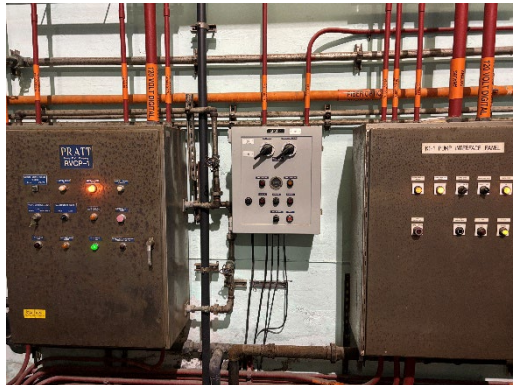
The pump control panels are located on the lower level, and although the panel exteriors appear to be pitted, the panel interiors were upgraded in 2012 and are in good condition.

*Pump Control Panel Exteriors*

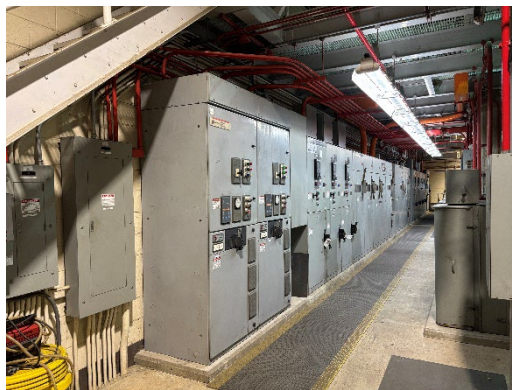
Switchgear SG8 serves Korah #2 & #3 electrical equipment and is fed from outdoor switchgear SG6. This 4160V switchgear dates from the early 1990s and is over 30 years old. Overall, the equipment is well maintained but is showing signs of corrosion. Immediate replacement is not required, replacement within 5 years is recommended due to the age of the equipment, corrosion and its critical role in the operation of the WTP. The following routine maintenance items are recommended to ensure that the equipment is functioning properly and to extend its lifespan:

*MCC-2, MCC-CC\* Bus-1 and SG8*

- The equipment is currently tested and maintained every three years. Maintenance was last performed in 2022 and is expected in 2025. Continue with routine maintenance schedule.
- Clean any dirt or dust accumulation from the equipment.

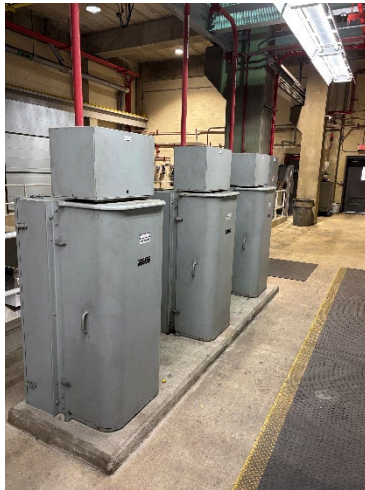
The original MCC construction consisted of two MCC busses extending from each side of switchgear SG8. On the MCC-CC8-Bus-1 side, Pumps K3-3, K3-4 and K3-5 are controlled via drum controllers, which date from the 1970's. These drum controllers are obsolete, and replacement within 5 years is recommended. On the other side, MCC-CC8-Bus-2 contains 2-speed starters for Pumps K2-1, K2-2 and K2-3. These starters have also reached their expected life and replacement is recommended. Improvements in 1996 included adding MCC-2 next to existing MCC-C8-Bus-1 which included new starters for added pumps K2-4 and K2-5. MCC-2 and associated starters are 29 years old and at their expected life. Replacement within 10 years is recommended. Toshiba VFDs for K3-2 and K3-2 were added and are in good condition, although there are complaints regarding the excessive noise levels while they are operating. Staff reported that the manufacturer has tested the drives and have reported that the noise levels are normal, and the drives are functioning properly. No further action is recommended currently.

*K3-3, 4 & 5 Drum Controllers*

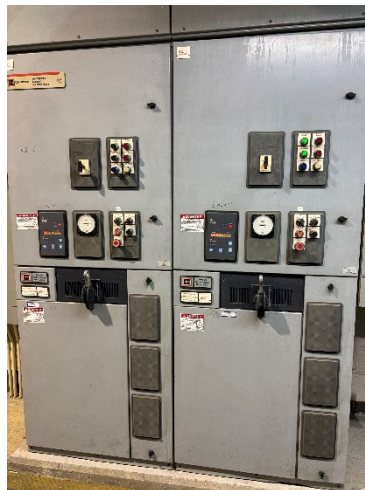
*K2-4 & 5 Comb. Starters*

- Replace K2-4 and K2-5 Combination Starters.
- Replace MCC-1 within 5-10 years
- Replace Panel PB within 5-10 years
- Replace Panel PA within 5-10 years

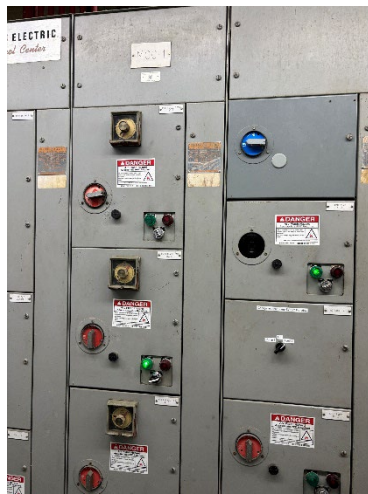
MCC-1

Low voltage, (480V and below), electrical equipment is also over 30 years old has reached its expected life. This includes 480V MCC-1, 480/277V Panel PA and 120/208V Panel PB. Replacement of this equipment in 5-10 years is recommended.

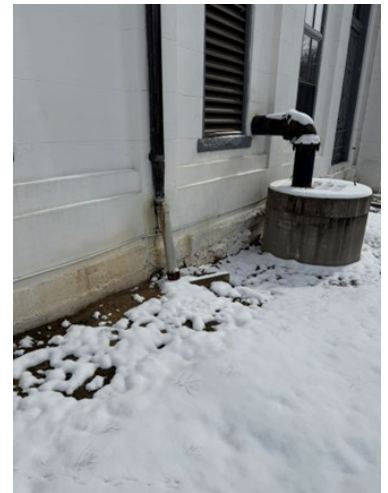
Pressure Relief Valve Discharge

- The pressure relief discharge pipe is inserted into the catch basin. It should be cut off to provide an air gap of at least one foot. It is unknown if the discharge is screened but should be screened with a corrosion resistant screen if not (12VAC5-590-1160).

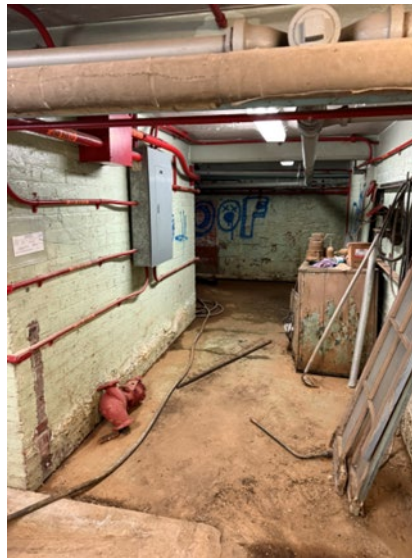
- Staining and mildew was observed on the exterior of the building should be power washed.
- The boarded up double door on the east side is showing signs of rotting and should be replaced.
- Two downspouts were observed to be disconnected and should be reconnected.
- Graffiti was observed in the basement.

*Basement Showing Graffiti*

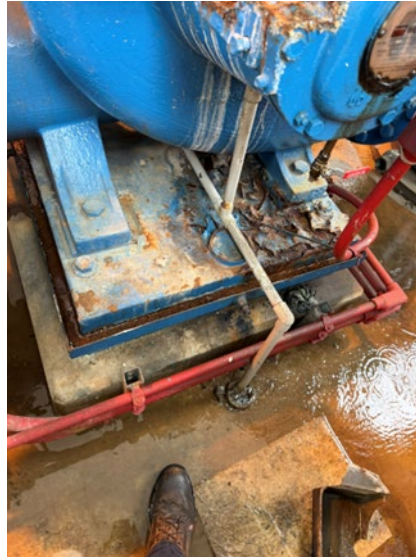
- R1 was offline during the site visit because the suction side butterfly valve was reported to have a leaking valve seat resulting in water leaking continuously out of the pumps drain lines, as well as a sample tap on the discharge side of the pump. The floor drain near the pump was also observed to be clogged. It is recommended that floor drains be cleaned.
- Process equipment drains were observed to be running along the floor and either inserted into or on top of drains. It is recommended to provide an adequate air gap for these drains and install a corrosion resistant screen.

*Floor Drain Adjacent to R1*

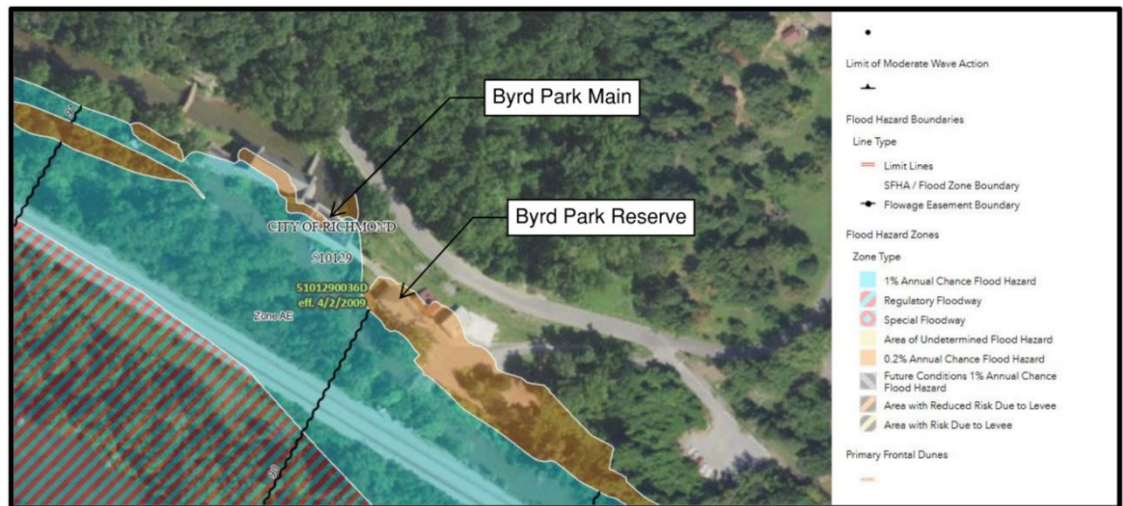
FEMA Flood Zone Map

- The pump station lies within the 500-year floodplain.

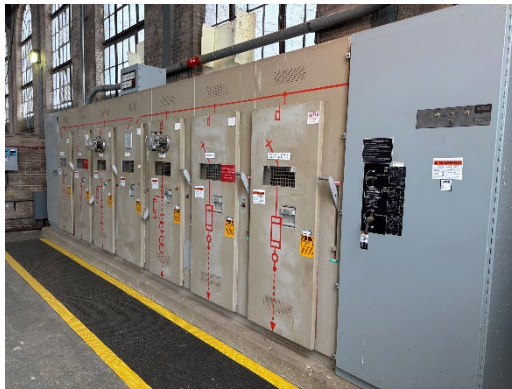
but has reached its expected life. Immediate replacement is not required, replacement within 5-10 years is recommended due to the age of the equipment. The medium voltage MCC contains medium voltage starters for the three pumps, P-1, P-2 and P-3. This MCC is over 30 years old and in addition to reaching its expected life, it has signs of corrosion and replacement within 5 years is recommended. The following routine maintenance items are recommended to ensure that the equipment is functioning properly and to extend its lifespan:

*Switchgear SG5*

- The pump emergency shutoff buttons were observed to be uncovered. It is recommended to provide covers.
- Perform annual routing maintenance on electrical distribution equipment
- Replace 4160V Switchgear SG-5 within 5-10 years.
- Replace MCC and associated P1, P2 and P3 starters within 5 years.
- Replace 120/208V Panels A and B
- Replace valve batteries with UPS.
- Replace lighting

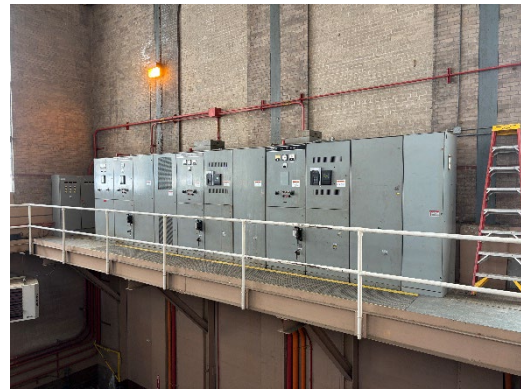
*MCC*

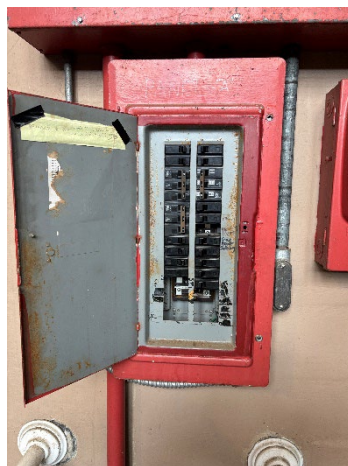
120/240V panels A and B are in poor condition and replacement is recommended. Panel A has exposed bus bar, which is a safety hazard for anyone operating a breaker within the panel.

*Panel A*

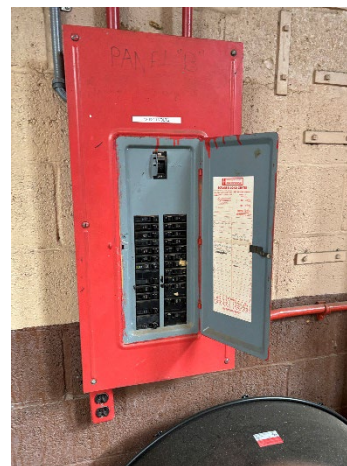
*Panel B*

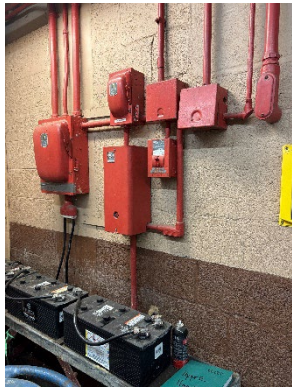
The DC backup system for the valves, although reported to be functioning properly, is dated and a more effective backup, such as a modern UPS is recommended to replace this system.

*Valve battery system*

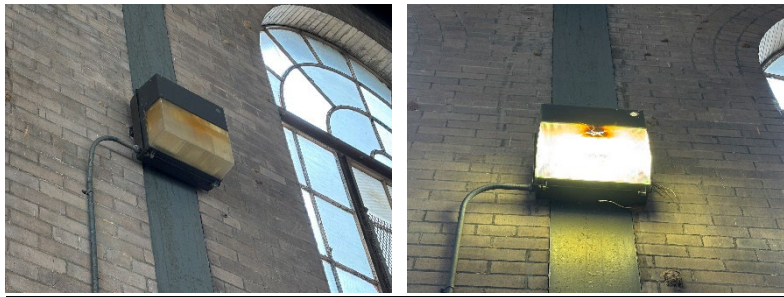
Wall mounted lighting fixtures are in poor condition and replacement is recommended.

*Wall mounted lighting fixtures*

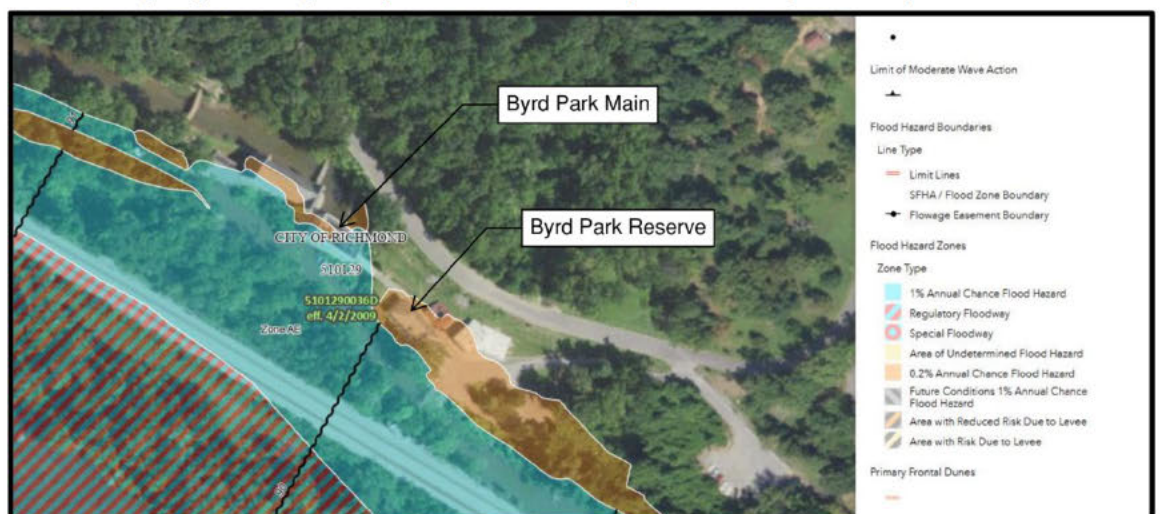
FEMA Flood Zone Map

- The pump station partially lies within the 100-year and 500-year floodplain.

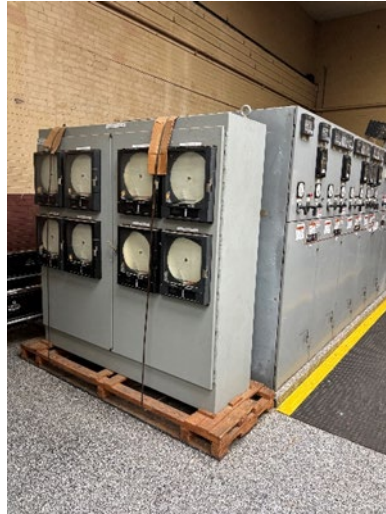
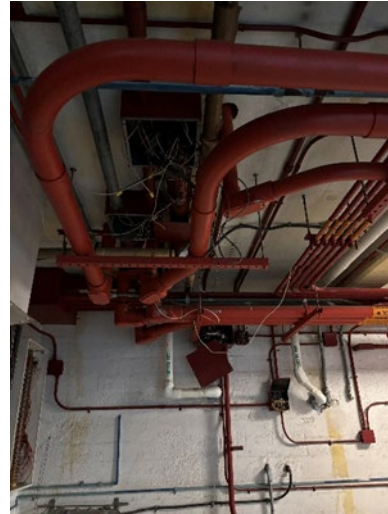
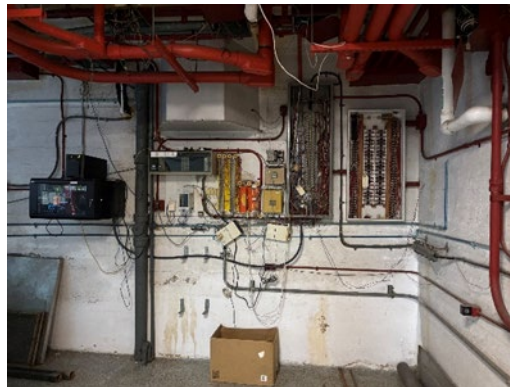
IMG\_8103

Open electrical boxes and wire management issues were noted in the basement, along with abandoned communication panels and hanging cables. Abandoned electrical wiring and equipment should be removed, boxes closed, and cable management employed to organize cabling.

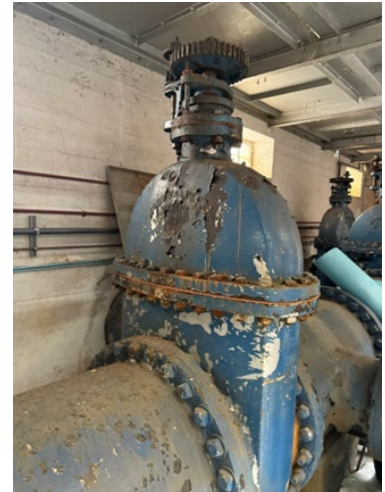
Combined Discharge Header with Excessive Corrosion

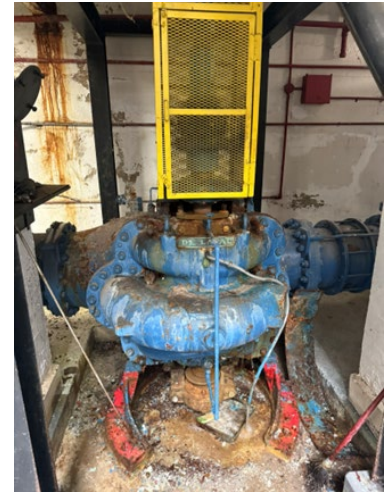
- T1 is at the end of its useful life and should be replaced. Pumps generally have a lifespan of 30-50 years depending on their maintenance cycle. The T2, T3, T4, and T5 appear to have been well maintained but are approaching the end of a typical life cycle. It is recommended to prepare a budget to plan for their replacement.

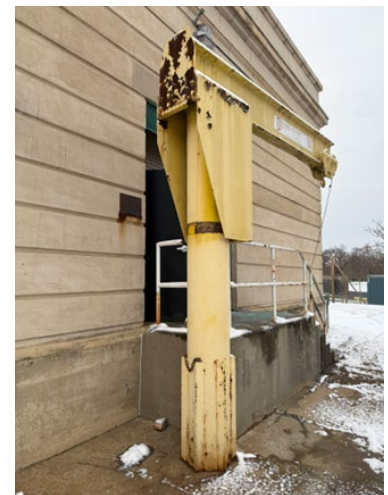
Exterior Crane

- The exterior crane and railing should be blasted and recoated.
- All windows are recommended to be replaced including the screens for the basement windows. Many of the screens were observed to be damaged.

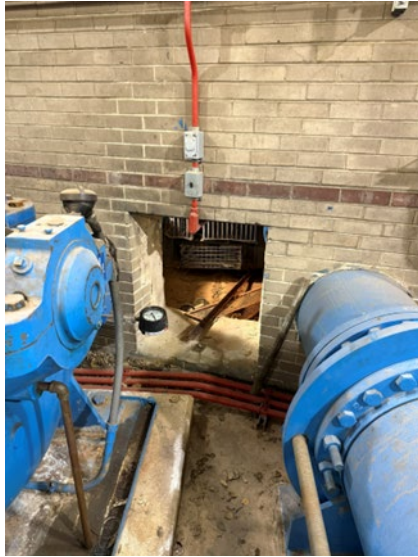
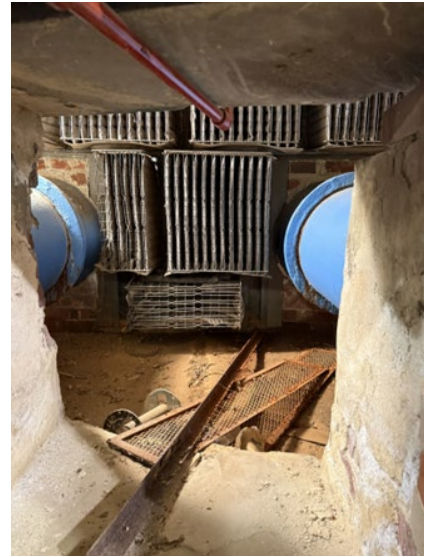
There is a small crawl space on the suction side of the pump station with what appears to be filtered vents. Cold air was observed to be coming through the crawl space.

*Crawl Space*

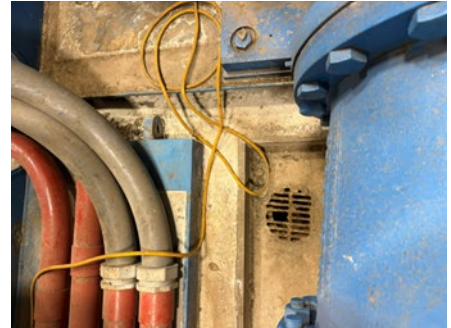
- The floor drains are damaged and recommended to be replaced.
- It is recommended that dehumidification be installed.
- Significant dust and dirt were observed within the pump station. it is recommended that good housekeeping be employed.

*Broken Floor Drain*

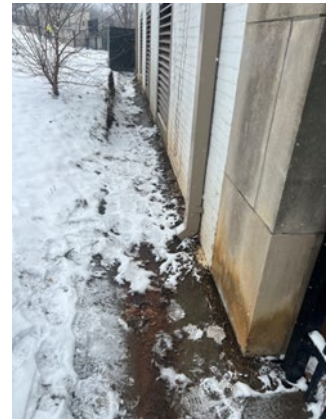
- C1 suction
  - C2 suction
  - C4 suction
- The south side of the pump station building was observed to have water staining up to approximately two feet up the wall potentially from runoff down the hill. It is recommended to consider regrading the site or installing a barrier between the building and the hill.

*Water Staining on South Side*

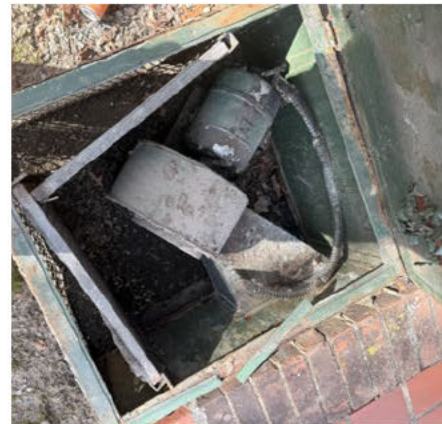
*Inoperable Exhaust Fan*

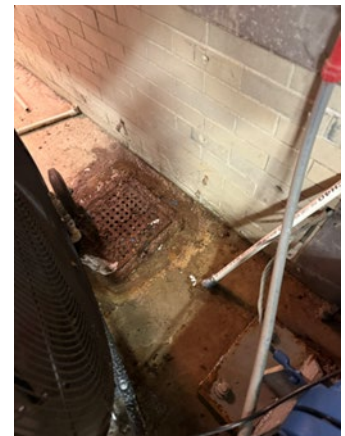
*Corroded Floor Drain*

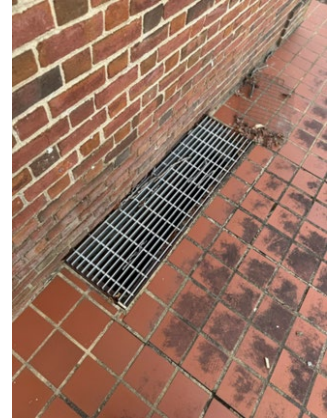
- It is recommended to remove unused equipment from the pump station.
- During the site visit, someone was camped out on the patio next to the exterior exhaust fan.

*North Side Patio*

- Site lighting is recommended above the entrance door and surrounding building to deter loitering.
- It is recommended exposed wiring near left louvre be fixed using a new junction box and conduit fittings.

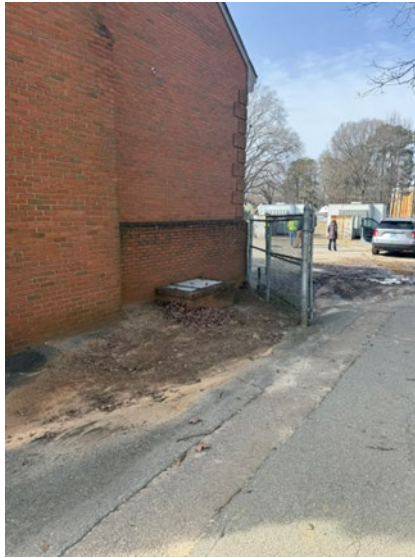
*Removed Air Intake Location*

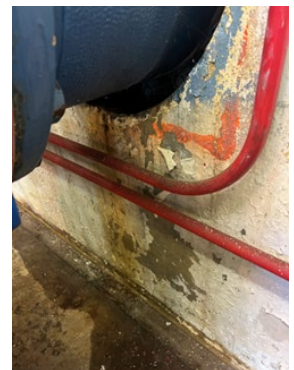
*Groundwater Leak  
through Linkseal*

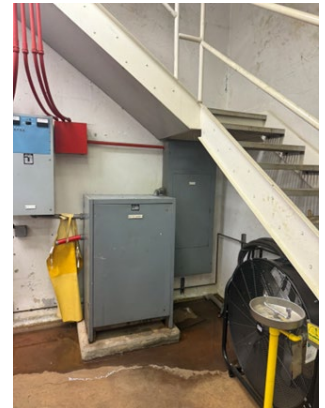
- Water was observed to be pooling around electrical equipment.
- It is recommended the unused conduit extending from the battery cabinet be capped or removed.

*Water Pooling Around Electrical Equipment*

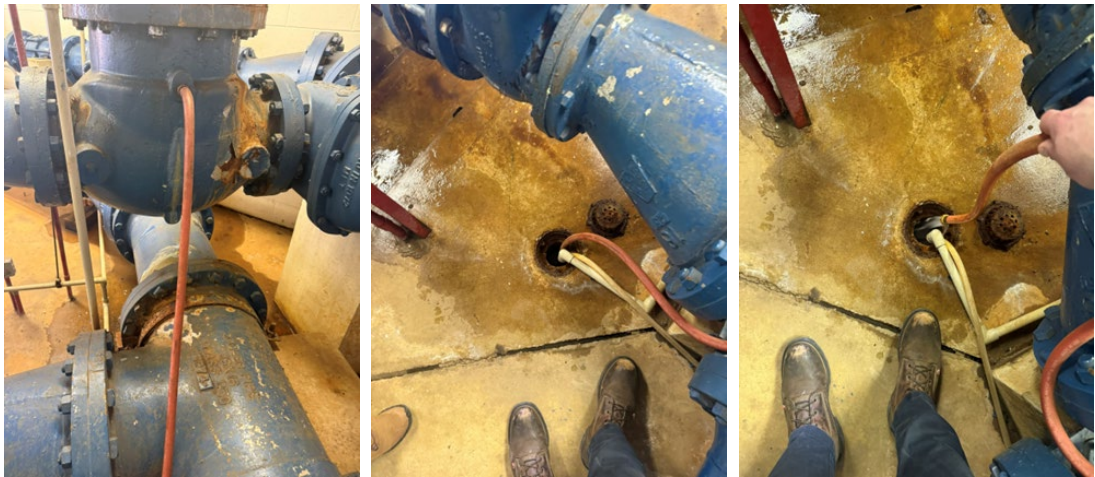
- The hydraulically actuated discharge valves continuously dump water through a hose which is tapped into the side of each valve. These hoses were observed to be inserted deep into the floor drain. These valves should not be operated this way and the taps on the side of each valve should be plugged as these taps are meant for additional valve piping to modify the function of these valves. Additionally, an unprotected hose inserted into the floor drain is a potential cross-connection and continuously dumping water into the floor drain is a waste of water.

*Hydraulically Actuated Valve with Hose to Floor Drain*

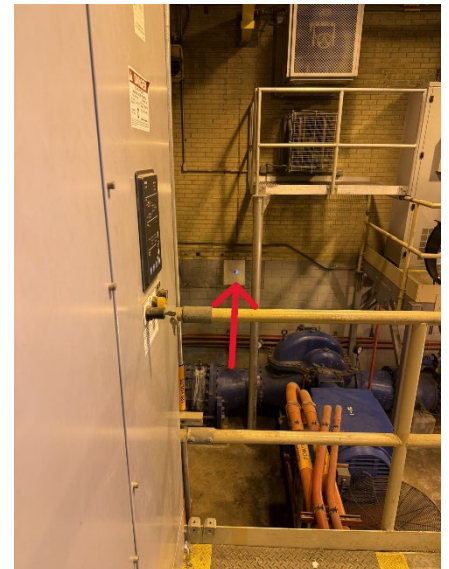
- An old transformer vault exists adjacent to the building on the east side. A hole, approximately a few inches in diameter, through the wall to the old vault let's in daylight. Additionally, numerous unused wall penetrations were observed in the walls of the bottom floor. It is recommended to patch unused wall penetrations.

*Hole Through Wall to Vault*

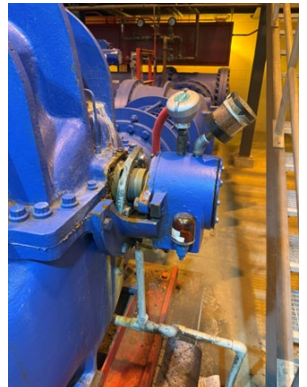
*Missing Shaft Cover*

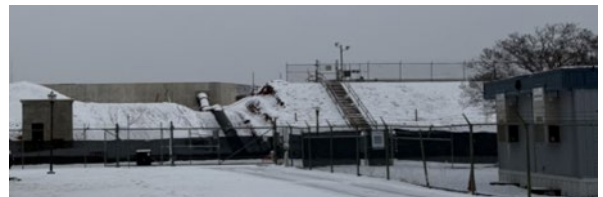
- Due to ongoing construction at the site for the west basin, the reservoir could not be fully inspected.
- A new overflow, which did not exist previously, was observed to be installed.

*New Overflow*

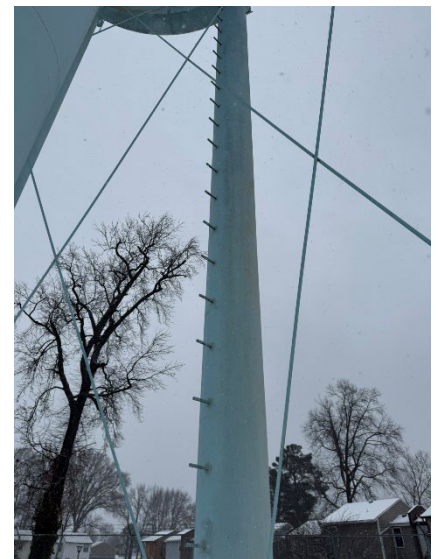
- Condition of the altitude vault was not observed.
- Areas of the barbed wire are facing into the site and areas of the barbed wire were observed to be loose. It is recommended to repair the barbed wire and direct the barbed wire outwards from the site.
- Unused cable brackets on one of the tank legs extend from the ground to the bottom of the tank. While not a security risk, it is recommended that these brackets be cut to prevent people from climbing the tank.
- The cathodic protection was observed to be not operating. Additionally, the exterior coatings were observed to be chalked with areas of rusting. A full coatings rehabilitation is likely needed in the future. During the next rehabilitation project, it is recommended to remove the cathodic protection system. Industry standard is to remove cathodic protection systems as current coating systems utilize a zinc primer.

*Unused Cable Brackets*

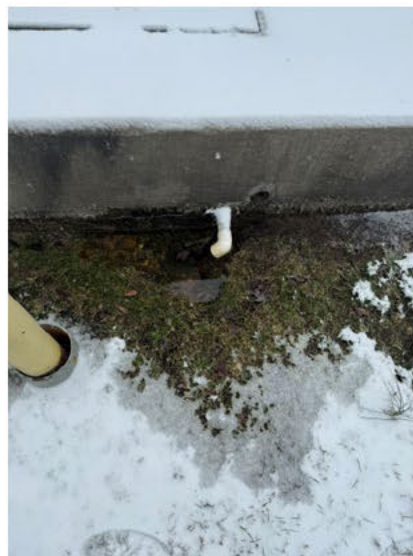
The vault's sump pump discharges out of the side of the vault above grade. It is recommended that the discharge be brought further away from the vault, or a splash pad be installed, to prevent erosion along the vault.

*Sump Pump Discharge*

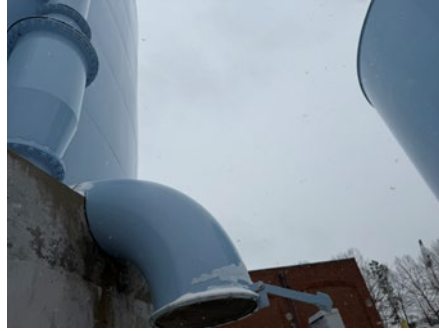
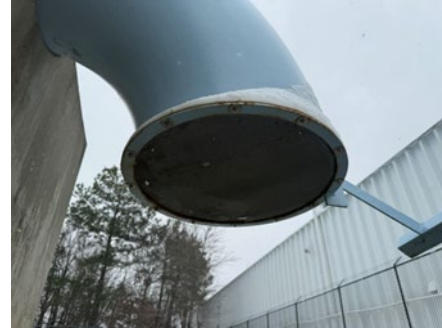
*Screen Flapper Valves*

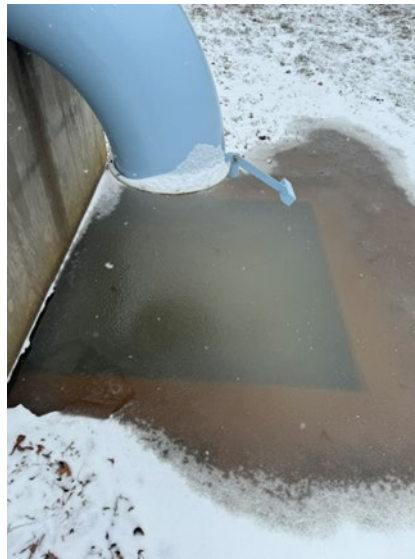
*Flooded Catch Basin*

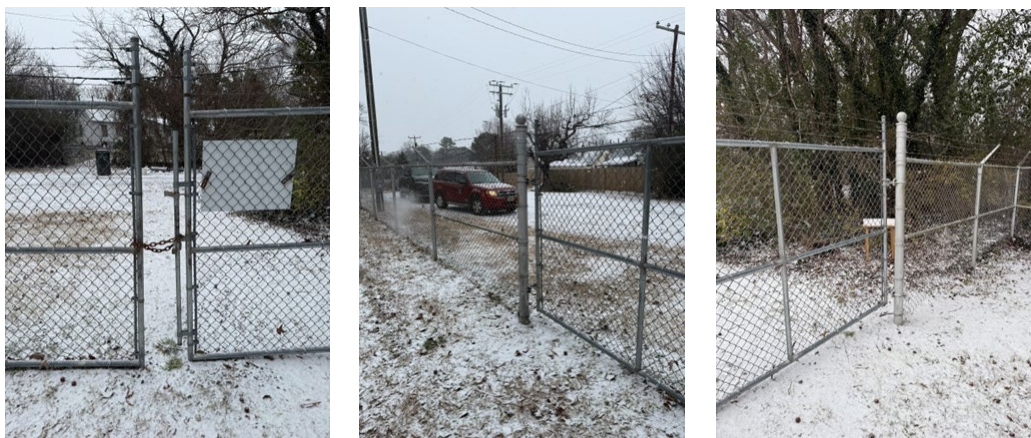
- The vehicle gate was observed to have a large gap between the two gates. Additionally, the hinges for the gates are turned to the exterior of the fence line providing an access to climb the tank. It is recommended to turn the hinges inward which would also close the gap between the two gates.

*Vehicle Gate*

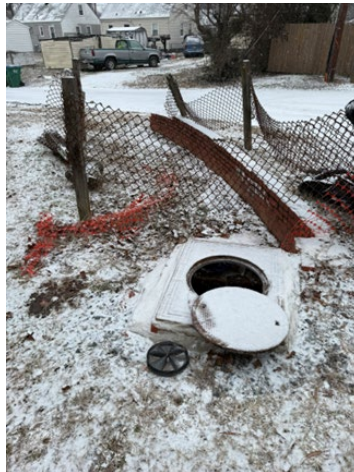
- The overflow manhole was found to be full of water, a tire, and a log. It is recommended to clear out the manhole to provide adequate drainage for the overflow function of the tank. Additionally, the manhole discharges into a brick drainage structure that currently has chainlink and snow fencing around it. Staff stated this is to prevent children from playing on and around the structure. Staff stated that the structure is planned for reconstruction.

*Manhole and Drainage Structure*

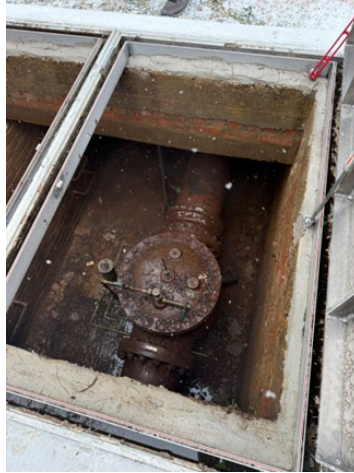
- Process piping coatings within the altitude valve vault were found to be in poor condition. It is recommended that the process piping be blasted and recoated. The vault contains a sump and pump.

*Process Piping within Vault*

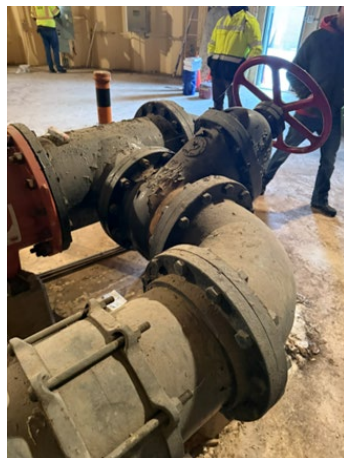
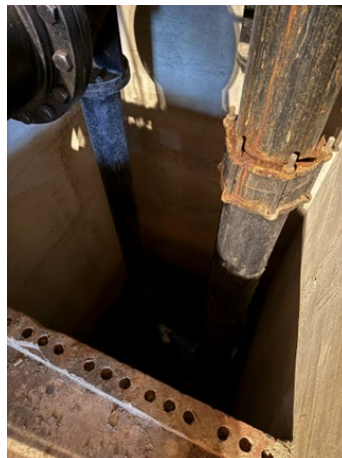
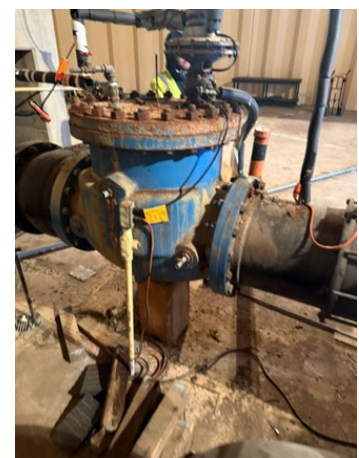
- The process piping within the tank is in poor condition and need of blasting and recoating.

*Process Piping*

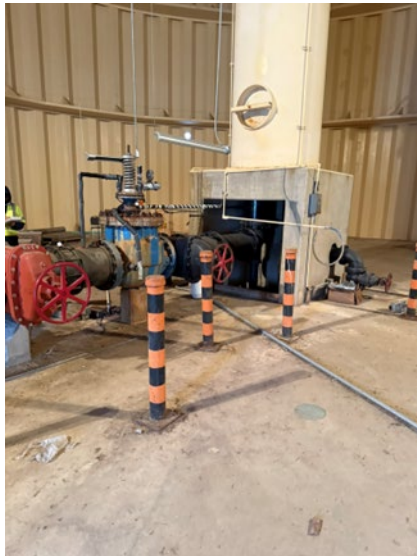
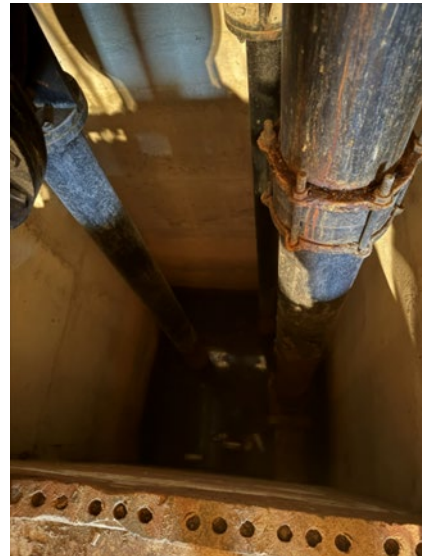
- A vault within the tower that is connected to the dry riser containing the riser, overflow, and drain pipe does not have any fall protection. It is recommended to provide a railing to protect the opening.

*Unprotected Vault*

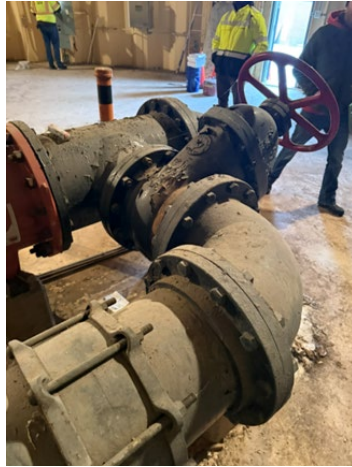
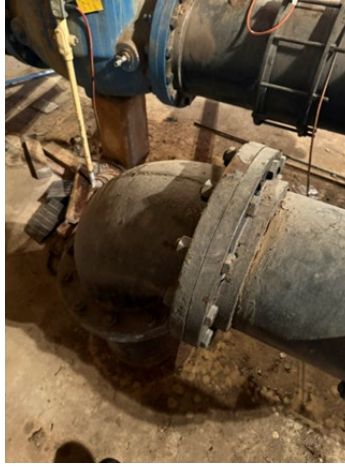
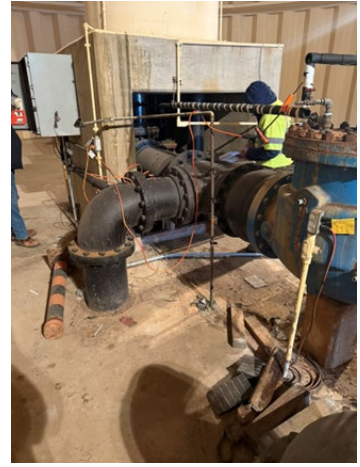
- Heat tape was observed on the altitude valve and heat lamps were observed to be mounted above the rest of the process piping.
- The altitude valve bypass piping dips down under the slab on grade flooring and then back up through the floor before connecting to the riser pipe. This may be to allow access to the altitude valve for installation and removal, though the valve can be accessed on the other side.

*Altitude Valve Bypass Piping*

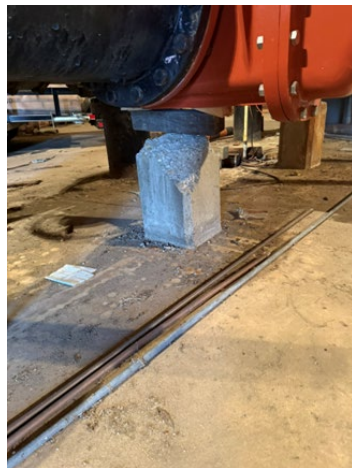
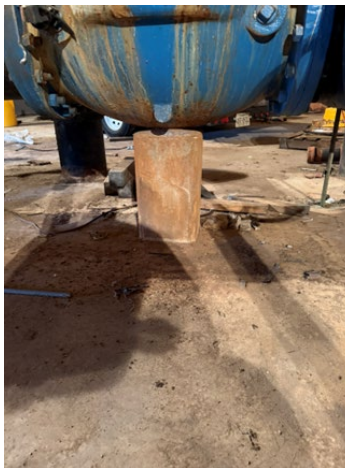
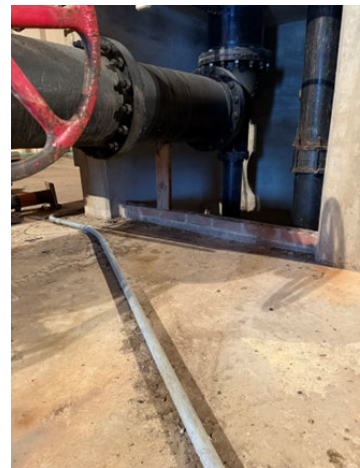
- The process piping is supported by inadequate pipe supports, including a pieces of wood. It is recommended to install adequate pipe supports.

*Pipe Supports*

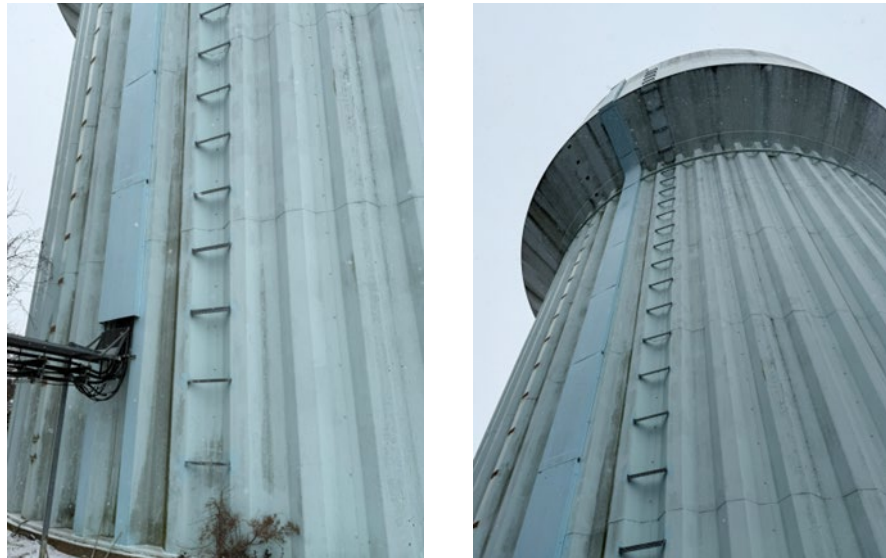
- Brackets on the exterior of the tank are unused and act as a ladder to the tank roof. It is recommended to cut off these brackets.

*Unused Brackets*

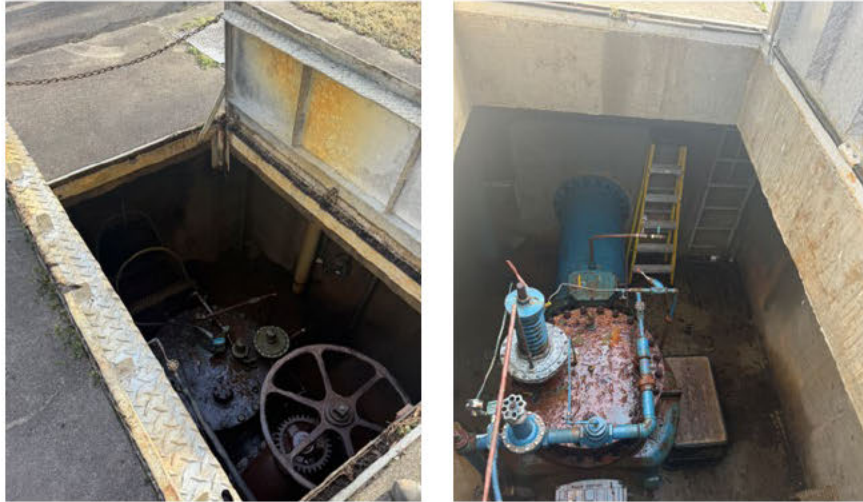
- The tank has two altitude valve vaults, each containing a sump pump, and one containing the tank level transmitter. Staff stated that the altitude valves are alternated. The process piping within the vaults are in need of blasting and recoating. In one of the vaults an altitude valve was observed to be leaking, one of them was observed to be leaking in groundwater onto an electrical box, and the discharge piping for the sump pump in one of the vaults was leaking and allowing discharged water to dump back into the sump.

*Altitude Valve Vaults*

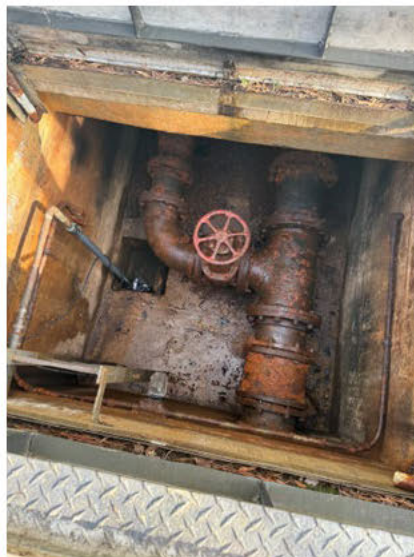
- A third vault, located next to the overflow, contains the tank drain which discharges into a manhole. The vault contains a sump pump. The process piping within the vault is in need of blasting and recoating.

*Vault with Tank Drain*

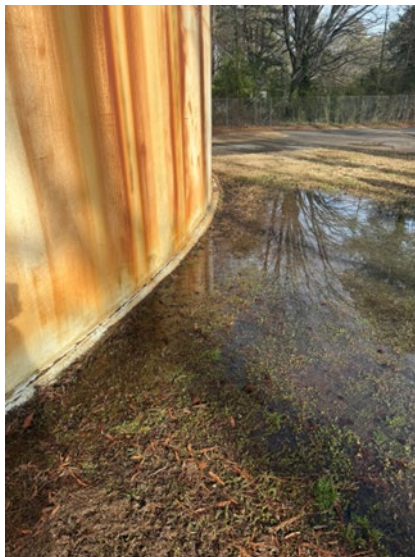
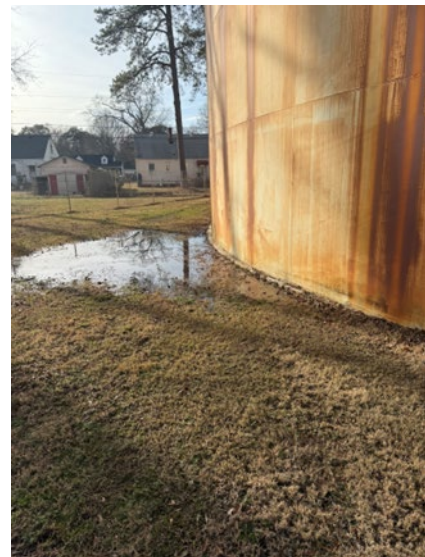
- Water was observed to be pooling around the tank. It is recommended to regrade the site to provide drainage away from the tank.

*Pooled Water*

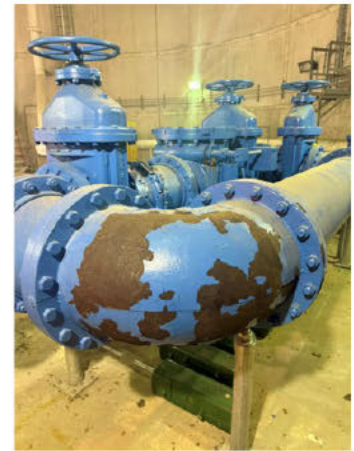
- The process piping within the tower was observed to be covered in dust and with areas in need of blasting and recoating. It is recommended to employ good housekeeping.

*Damaged Process Piping Coating*

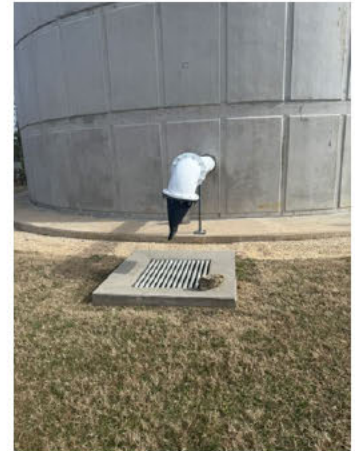
- The overflow discharge is downturned with a duckbill check valve. The overflow discharges into a dedicated catch basin. The discharge elbow is turned at an angle indicating the catch basin was installed in the wrong location and not centered on the overflow discharge.

*Overflow*

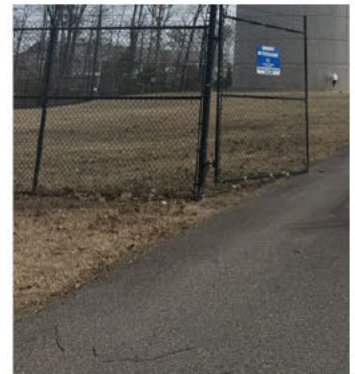
- The front gate is bent likely due to the hinges being rotated differently. It is recommended to repair the gate.

*Bent Gate*

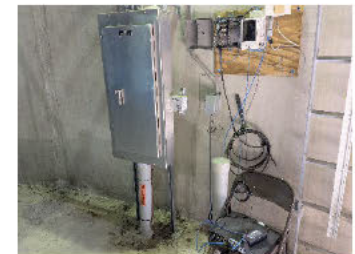
- It was observed that the communications equipment was not properly installed. A router was using a metal folding chair as a shelf. There was also a piece of equipment ziptied to conduit. This equipment should be properly mounted to the backboard or have wall mounted enclosures installed for their protection.

*Communication Equipment*

*Equipment in top right of image is mounted on conduit using ziptie.*

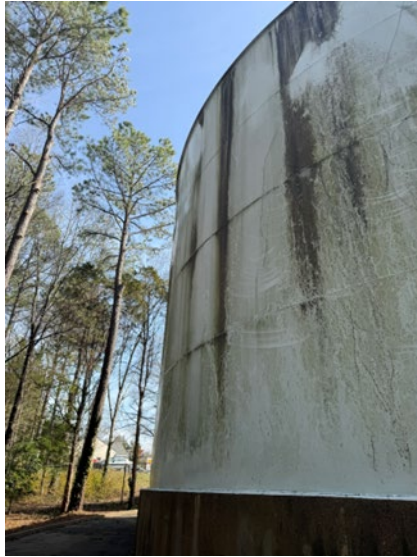
- The tank exterior was observed to have mildew and rust was observed along the base plate. Staff stated that the tank is planned to be pressure washed in the near future. During the next rehabilitation project, it is recommended to remove the cathodic protection system. Industry standard is to remove cathodic protection systems as current coating systems utilize a zinc primer. An inspection report from April 2023 noted recommendations for the interior and exterior of the tank that should be addressed at the next inspection or rehabilitation project (5 years).

*Mildew on Tank Exterior*
