# Comprehensive Waterworks Evaluation and Cost Estimate

## City of Richmond, VA

Virginia Department of Health, Office of Drinking Water

VADOH 183662 | April 8, 2025

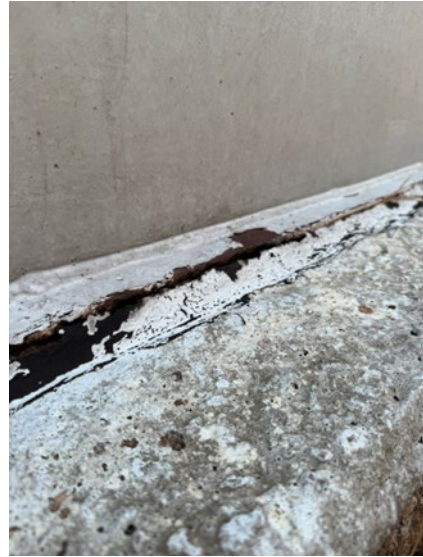
- The tank exterior was observed to have mildew and rust was observed along the base plate. Staff stated that the tank is planned to be pressure washed in the near future. During the next rehabilitation project, it is recommended to remove the cathodic protection system. Industry standard is to remove cathodic protection systems as current coating systems utilize a zinc primer. An inspection report from April 2023 noted recommendations for the interior and exterior of the tank that should be addressed at the next inspection or rehabilitation project (5 years).

*Corroded Base Plate*

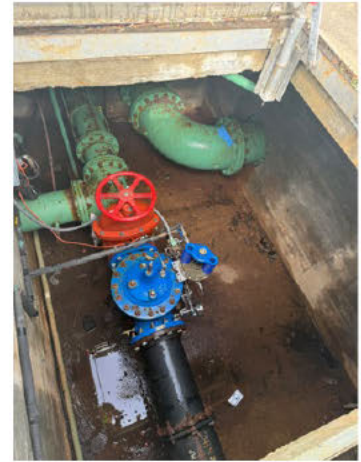
- The altitude valve is located within a vault. The vault also contains the altitude valve bypass line, the tank effluent line, and a sump pump. The process piping within the vault is in need of blasting and recoating and a section of the piping has never been painted.

*Altitude Valve Vault*

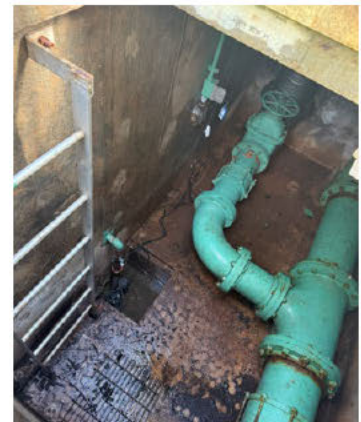
- A second vault on the other side of the tank contains the tank's overflow and tank drain. The vault contains a sump pump.

*Tank Overflow and Drain Vault*

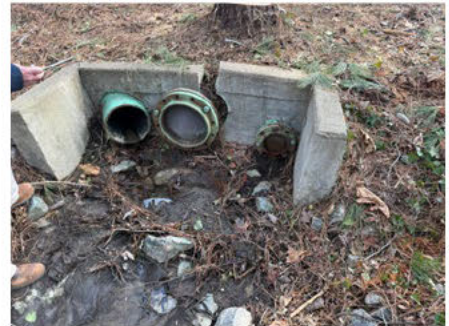
- The overflow discharge, an unknown discharge, and a discharge line from a nearby catch basin discharge into a common drainage structure. The drainage structure is damaged and in need of repair. It was thought the unknown discharge is the tank drain though the tank drain discharges into the overflow pipe. Both the overflow and unknown pipes are screened.

*Damaged Drainage Structure*

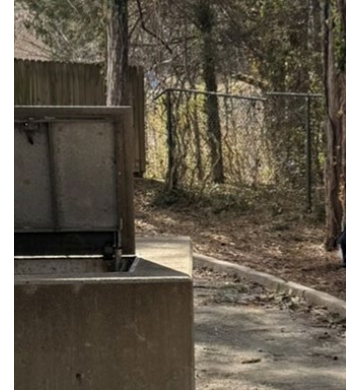
- It is recommended to install security fencing (6 ft or more) with barbed wire to surround the entire site. The existing fence on the north side of the site is damaged in areas and vegetation was observed to be encroaching on the site fencing. It is recommended to provide a sterile zone along the fence line and repair the damaged areas of the fence.

*Damaged Fence*
